Clifton Scannell Emerson
Associates

Appraisal of Existing Structures Abbeylands Public Realm Cavan for Design and Redevelopment

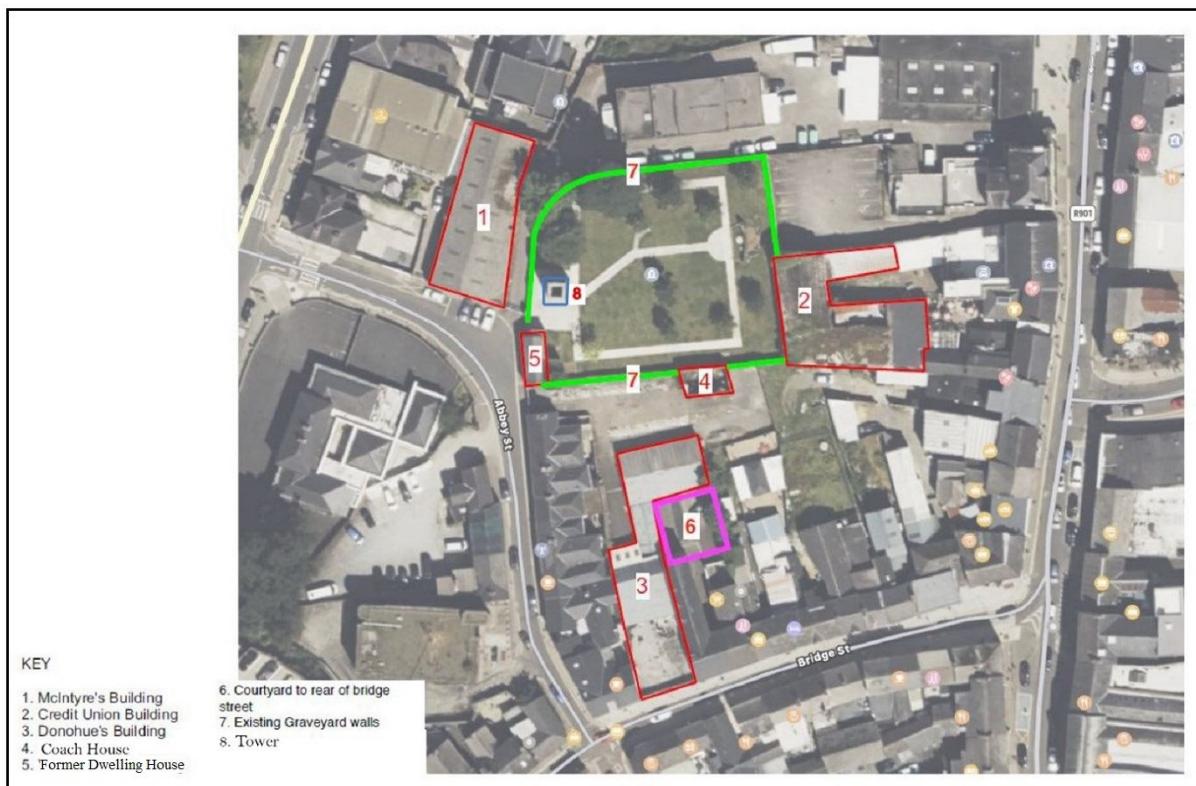
2 McIntyre's Building

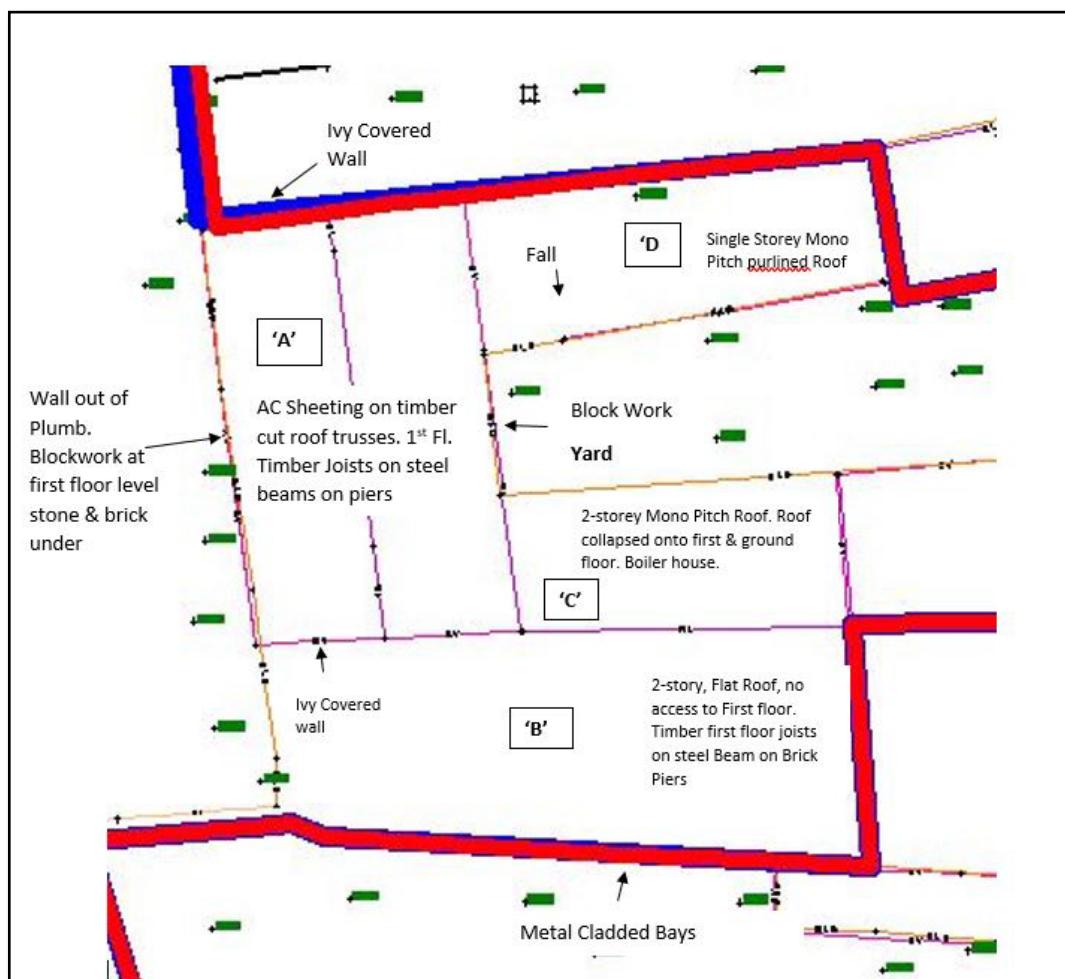
Building "A" is a two storey structure with a timber trussed roof and timber first floor supported by steel beams. It's western wall faces onto the graveyard and consists of stone and brick with the first floor

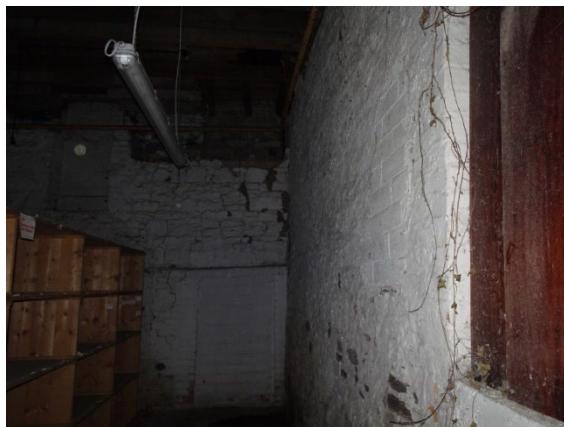
Crack in Southern Wall A

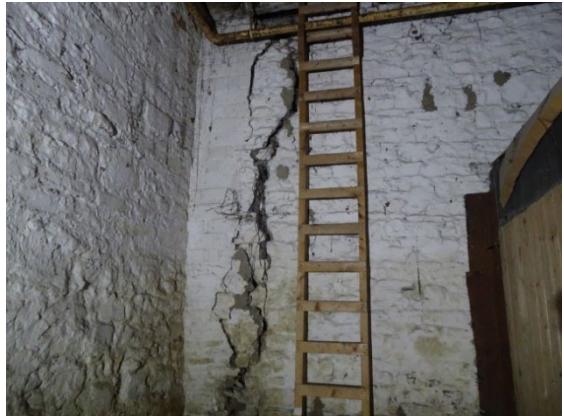
Crack in Northern Wall 2022 A

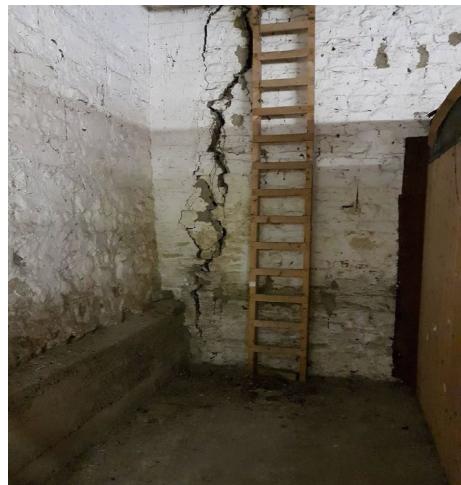
Crack in Northern Wall 2019 A

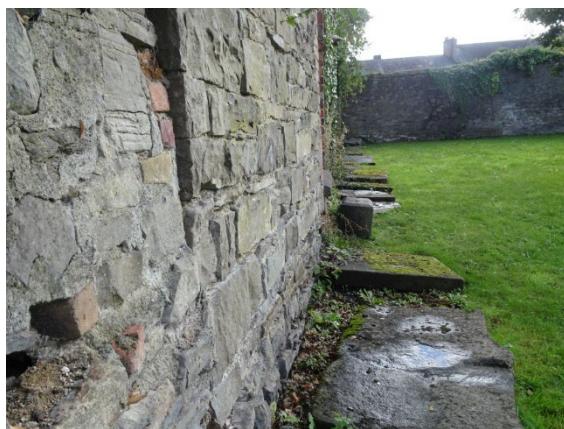
Western Wall Misaligned and Out of Plumb A

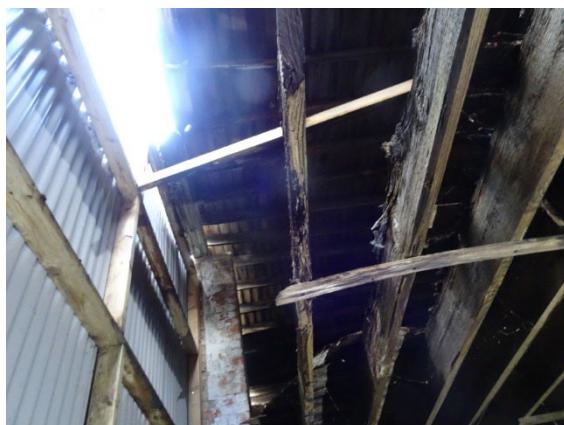
Flat Roof Section Roof Failure, South wall Metal cladding, and First Floor Joists Decayed B

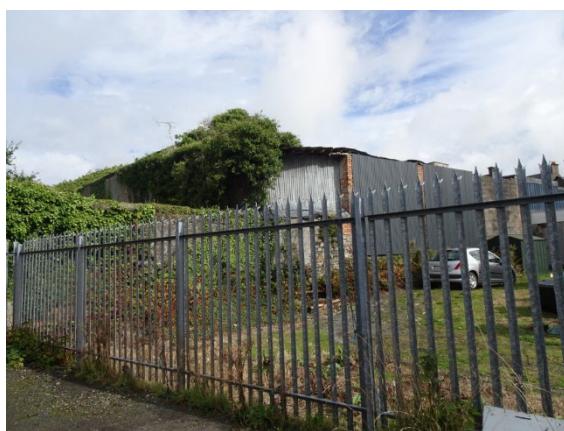
External View Wall Cladding Panels B

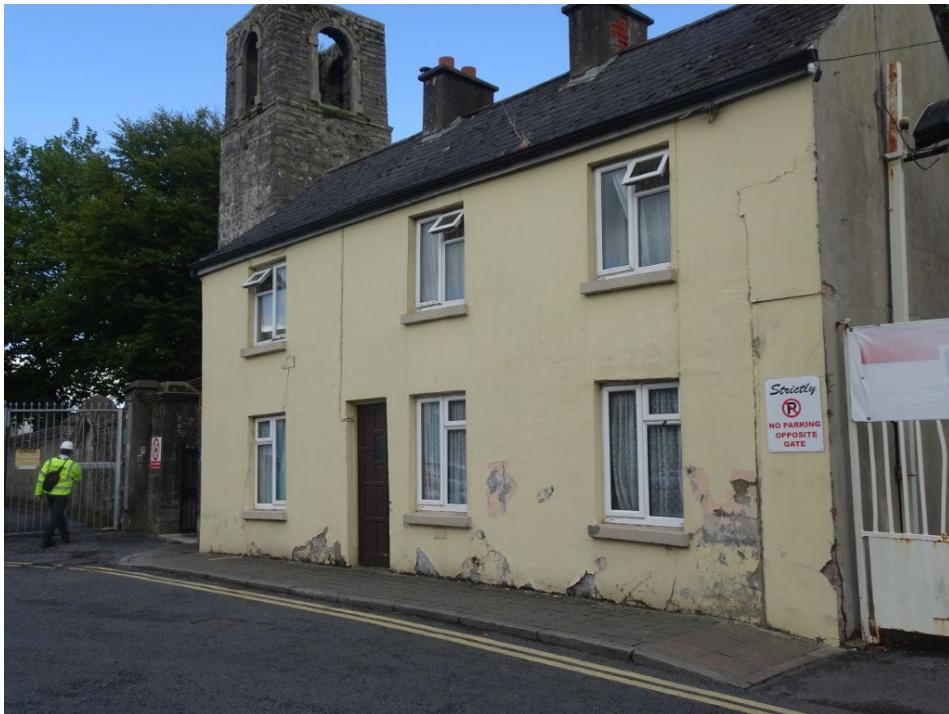
Front Elevation is in Good Condition

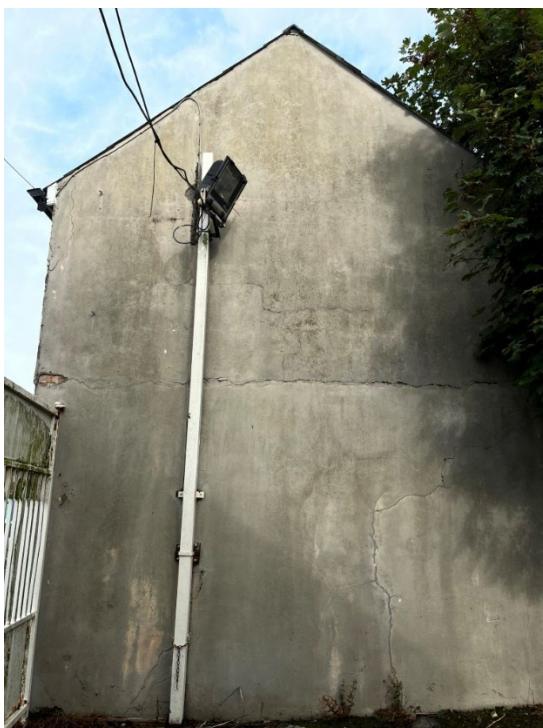
Southern Elevation with some Plaster Cracking but is in quite good condition

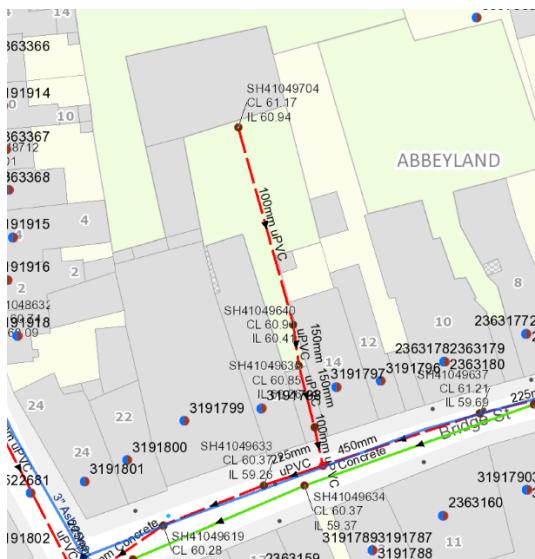
Irish Water records of Foul drainage manhole levels in courtyard leading to Bridge Street

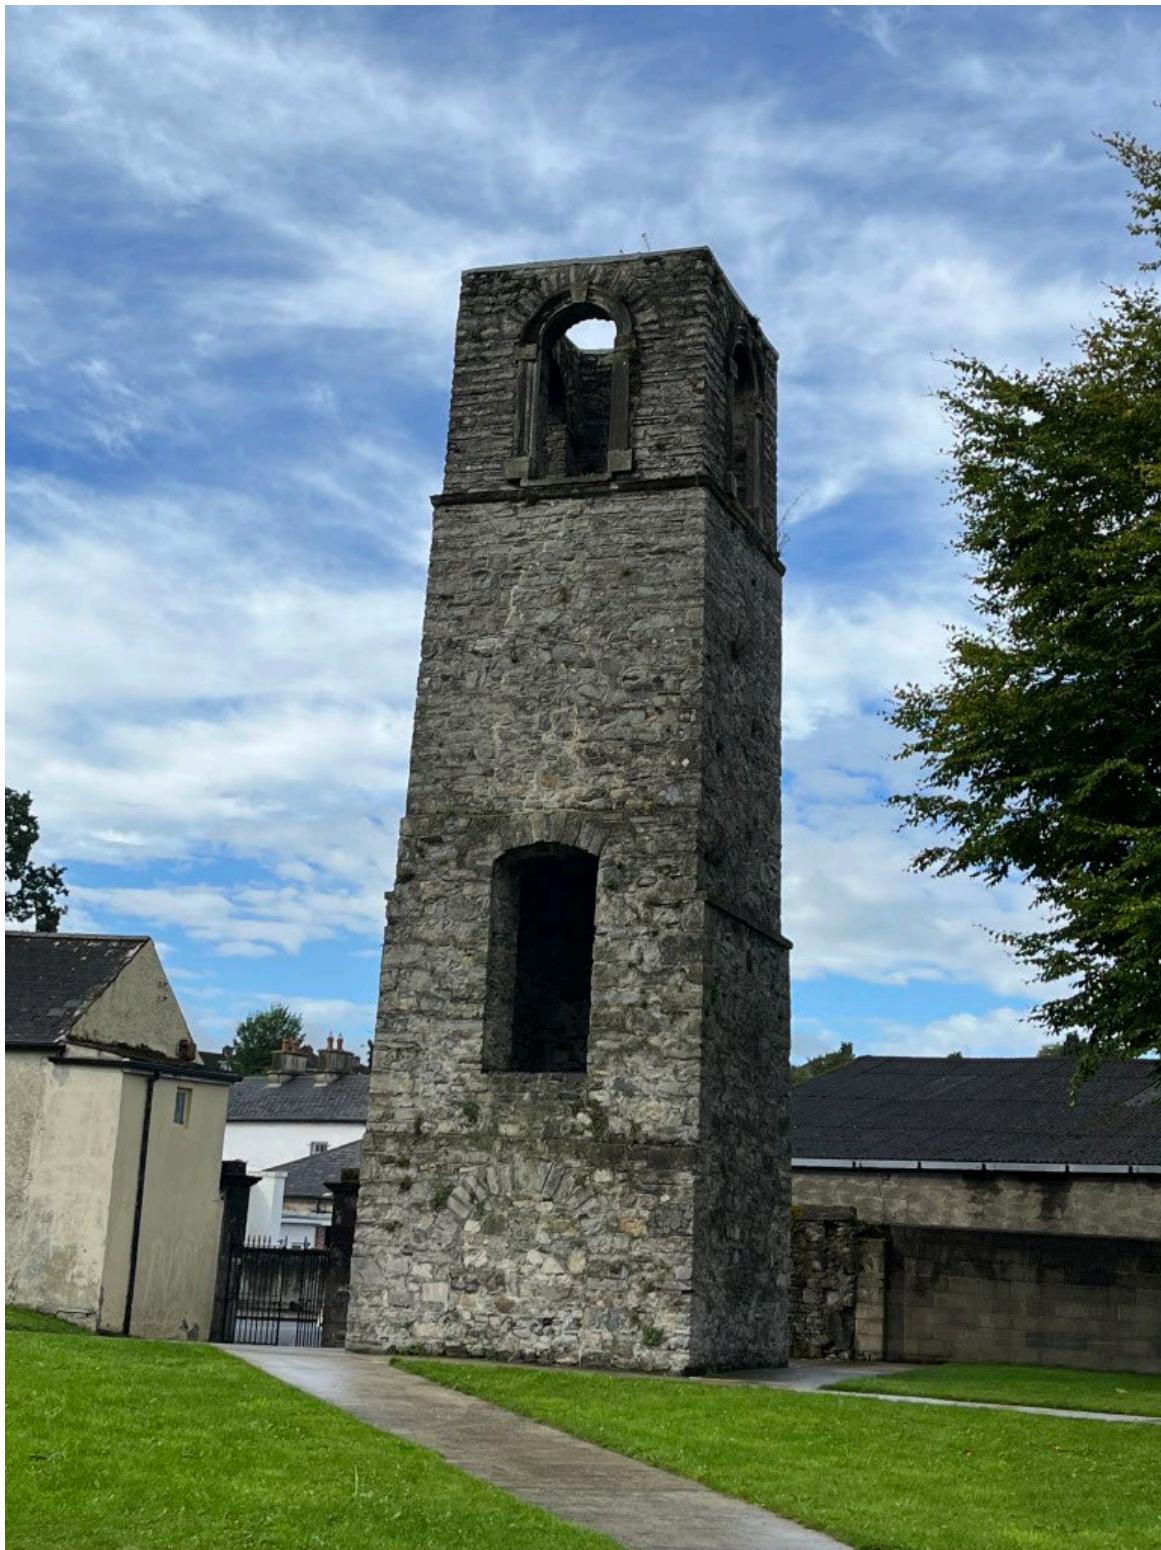
The Existing Tower observed to be in reasonable structural condition
