**Bat surveys and Building Assessment for Bats  
Development at Abbeyland, Cavan town, Co. Cavan**

**September 2022**

**Report prepared for:  
Cooney Architects and DHB Architects, September 2022**

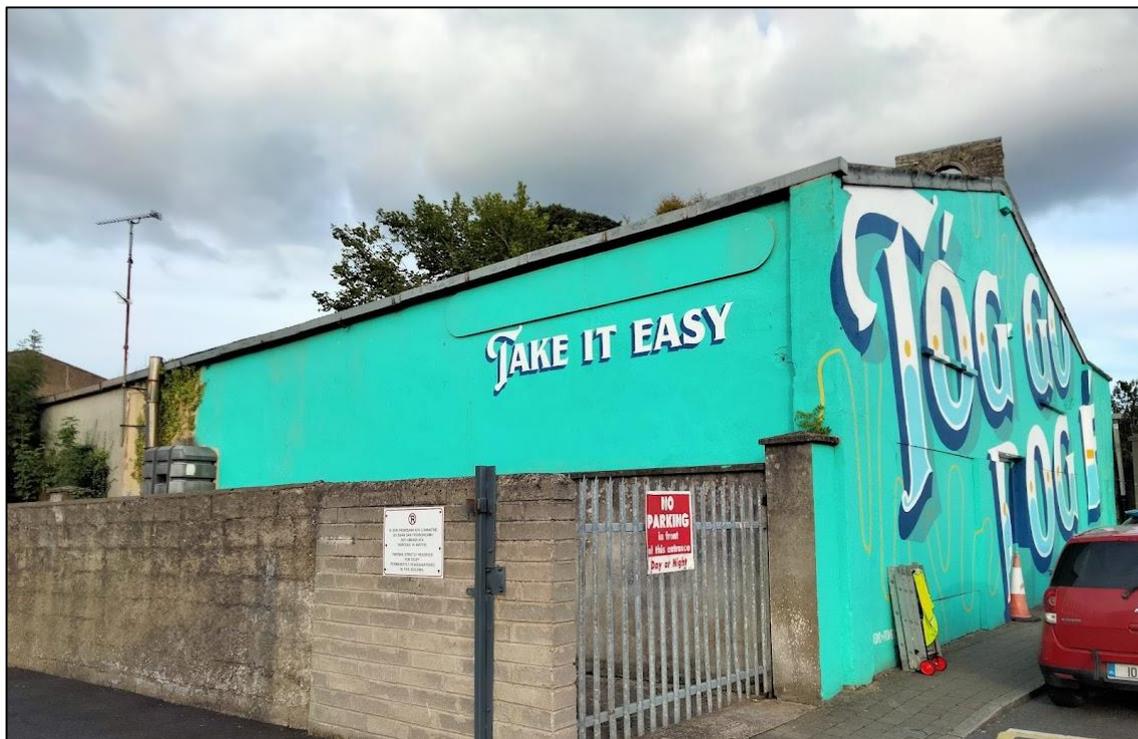
Plate 1. McIntyre's front and west side. Photo facing north-east

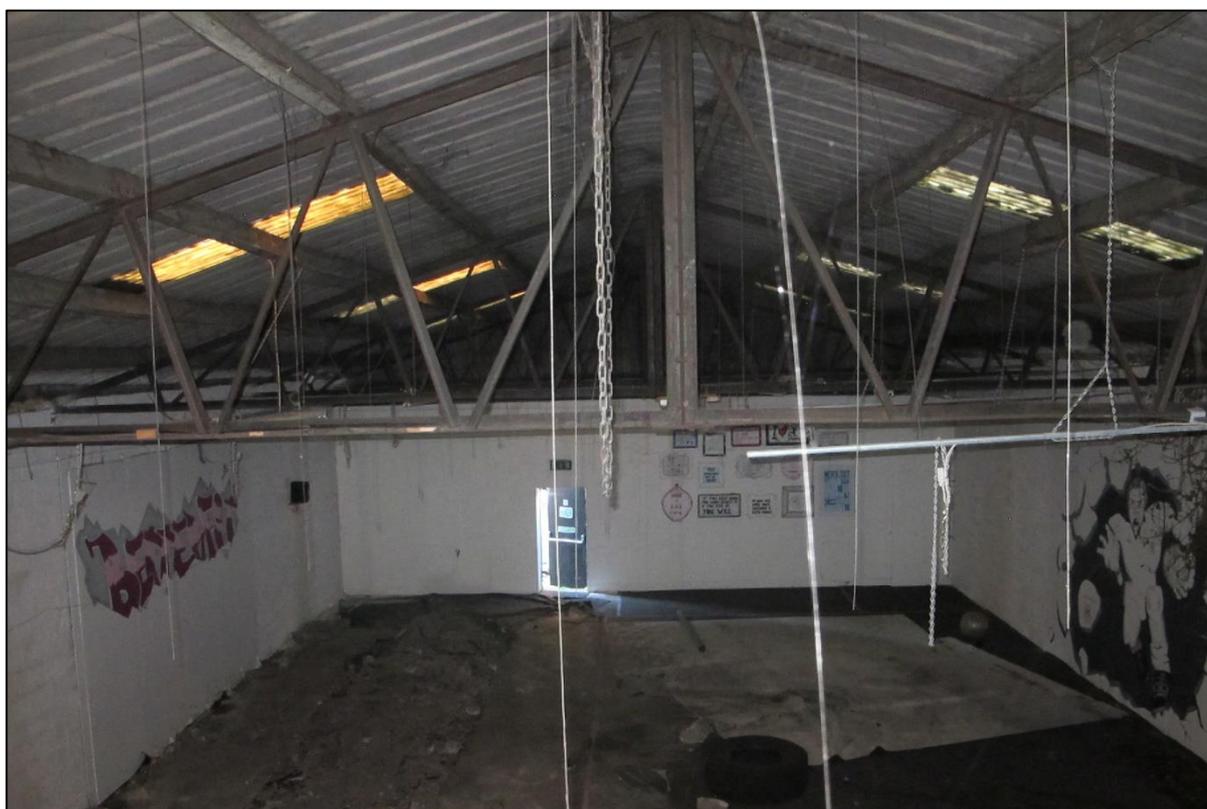
McIntyre's is a modern building with sheet metal roofing with no discernible access points for bats with exception of the east side of the building where sections of the external wall are rough and unfinished. This area corresponds with an interior toilet which showed signs of a rat infestation. Signs of rodents were restricted to the toilet and were not observed elsewhere in the building. The wall is not considered suitable for bat roosts as it suffers severe light pollution from the An Post access lane running adjacent to the wall.

Plate 2. McIntyre's interior. Photo facing rear wall,

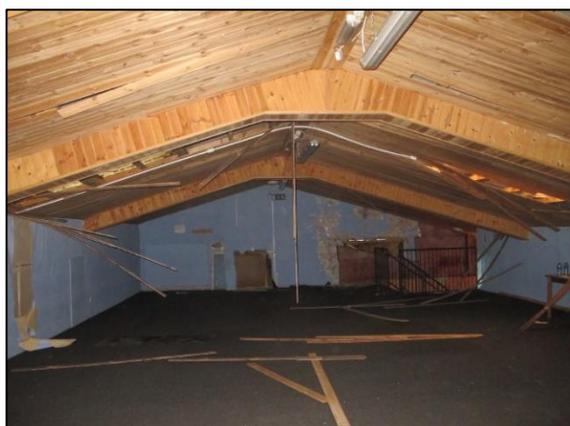
**Plate 3.** First floor with timber cladding

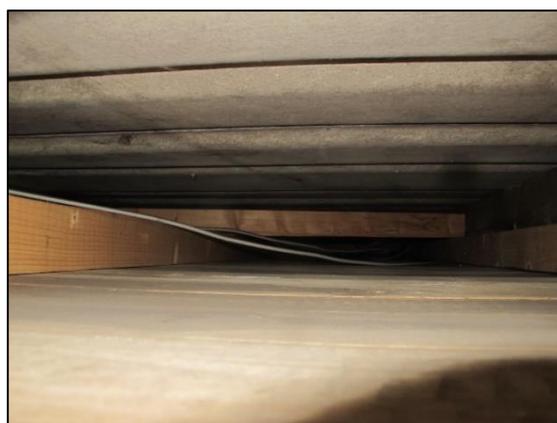
**Plate 4.** Space between sheet metal roof (above) and cladding (below) is not insulated

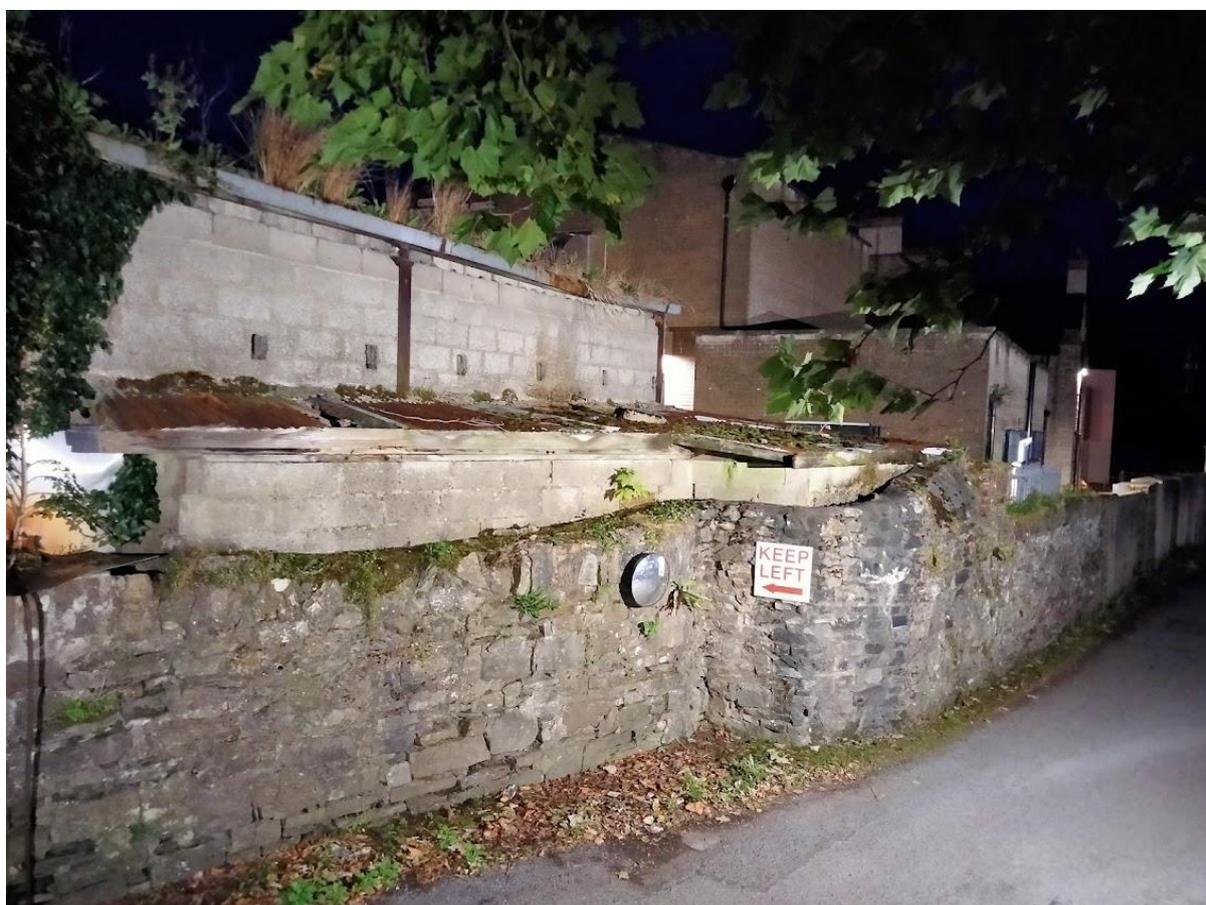
**Plate 5.** McIntyre's east side is subject to serious light pollution from brightly lit access lane (An Post) which greatly reduces suitability for bats roosting. These lights overspill into the adjacent Abbeyland Park and negatively impact the foraging potential for bats. Photo facing north-west

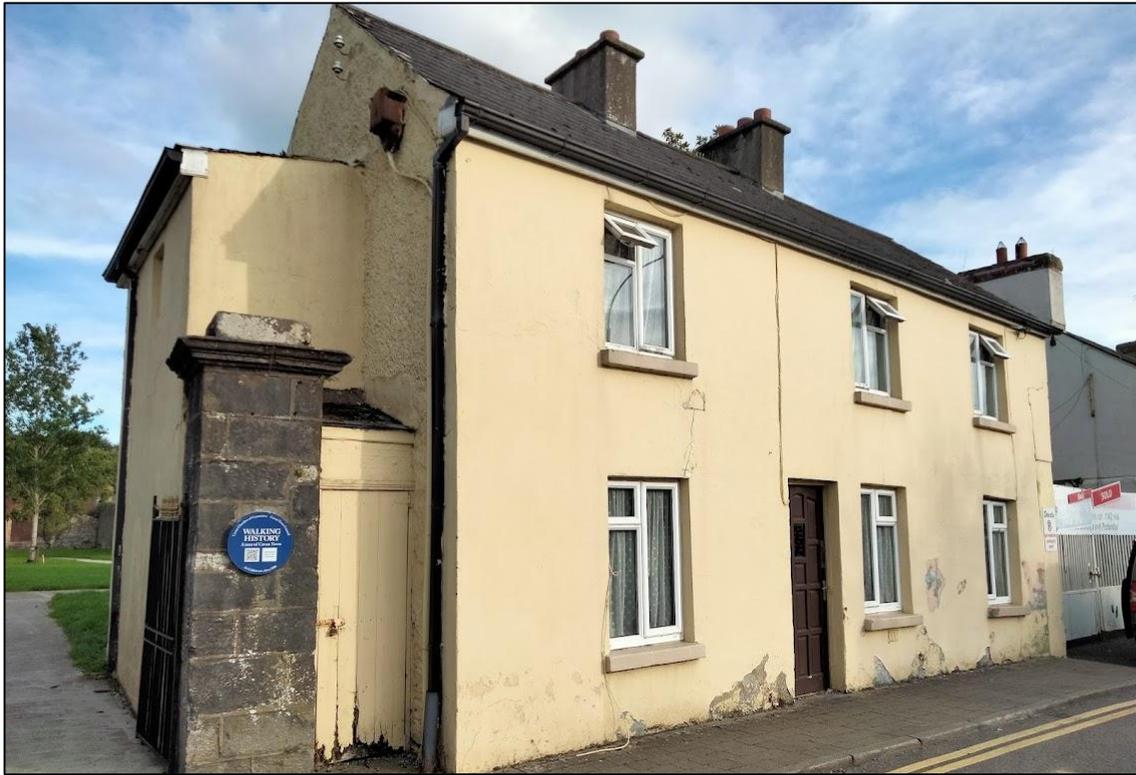
**Plate 6.** Front of 16 Abbey Street. Photo facing south-east

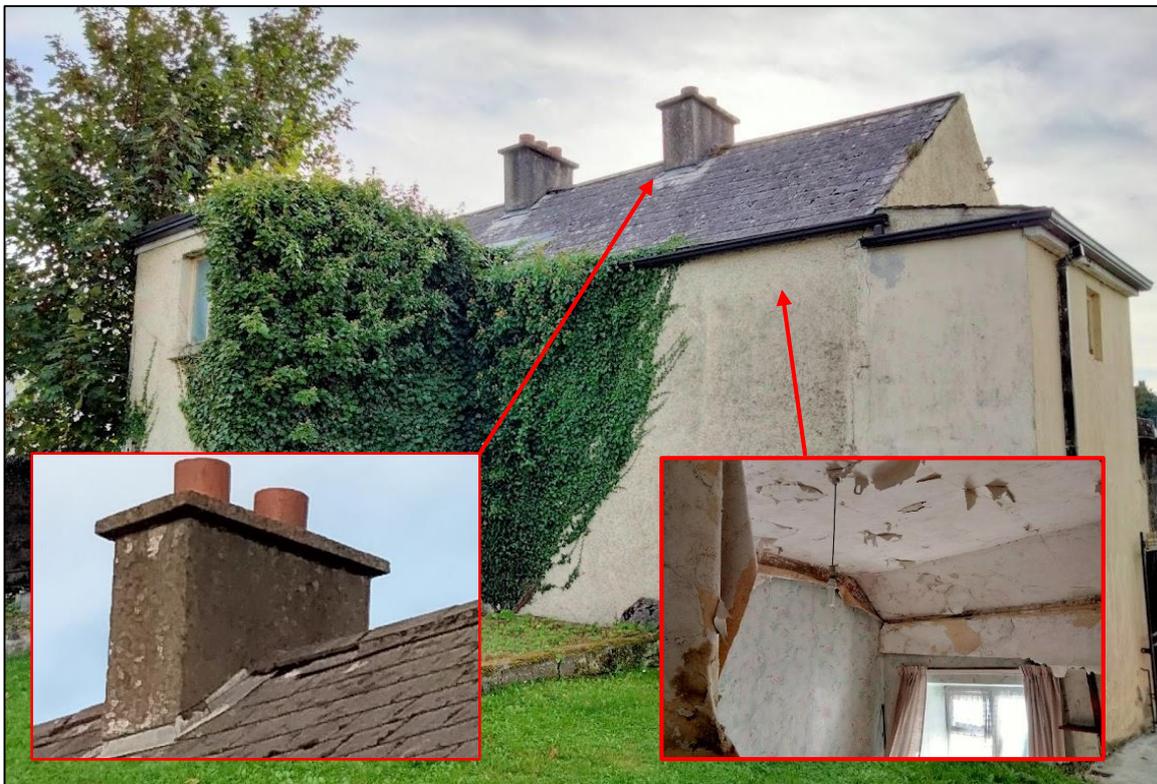
No 16 is a detached two-story house in poor repair with water ingress through the roof causing dampness throughout the building and adversely affecting the upstairs ceiling though it is still intact. The ceiling is not provided with an access hatch which makes a survey of the attic space impossible. The water storage tank is located on the flat roof extension to the rear of the house. The rear slated roof has gaps around ridge tiles and chimney flashing which are potential access points for bats.

**Plate 7.** Rear of 16 Abbey Street. Roof has potential bat roost features around chimney flashing and ridge (inset photo). Building suffers from damp with apparent water ingress of rain through roof with ceiling plaster deteriorating. Ceiling has no attic hatch and roof space could not be surveyed. Water storage tank is located on flat roof at rear of house. Photo facing south-west

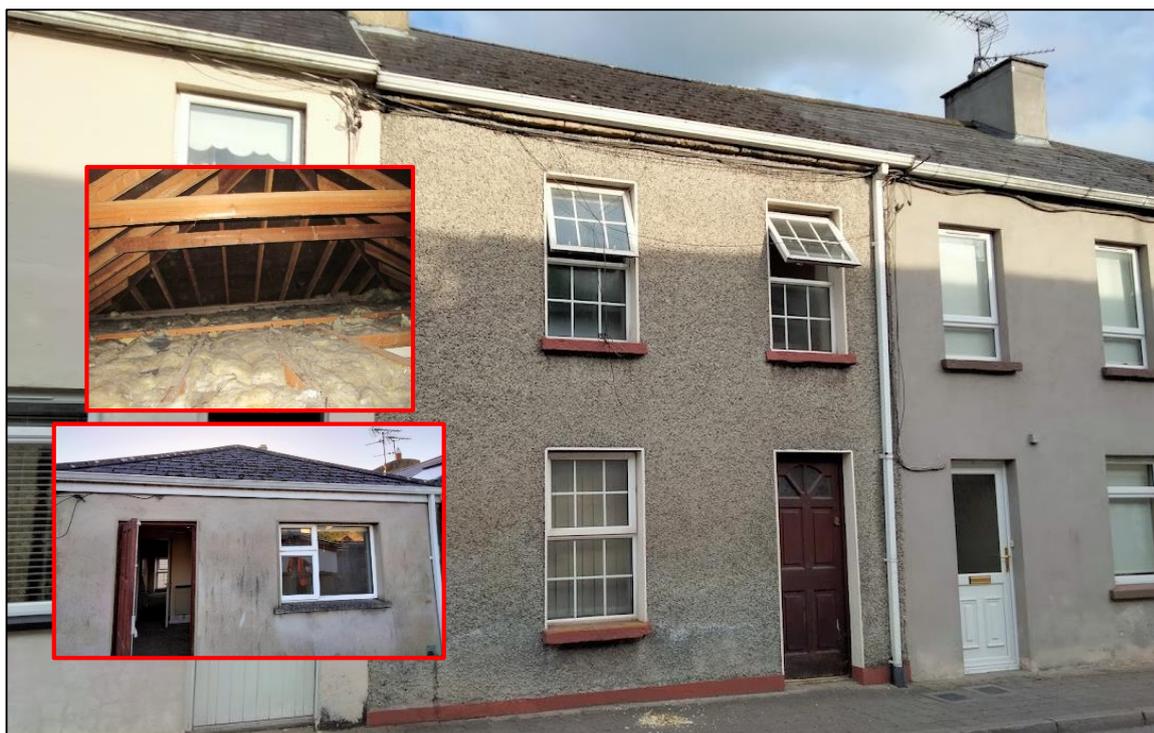
No 8 is a terraced house in good condition and no access points for bats were noted on the exterior. The search of the house and attic space revealed no trace of bats.

**Plate 8.** Exterior 8 Abbey Street (centre) with inset photos of rear roof and attic

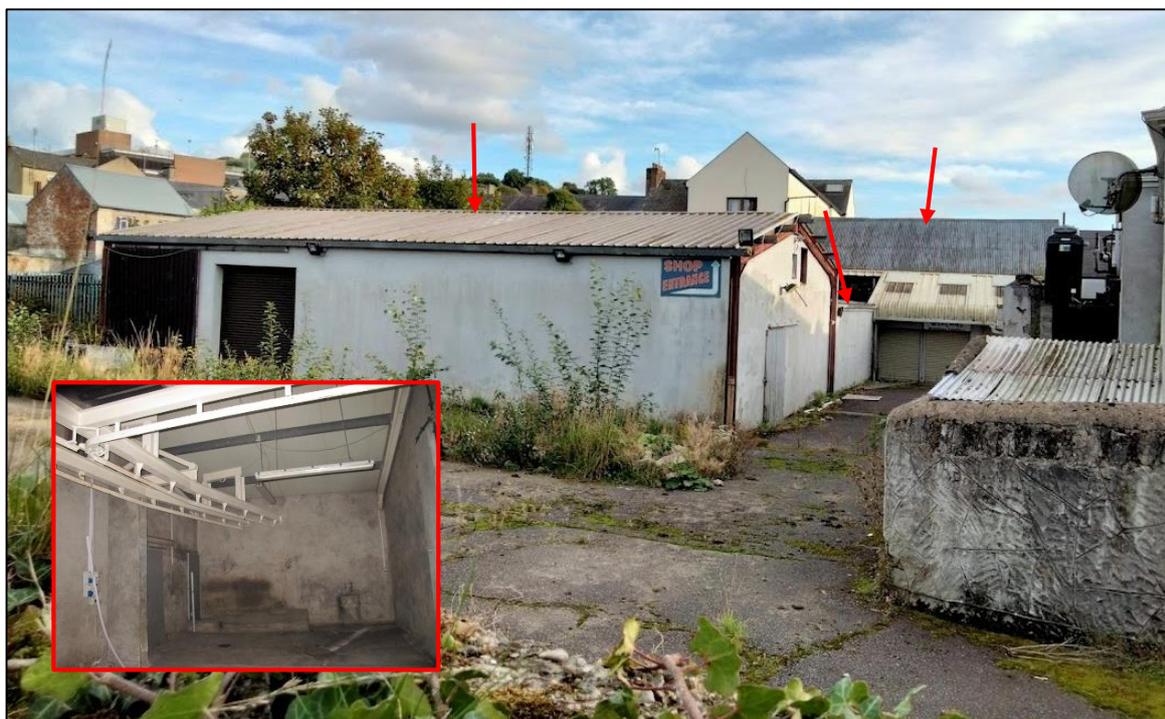
**Plate 9.** Rear of Donohoe's Foodfare buildings, marked with red arrows. Inset photo of meat processing room. Photo facing south

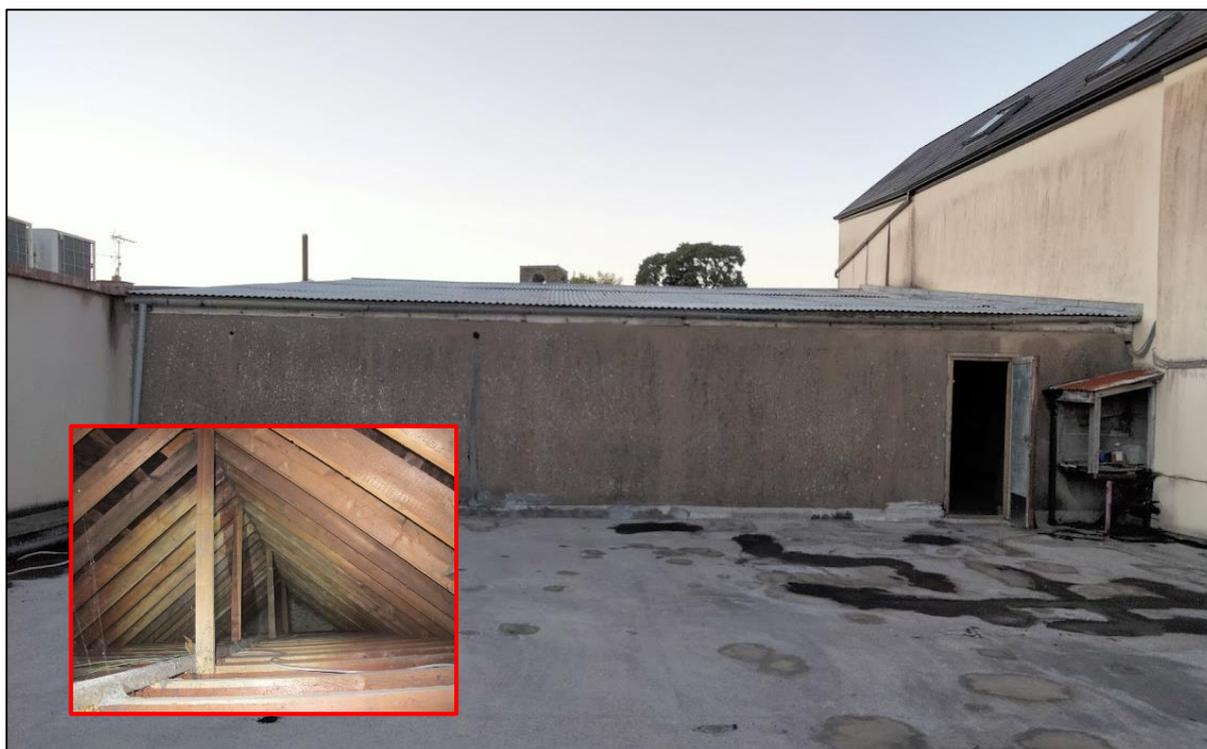
**Plate 10.** South facing corrugated roof of Donohoe's Foodfare. Inset photo of attic. Photo facing north

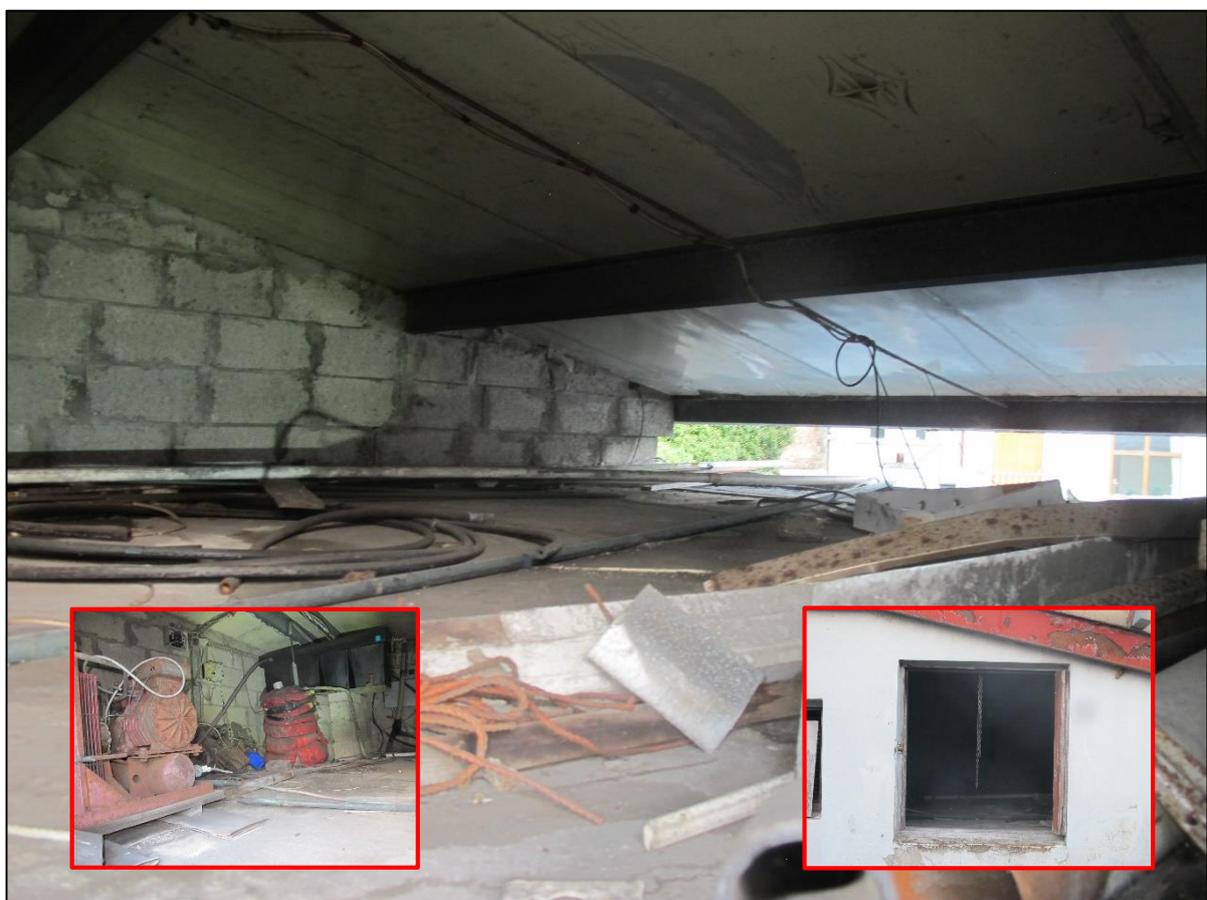
Donohoe's Foodfare is a collection of buildings associated with food processing and storage. The buildings have sheet metal roofs. The first floor has an attic space with sufficient height to be used by bats. No signs of bats were observed with the exception of a small open area housing machinery located over meat processing rooms below. Two unidentified droppings were noted at the opening of this space on its north side. In the absence of any other signs of bat activity, including feeding remains, i.e. moth wings, it is probable the droppings arose from bats entering the space exploring or hunting for insects at night.

**Plate 11.** Donohoe's Foodfare machinery housing. Inset photos of machinery and services (left) and west facing hatch (right) where two bat droppings were noted.

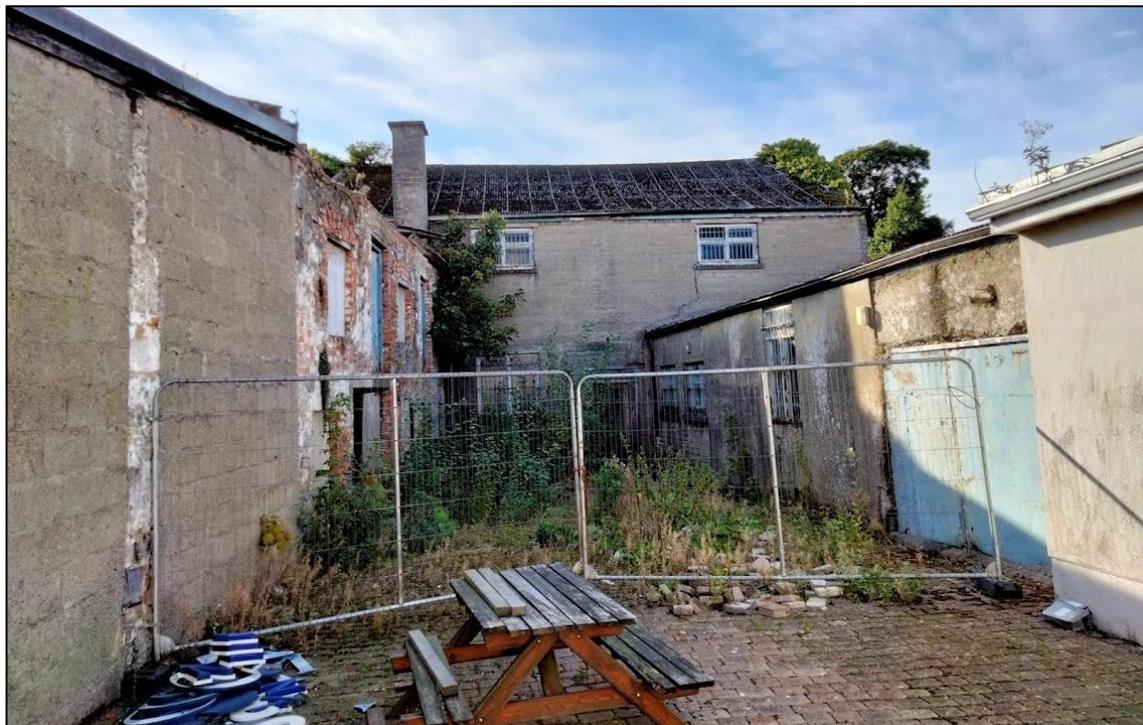
Plate 12. Back Building (centre) with left annex (left) and right annex (right)

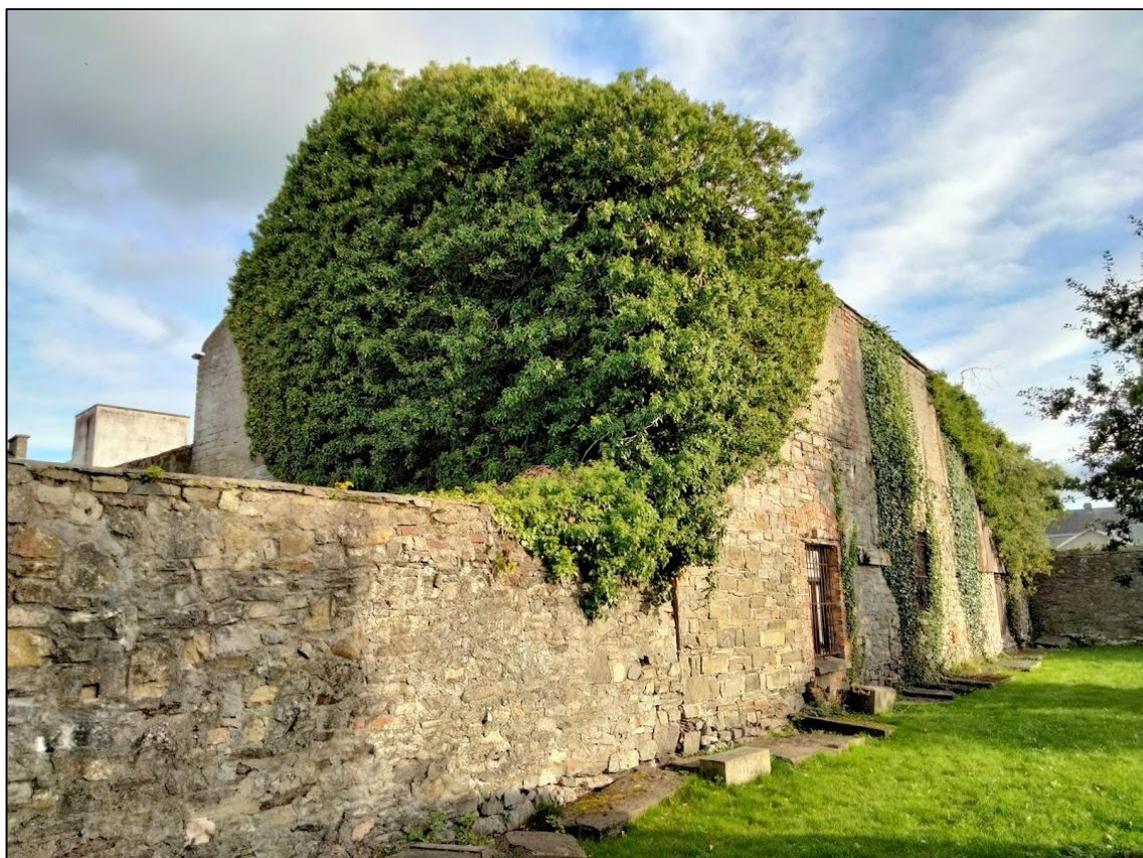
Plate 13. Rear of Back Building facing west onto Abbeyland Park with northern side on left. Photo facing south-east

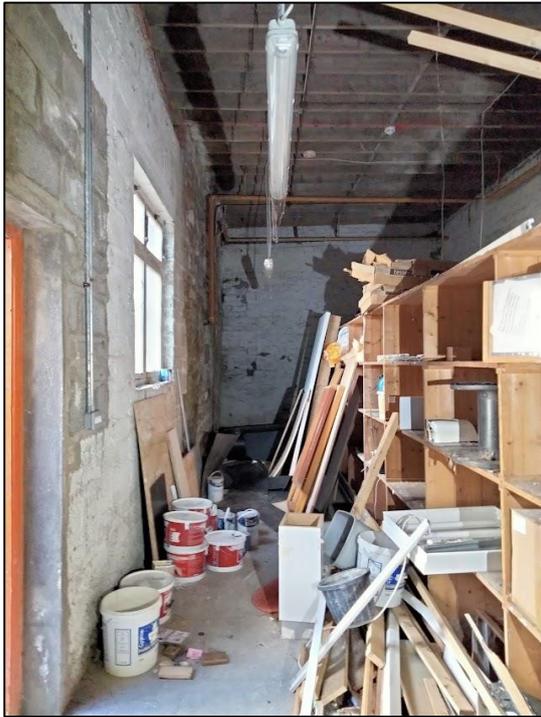
**Plate 14.** Inner bay of Back Building (front door on left)

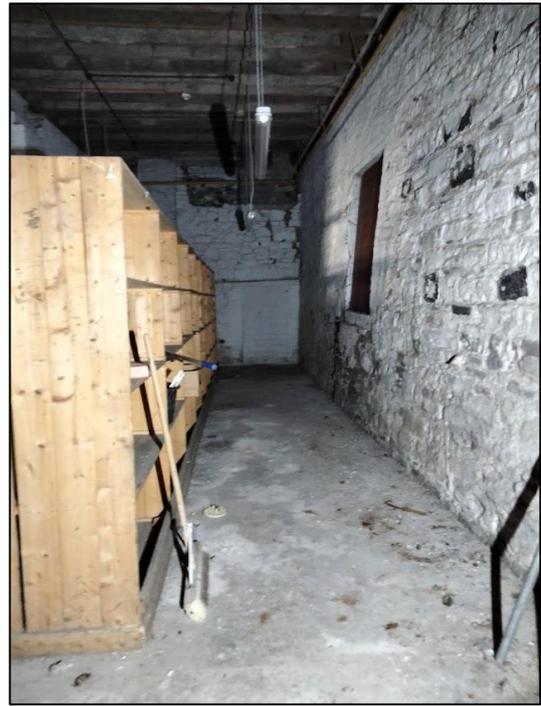
**Plate 15.** Outer bay of Back Building

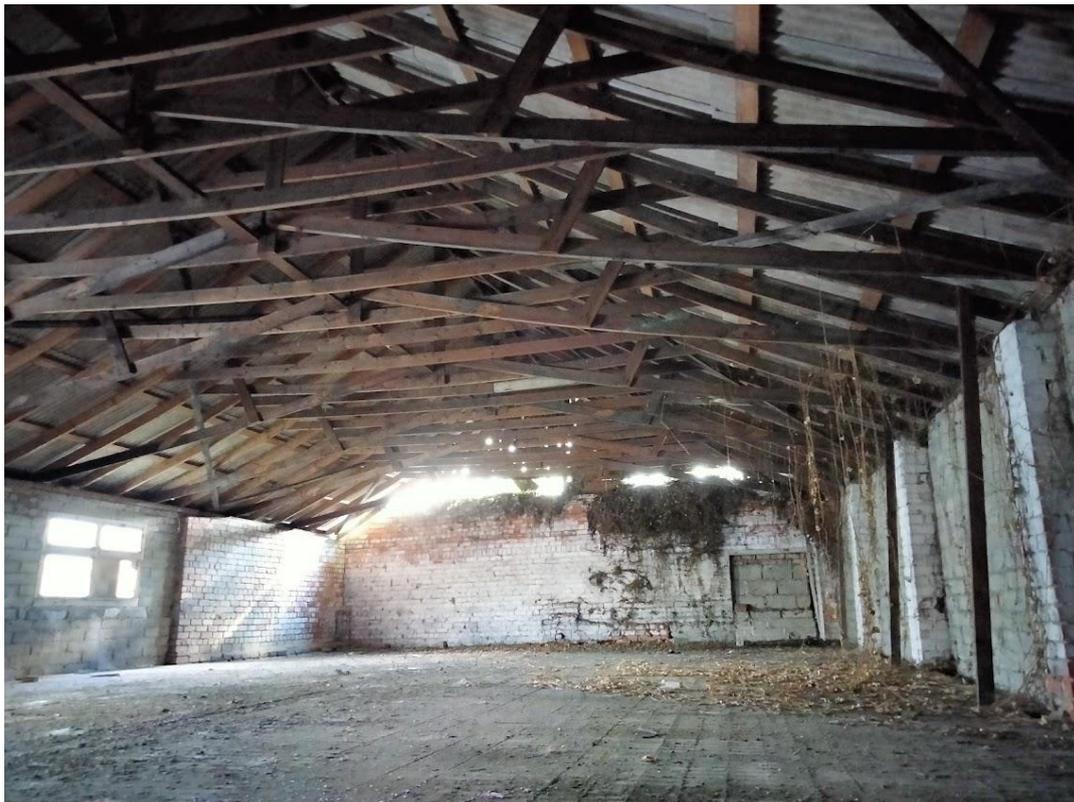
A search was made of the ground floor areas of all three buildings and no evidence of bat presence was noted in any of the buildings. The Back Building and the Left Annex are two story buildings but survey of the upper floor areas was not possible due to the dangerous condition of the floor timbers.

**Plate 16.** First floor of Back Building. Survey of this space was not possible due to floor in dangerous condition with wall plate supporting the floor coming away from wall bulging outwards (on right/back wall). While no bat roost features were discerned from a vantage point in the north-west corner (as per photo) the building is open at the southern end and there is potential for night roosting/perching in the roof timbers. Bats were not observed emerging from the Back Building during surveys.

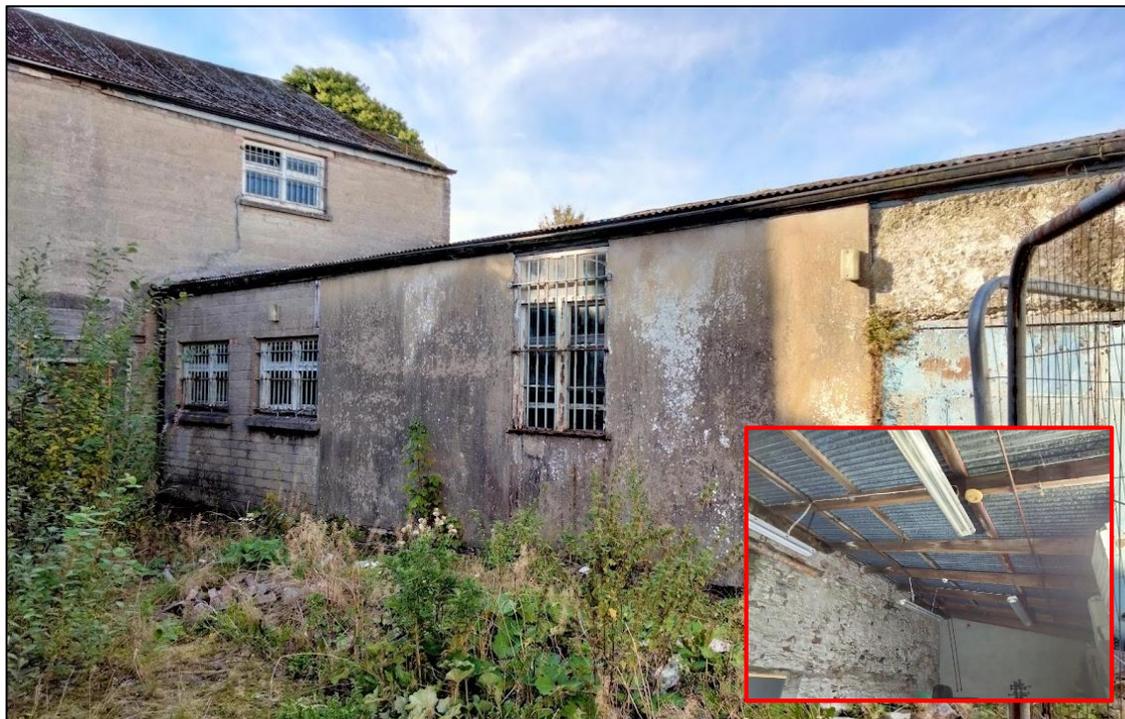
Plate 17. Right Annex off Back Building. A dead startling was noted in this section which connects with the Back Building. No likely access points for bats were noted. Inset photo of internal roof space

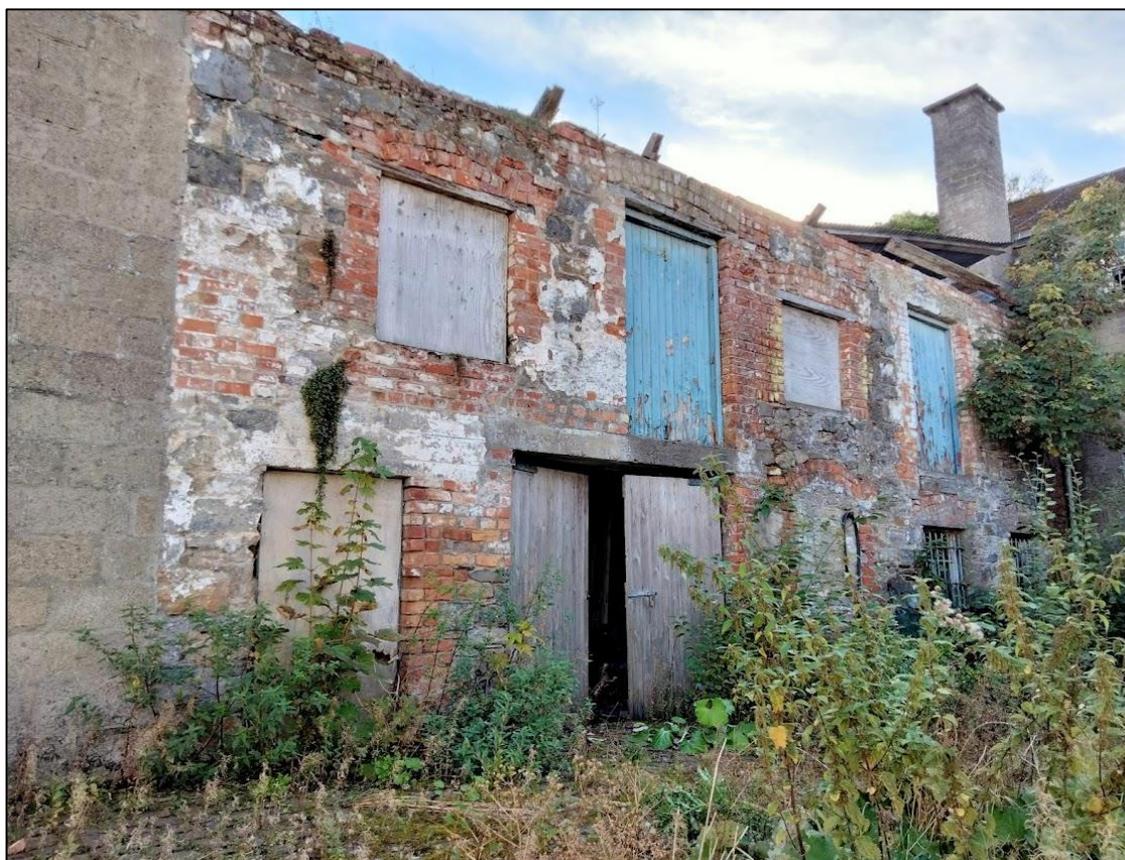
Plate 18. Front of Left Annex. Phot facing south-west

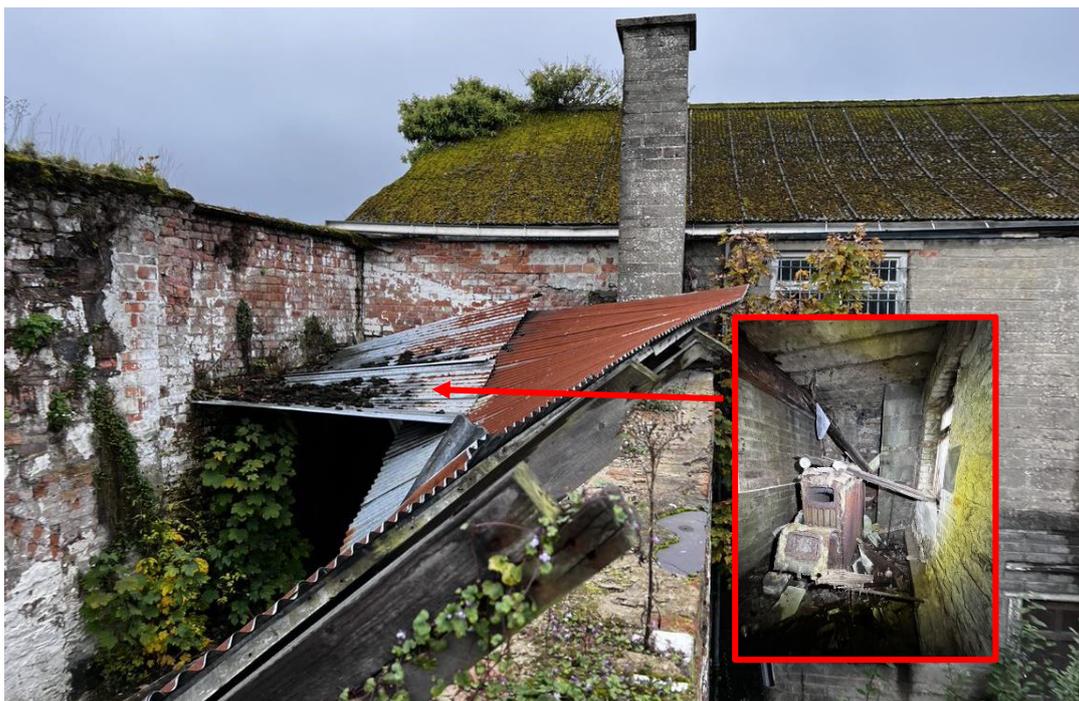
**Plate 19.** Left Annex, roof facing onto the front (north) has collapsed, rooms below are exposed and damp. Photo by Liam O'Reilly, Architect (Cavan Co. Council)

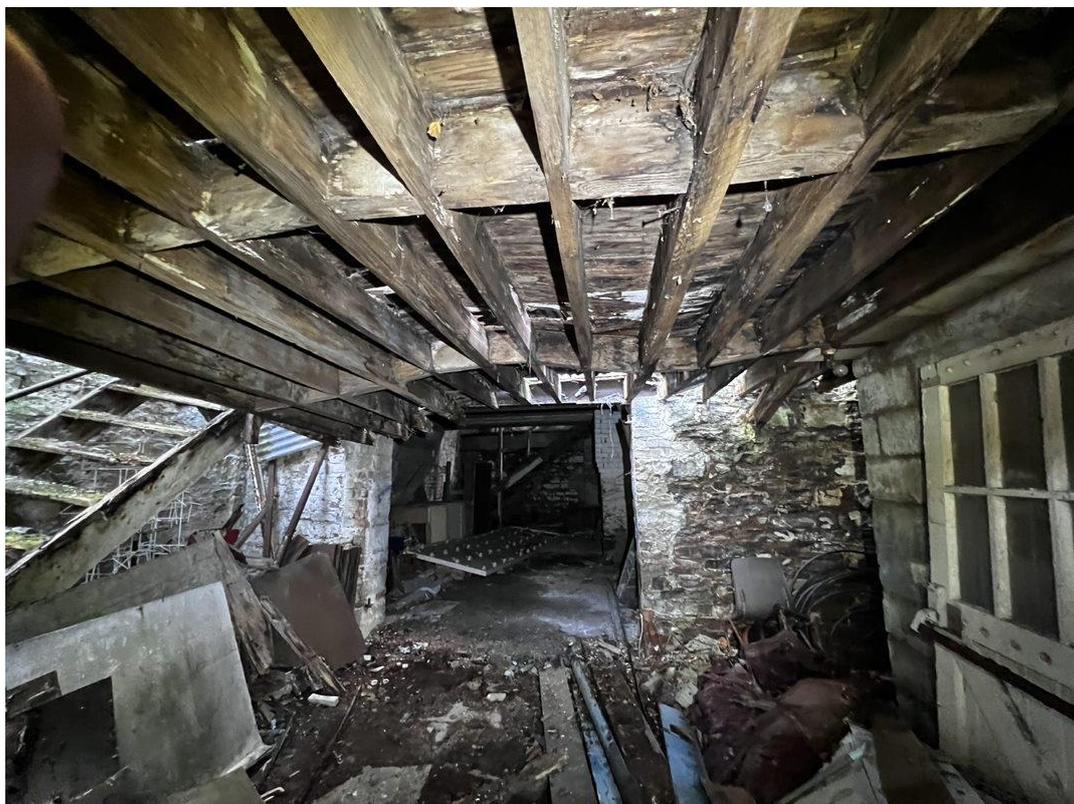
**Plate 20.** Left Annex interior. The floor timbers are rotten and dangerous to walk on, a survey of the upper floor was not possible. The building is in a state of dereliction and is suffering badly from the ingress of rainwater and is very damp. Photo by Liam O'Reilly

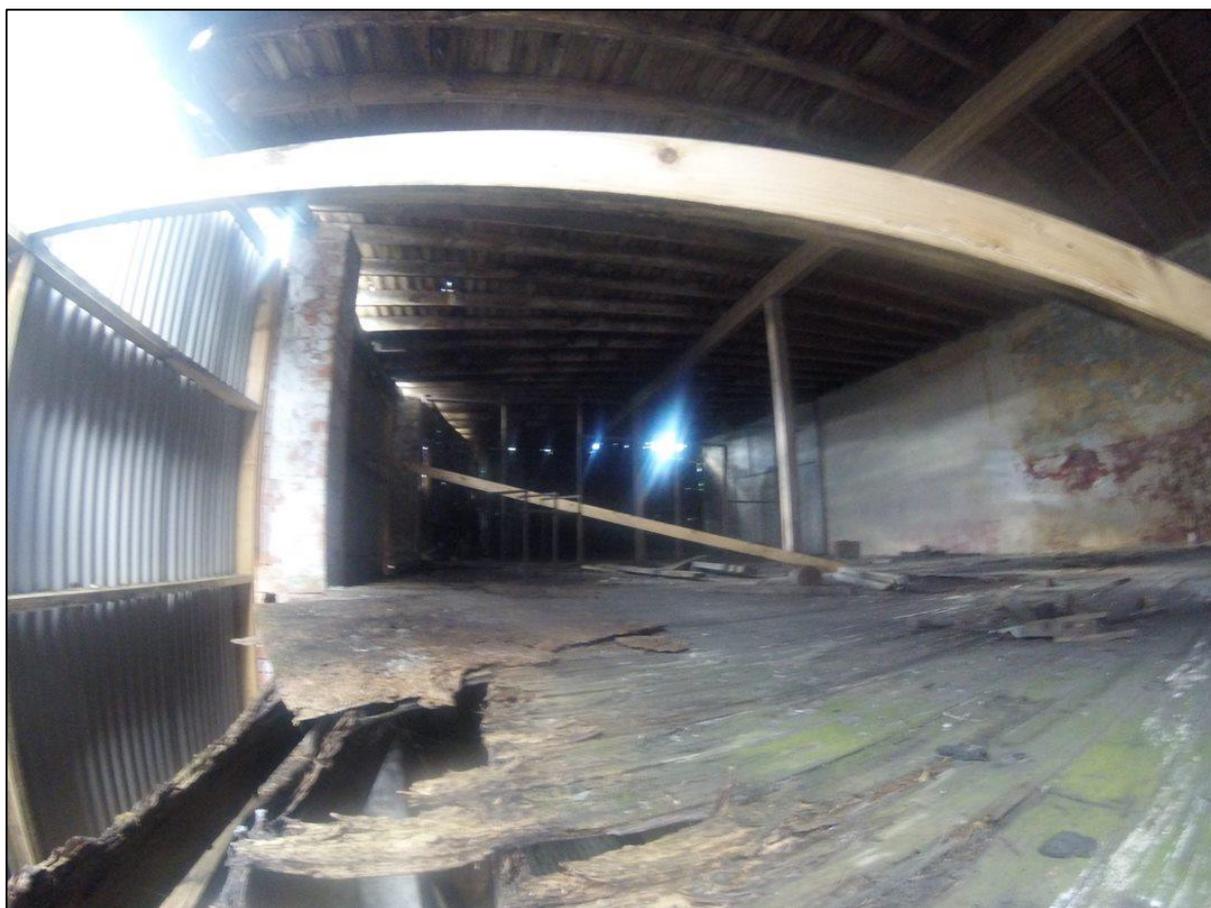
**Plate 21.** Upper floor of Left Annex. Photo by Liam O'Reilly using a GoPro camera on extension
