Assan Bridge, Assan, New Inn, Co. Cavan (NIAH Reg. No. 40403301)

Architectural Heritage Impact Assessment (Amended for revised scheme)

28.09 2022

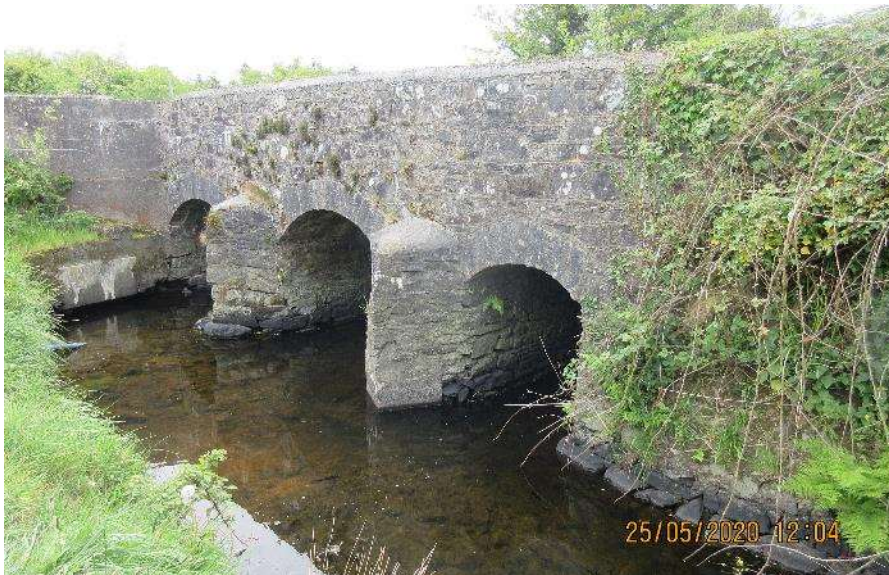
Fig. 4: The three arches and cutwaters, upriver elevation of the bridge

The existing piers with engaged cutwaters are exhibiting signs of movement with the loss of material because of scour action and may require intervention. This will be addressed using a concrete underpinning technique. These generally will not be visible and any stone loss at the base of the piers at the riverbed will be indented with similar stone and pointed up to help mitigate against any negative visual impacts. The work will result in positive physical impacts on the historic bridge.

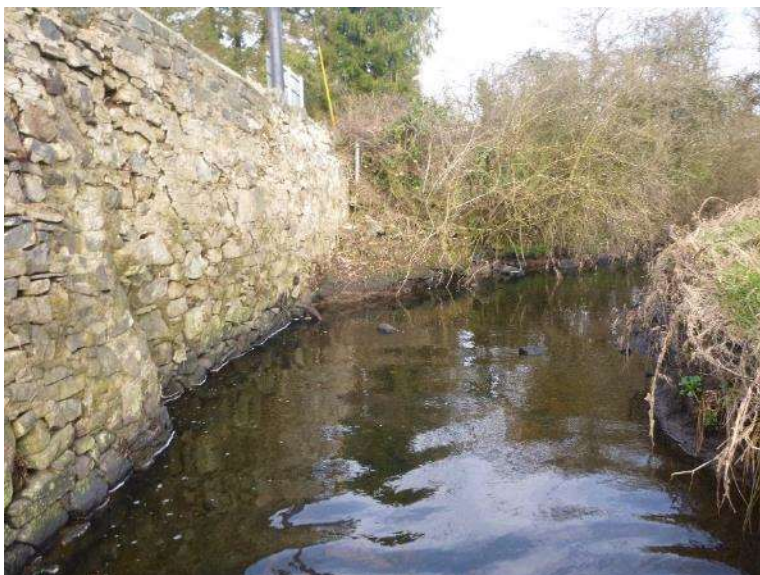
This will be removed as part of the riverbed realignment. However, as noted above, the course of the river has changed since the construction of the bridge and this northeast wall comprises a later intervention carried out following the change in the river course. It is not of historical significance.

Fig. 5: The course of the river has changed significantly, and the water now approaches the bridge from the side rather than straight on to the cutwaters.

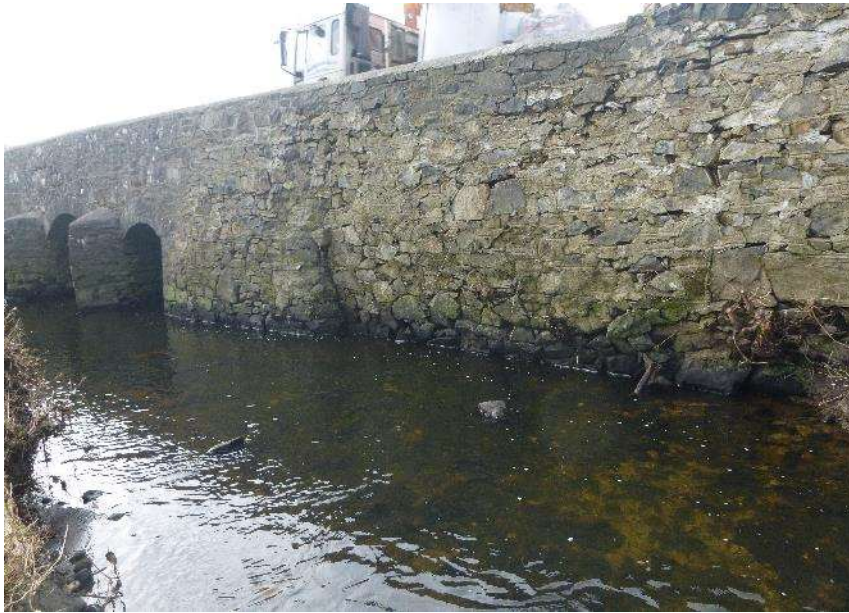
Fig. 6: Upriver elevation of the bridge and wing wall, showing the course of the river as it approaches from northwest.

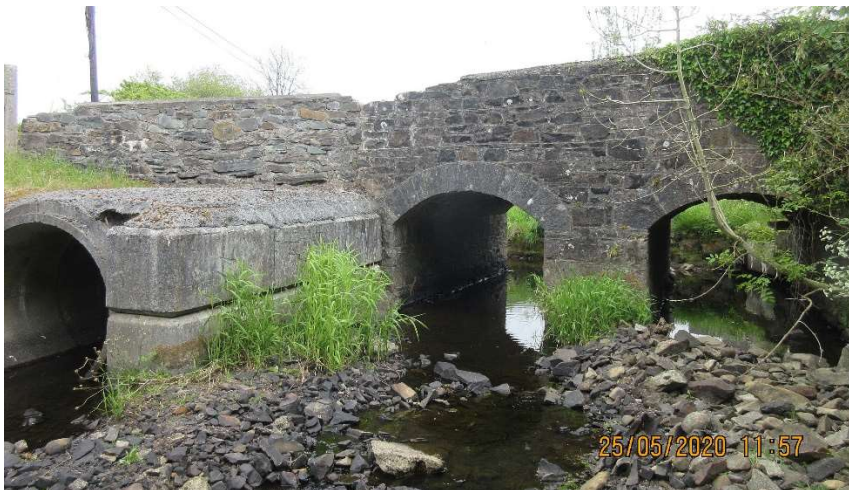
Many alterations and repairs have been carried out to the bridge over the course of its history. Most notable and visually intrusive is the recent addition of the concrete pipe and embankment to the downriver side which has obscured the arch on the western side. Parts of the wing walls have also been reconstructed, and there are many areas of repair, rebuilding, repointing and refacing. Unfortunately many of these interventions are unsympathetic to the historic fabric of the bridge and include strap pointing with a cementitious mortar and the use of concrete.

Fig. 7: Downriver elevation of the bridge, showing concrete pipe and embankment constructed to the westernmost arch of this elevation, obscuring original cut stone arch.

The proposed removal of the pipe intervention is welcomed as this currently negatively impacts the aesthetic appreciation and setting of the bridge. The removal of this concrete element will form part of the proposed repair and restoration work of the historic bridge.

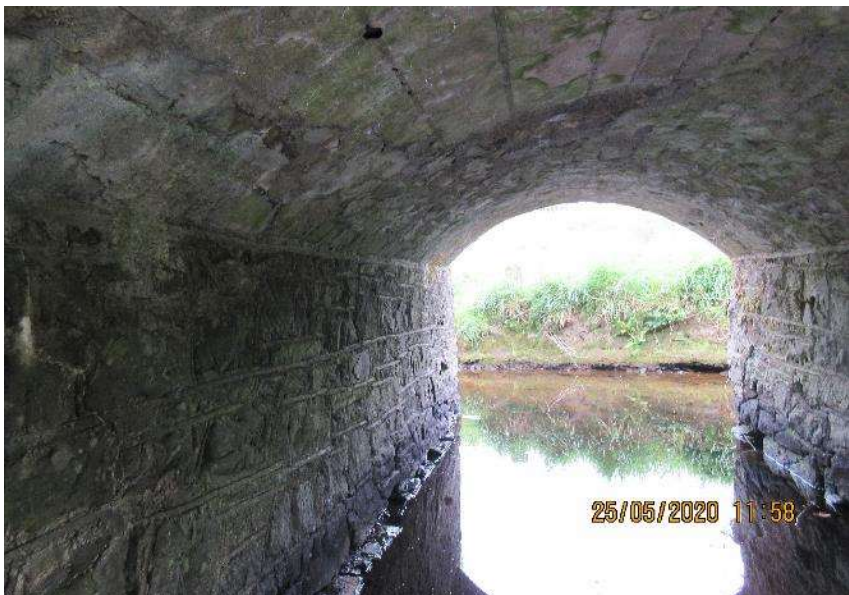
Fig. 8: Southernmost arch (as seen from downriver elevation) showing the soffit and pointing and render repairs.

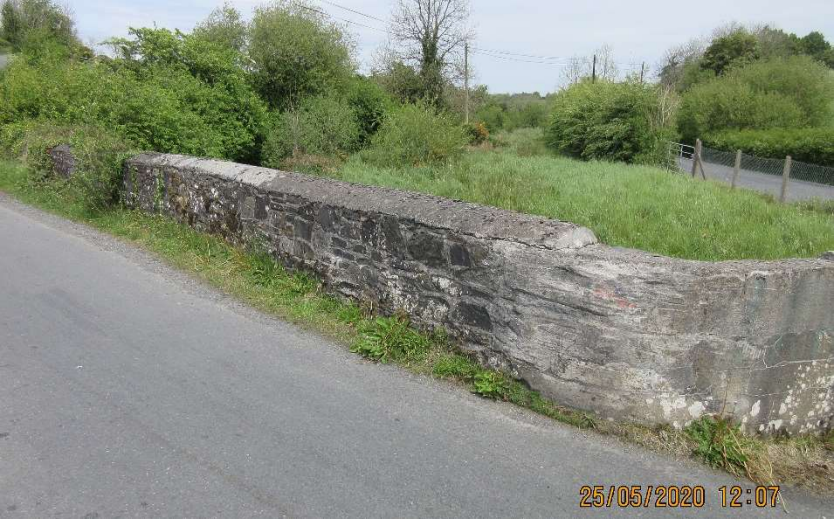
Fig. 9: East parapet wall of bridge, with concrete wing wall to corner

The parapet walls will be retained but require repair works. They appear to be constructed of a mixture of rubble sandstone and limestone. Any loose blocks which require removal will be salvaged and reinstated as part of the repairs. Materials and coursing of stonework carried out as part of the repairs should reflect the original masonry patterns.

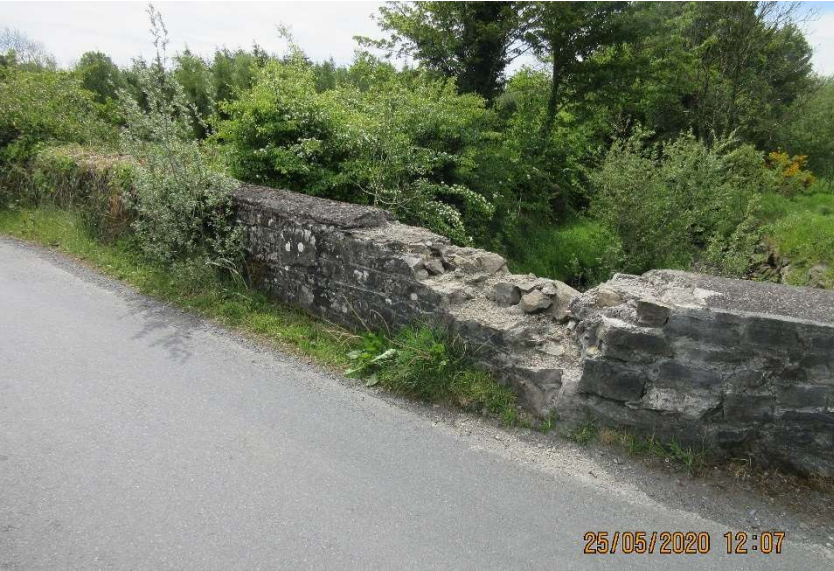
In addition to these unsuitable repairs, many areas of the bridge are in poor repair and require attention. This damage has been caused by both collision and also weathering and the wear and tear of the river, including the washing out of the mortar at the base of the bridge piers and cutwaters.

Fig. 10: West parapet wall, showing collision damage to stonework
