Architectural Heritage Impact Assessment Report For Kingscourt Town Centre Regeneration Scheme, Co. Cavan.

Client: Cavan County Council

Date: 06th December 2022

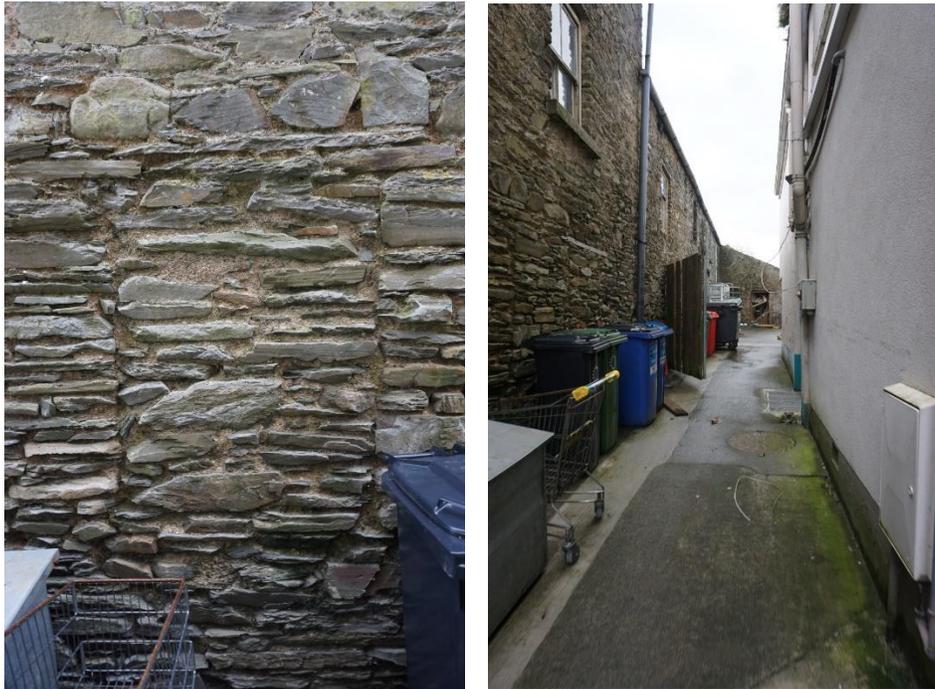
Photograph 7 – View of the boundary wall, original opening blocked up (date unknown)

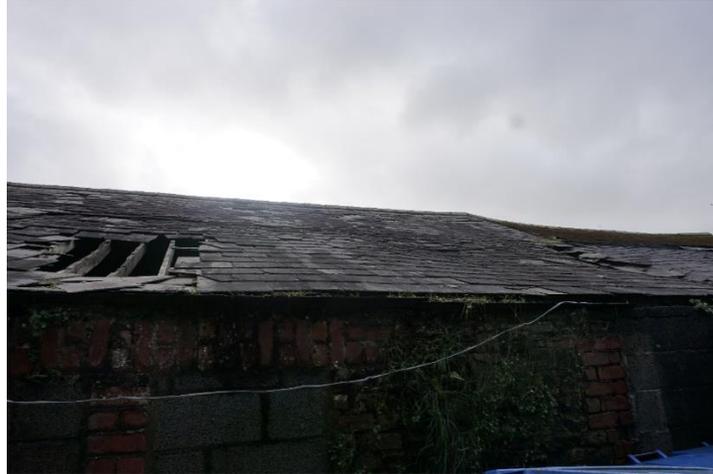
Photograph 8 – View of rear outbuilding. Natural slate finish, some slates missing and slipping.

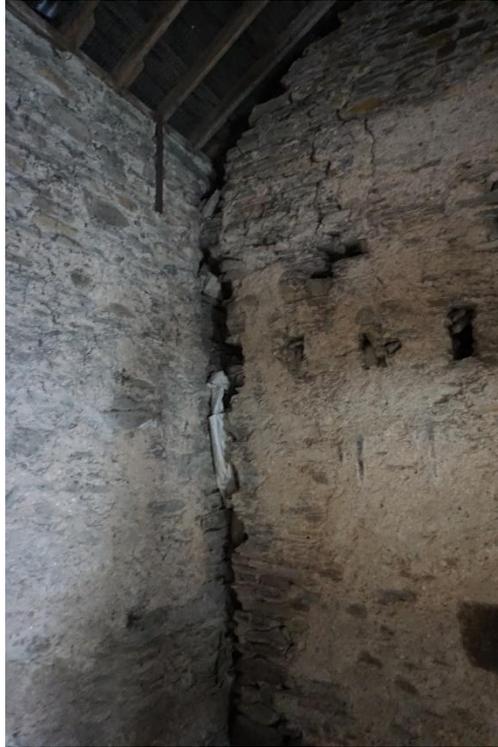
Photograph 17 - Internal View of the sheds to be deconstructed. Internal walls in disrepair and cracking occurring. (Shed 2)

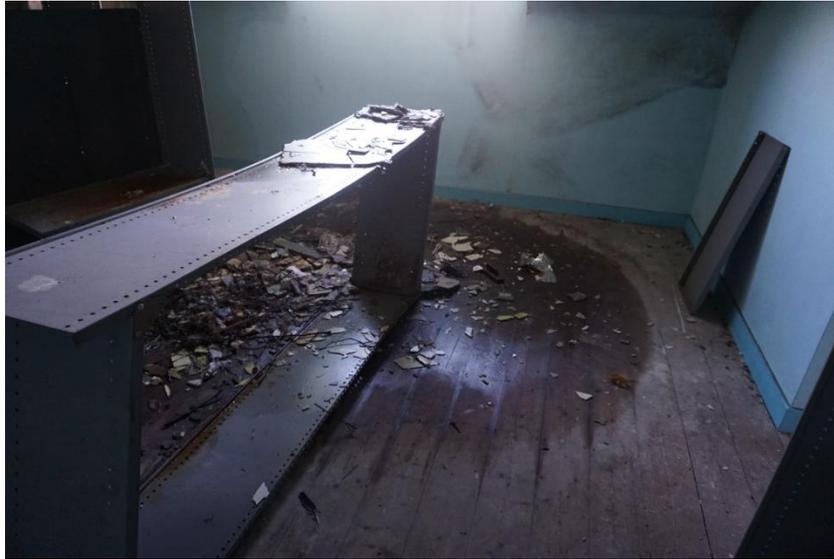
Photograph 52 -Image of water ingress on the top floor

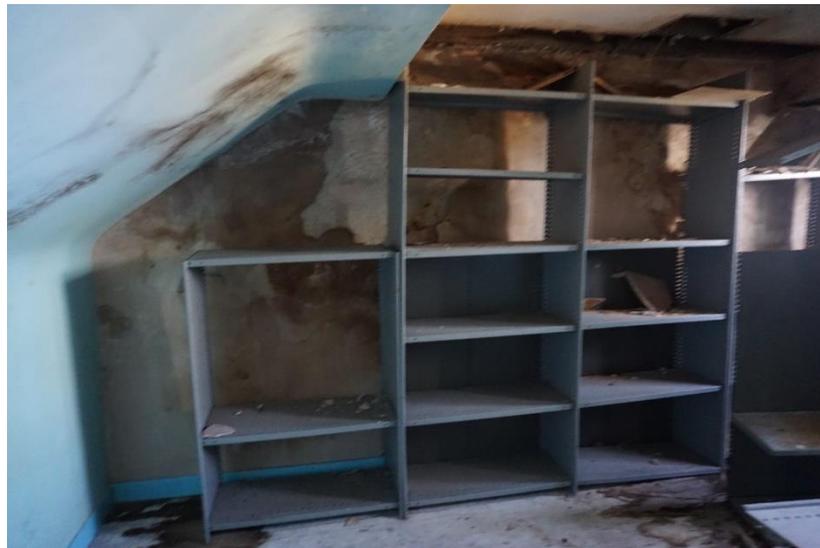
Photograph 53 - View of damage occurring due to water ingress

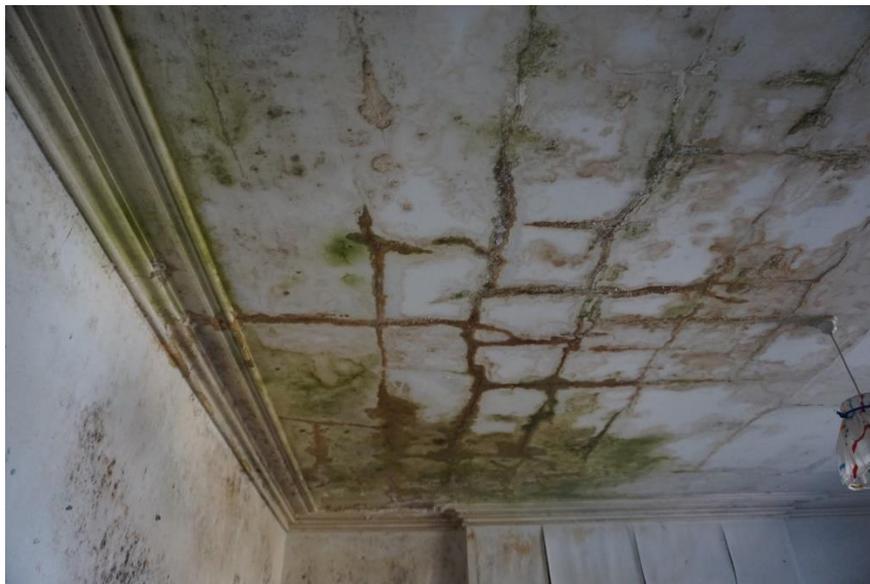
Photograph 57 - View of damage to the ceiling due to water ingress

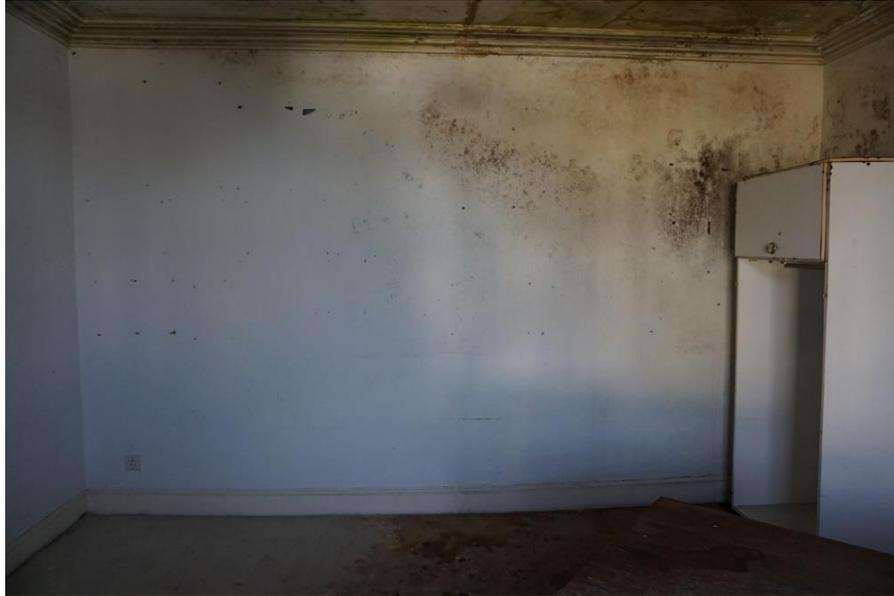
Photograph 58 – View of the room with water ingress damage

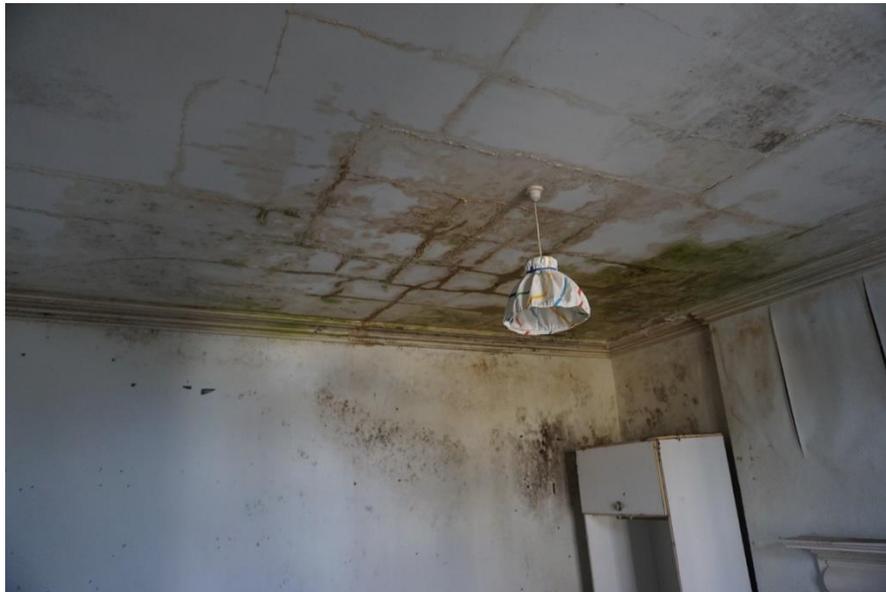
Photograph 59 – View of water ingress damage

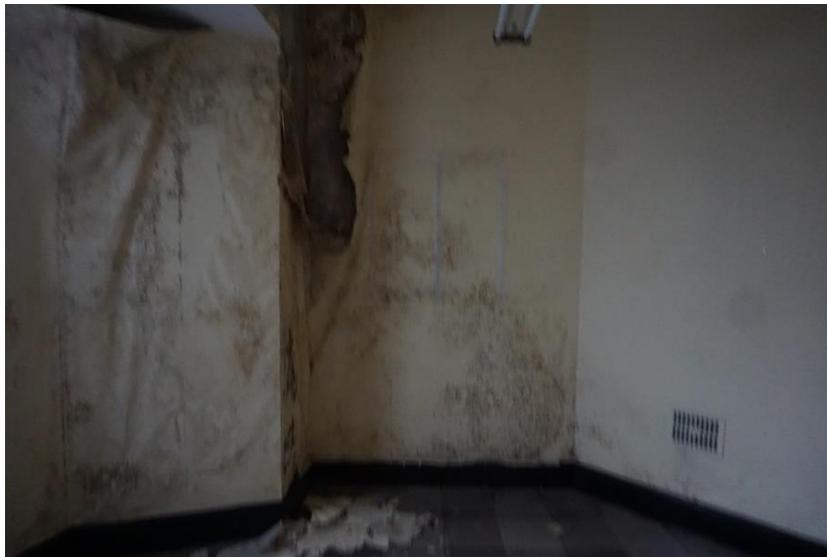
Photograph 71 – View of water damage at ground floor level
