Project Number: P2970_Issue 2

Geotechnical Preliminary Sources Study Report

Cavan Regional Sports Campus, Cavan County Cavan

Issued: March 2024

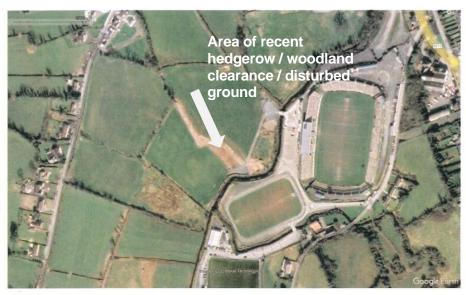
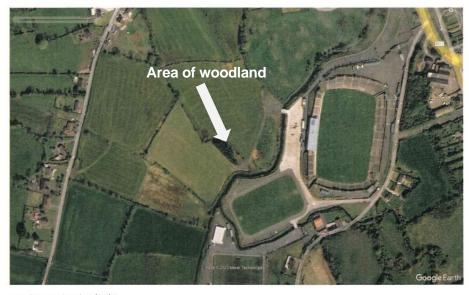
Figure 4: Area of Recent Ground Disturbance

The field boundary and associated small area of woodland observed to exist between Field 9 and Field 11, as observed by comparing aerial photography dated between 2021 and 2022 (Figure 4), has recently been removed creating a strip of bare / disturbed cleared ground now partly occupied by the new playing field.

Google Aerial 2023	The area of recent hedgerow / woodland clearance / disturbed ground is evident. The field boundary and associated small area of woodland observed to exist between Field 9 and Field 11, has been removed creating a strip of bare / disturbed cleared ground now partly occupied by the new playing field. Work has begun on the creation of the car park in Field 9.

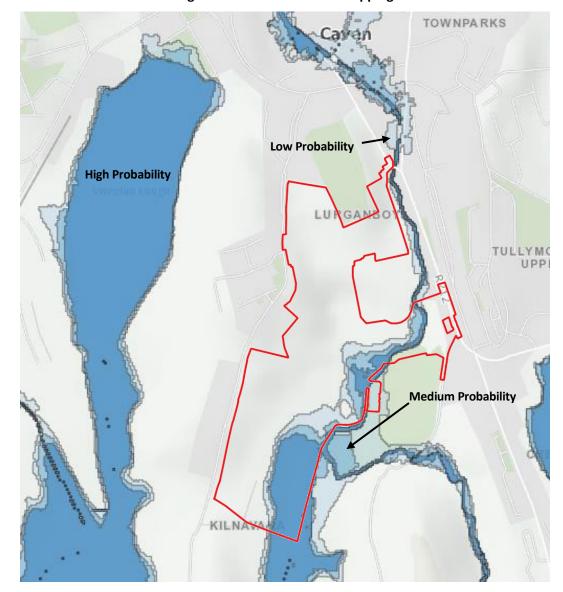
Figure 14: FloodInfo Flood Mapping

A review of the FloodInfo Ireland Flood Maps indicates that the western/southwestern areas of the site adjacent to the Cavan River is located within the 'High Probability' for River Flooding, as shown below in **Figure 14.**

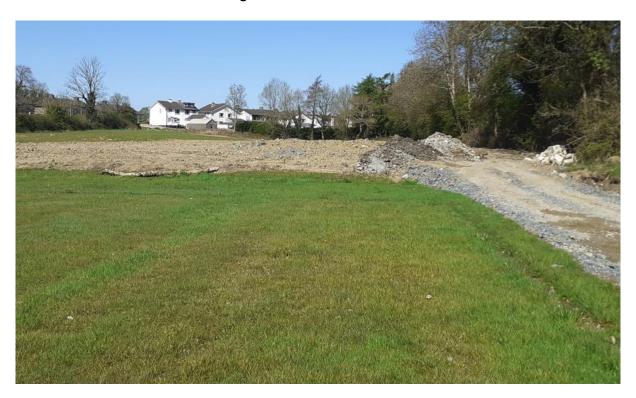
Plate 13: Field 3 looking north. Constrcuction landraise material evident

Geotechnical Investigations should be carried out in all areas where structures are proposed, including the area of minor landraise in Field 3. CBR testing should be undertaken in all areas where new roads are constructed and within the new pitches. Standard Penetrations Tests are recommend for foundation design. These should be appropriately spatially distributed to ensure maximum coverage of the site is established.

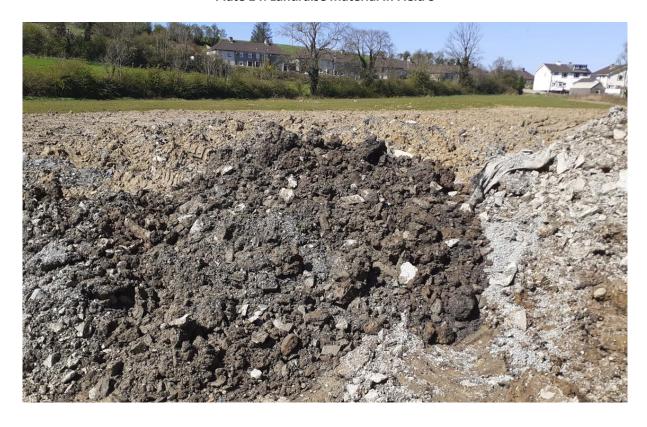
Plate 14: Landraise material in Field 3

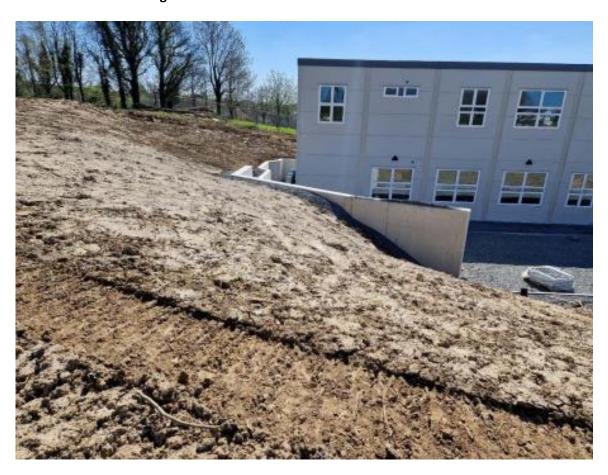
Areas of exposed till and reworked till are presented in the vicinity of the school construction site (Figure 3), where the development has cut into the till and a retaining wall constructed (Plate 18). It would appear that the excavated till has been deposited, along with other construction wastes in an area to the north of the new school building (Field 3), Creating an area topped with c1m thick made ground (see Figure 3).

Plate 17: New school building with recently constructed retaining wall, note cutting made into ground to accommodate building

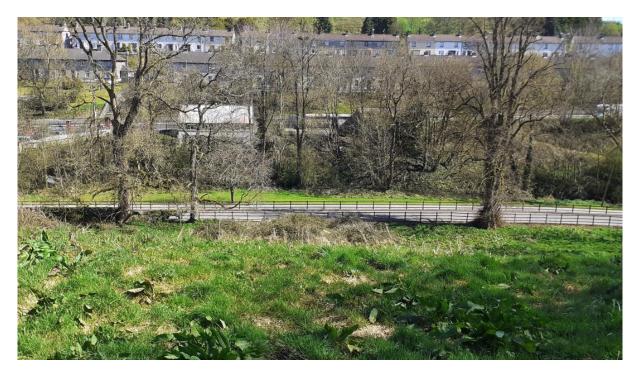
Plate 18: Field 3 looking east. Steep decline in topography eastwards

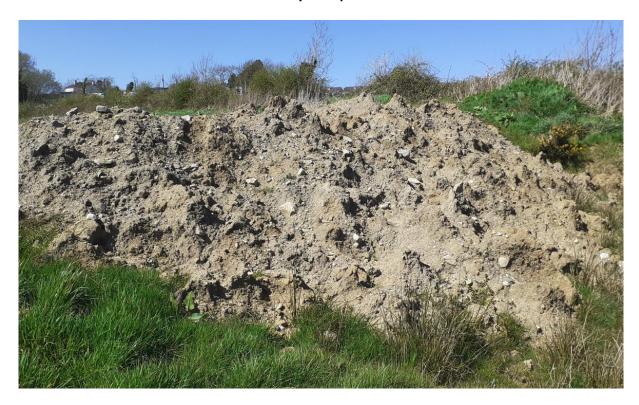
Plate 22: Clay Stockpile in Field 9

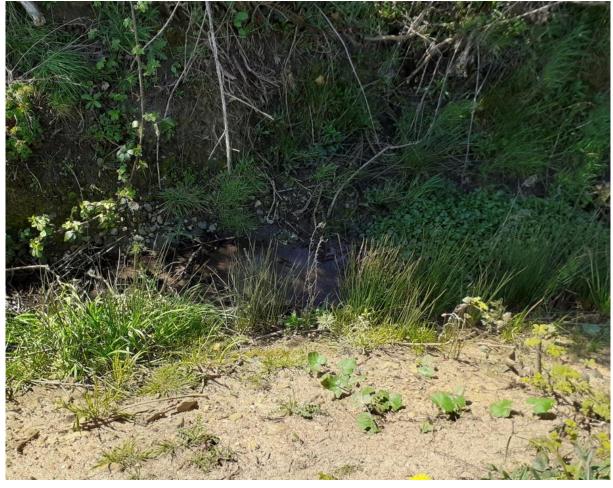
In the northwest corner of Field 9, along the boundary with Field 8, a low flowing watercourse enters the site flowing southeast (Plate 24).

Plate 24: Watercourse entering the north west corner of Field 9, along the boundary with Field 8

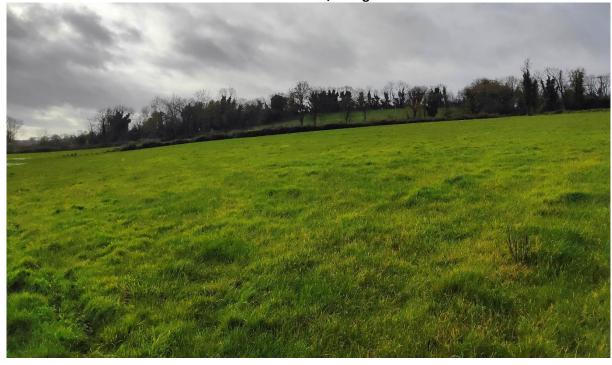
Plate 31: Flood extent on Fields 13-15, facing south

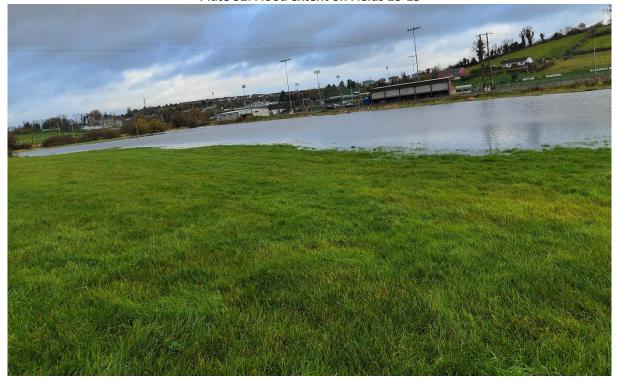
Plate 33: Flood extent on Fields 13-15
