# **Proposed Greenway at Cootehill, Co. Cavan**

Stage 1 Road Safety Audit with Appended Re-audit

Final Report

Michael Fitzpatrick Architects Ltd.

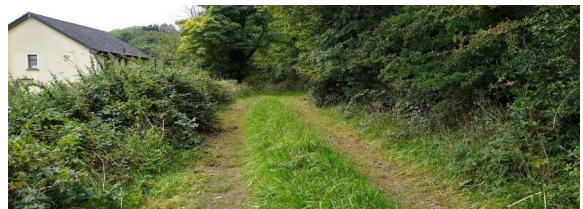
- Route section 1 of the route is currently a track/laneway used by agricultural machinery to access neighbouring fields. The width of the track varies, but is typically in excess of 3m. From the north, the track falls in grade to a point tangential to the rear of the Errigal County House Hotel, before rising to a point to the rear of the residential properties on Annalee Grove, and then falling to the R188 Cavan Road.

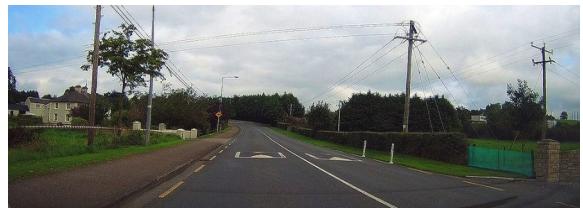
- From the south-west, route section 2 of the route has a kerbed footpath on the north-western side of the carriageway for a distance of approximately 275m, followed by a shoulder for a similar distance. The carriageway has a typical sealed width of 7.1m and traffic calming features and public lighting are present.

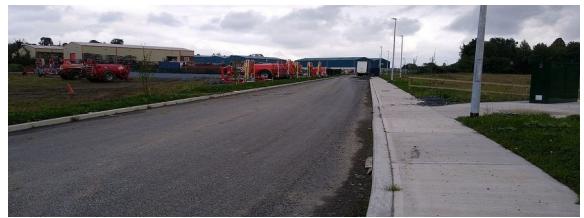
- Route section 3 of the route follows the alignment of an internal road within the Cootehill Industrial Estate. The width of the existing footpath is restricted to approximately 1.1m at the access gate off the R188. At the time of the audit site visit it was not possible to open this gate. The road within the estate varies in width from 7.3m to 8.3m. A continuous concrete footpath of between 1.8m and 2.0m in width aligns the western side of the road. The north-western end of the road is positioned adjacent to a steep slope approximately 4.5m in height. It is understood that a way-leave for agricultural vehicles is present at the bottom of the slope. Surface water drainage and public lighting are present.

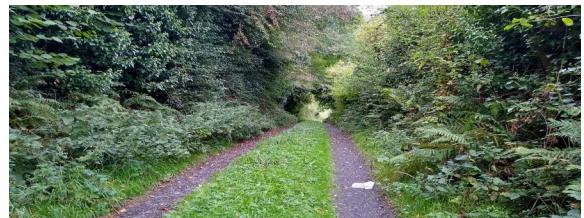
- Route section 4 is currently a mix of agricultural and field tracks, the section of route running west from the R188 Monaghan Road appears to be regularly used and a damaged steel gate is present on the northern side of the track set back from the R188. The width of the track varies, but is typically in excess of 3m.

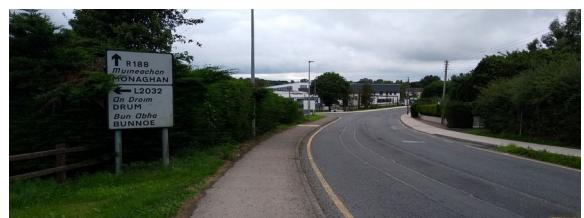
- Within route section 5, the footpath on the western side of the R188 Monaghan Road terminates at the northern boundary of the Holy Family School, entering the Clements Town Estate. A footpath with a sealed width of 1.5m, but an effective width of 1.0m due to overgrowth of vegetation, continues on the eastern side of the R188 Monaghan Road. The carriageway has a typical sealed width of 6.8m, but visual inspection of the carriageway shows areas with surface defects such as pot-holing. Public lighting is present.
