Kingscourt Town Centre
Regeneration Scheme

Stage 1 Road Safety Audit

Document Ref: P22-187-SA01-RP-001

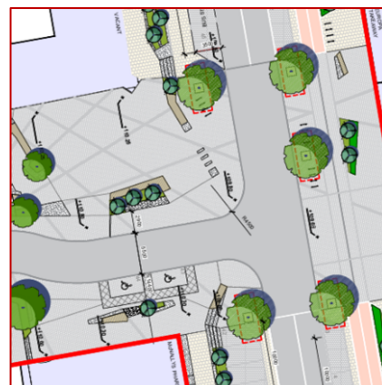
Location: Drawing 221545-1-101 (-)

Summary: Unclear if it is proposed to provide a level difference between the pedestrian areas and the carriageway.

The proposed footpath arrangements along Main Street will have footpaths bounded on one side by the building line and on the other side by a combination of planting, parking spaces, bicycle parking stands, a two-way cycle facility and other items of street furniture. It is unclear if it is proposed to provide kerbs between the footpath and the cycle track, carriageway and/or parking spaces.

Should no kerbs be provided between the footpath and the two-way cycle facility/carriageway/parking spaces, there is a risk of visually-impaired pedestrians inadvertently entering these areas with a resulting risk of being struck by a vehicle, colliding with items of street furniture or being struck by a cyclist.

Kerbs should be provided separating the footpath from the parking spaces, carriageway and two-way cycle tracks, except at pedestrian crossings and at mobility-impaired parking spaces where dropped kerbs should be provided to facilitate mobility-impaired access to the footpath along with associated tactile paving to advise visually-impaired pedestrians of the flush kerb.

A Safe Zone should be created within the footpath in accordance with guidance published by the National Disability Authority to assist visually-impaired non-motorised road users to navigate the proposed street layout and avoid collisions with items of street furniture.

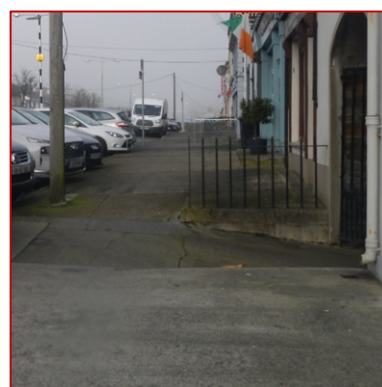
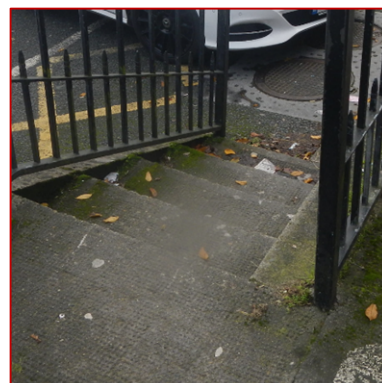
Location: At various locations Throughout the Scheme

Summary: Possible slips, trips or falls at height hazards within the scheme.

The existing footpaths include a number of changes in level, with some locations including steps & steep gradients most of which are protected by railings.

The proposed scheme will, presumably, remove many of these existing level differences, however, some will remain. For example a level difference has been indicated as being retained between the footpath and the adjacent parking spaces, to be separated by steps, along the section of the western side Main Street immediately south of its junction with Rocks Road and the vicinity of the northbound bus stop to the north of the Rocks Road junction.

It is unclear from the information provided what, if any, measures would be provided to advise visually-impaired or inattentive pedestrians of the remaining height hazards.

Measures should be provided (e.g. railings, tactile paving) to warn visually-impaired or inattentive pedestrians of the height hazards within the Scheme (for example: the steps on the western side of Main Street immediately south of its junction with Rocks Road). Gradients within the pedestrian areas should comply with the guidance published by the National Disability Authority.

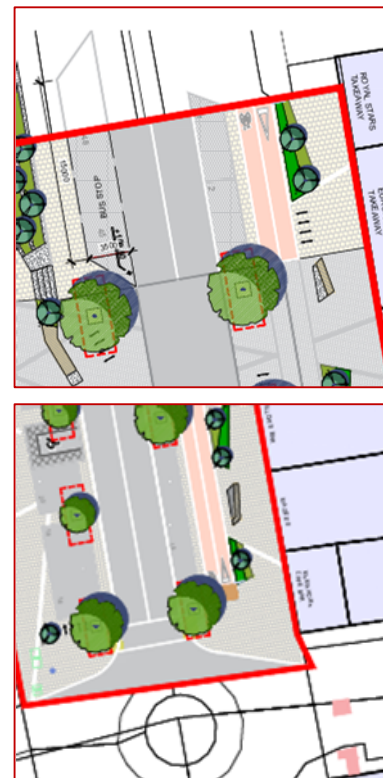
Location: Drawing 221545-1-101 (-)

Summary: *Unclear how cyclists will move between the amended and the existing road sections along Main Street.*

As part of the scheme, amendments to the existing road layout of Main Street have been indicated, including the provision a proposed two-way cycle track along the eastern side of Main Street. However, it is unclear how the proposed cycle track will tie-in with the existing Main Street road layout to the north and south of the scheme.

If safe transitions between the new cross section and the existing cross section are not fully considered at this early stage, there is a risk that locked-in land and road constraints could lead to unsafe road layouts at the next design stage. Additionally, the cycle lanes road markings indicated suggest that the cycle lanes switch direction north of the junction between Rocks Road and Main Street which might lead to confusion.

Ensure the amended sections of carriageway and cyclist facilities sufficiently align and tie-in safely with the existing road layout at the scheme extents.

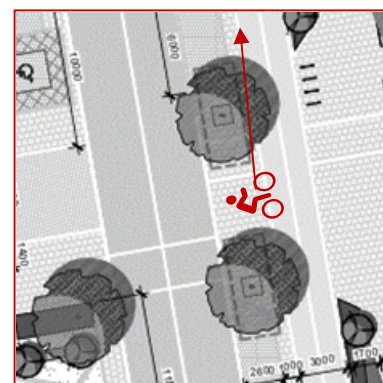
Location: Drawing 221545-1-101 (-)

Summary: *Overhanging trees may present hazards to pedestrians and cyclists travelling on the proposed Non-Motorised Users (NMUs) facilities.*

Trees have been indicated within the proposed scheme which overhang the proposed footpath areas & the proposed cycle facility. It is unclear what the clear-height to the canopy of the proposed trees would be.

If the canopies have insufficient vertical clearance there is a risk that the branches of trees may present a hazard to pedestrians, particularly the visually impaired, and cyclists resulting in road users colliding with low-hanging branches and suffering personal injuries.

In addition, as the trees shed leaves in the autumn/winter months these may accumulate within the NMUs facilities where they may pose a slip/skid risk to pedestrians and cyclists using the facilities.

Adequate vertical clearance to tree canopies should be provided. Routine maintenance should be undertaken to ensure that excessive accumulation of leaves does not occur on the pedestrian and cyclist facilities.

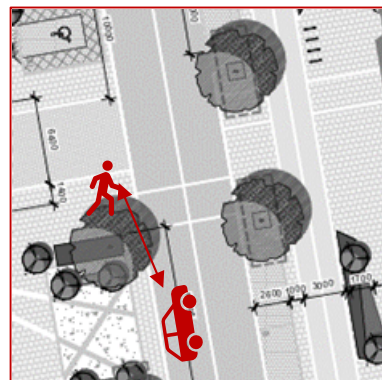
Location: Drawing 221545-1-101 (-)

Summary: *Proposed planting may impede inter-visibility between pedestrians and drivers at several crossing locations throughout the scheme.*

Trees have been indicated adjacent to the proposed crossings within the scheme. It is unclear from the information provided what type/species of tree/planting is proposed at these locations.

Planting/trees could impede inter-visibility between pedestrians and drivers at crossings which could lead to drivers failing to see a pedestrian about to undertake the crossing, resulting in a failure to stop and possible vehicular/pedestrian collisions

Planting/trees adjacent crossings should not restrict inter-visibility between pedestrians intending to use the crossing and drivers on the approach to the crossing.

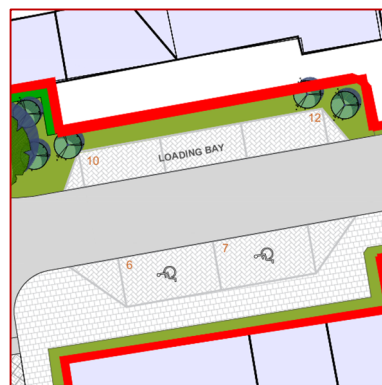
Location: Drawing 221545-1-101 (-)

Summary: *Loading/unloading activities at the proposed loading bay could result in personnel standing within the carriageway.*

The proposed Loading Bay on the access to the new car park from Main Street is bounded by a grassed verge area.

This is likely to result in loading activities occurring to/from the adjacent carriageway, with a resulting increased risk of goods or operatives being struck by passing vehicles.

An area off of the carriageway should be provided adjacent to the proposed Loading Bay where loading/unloading activities can be undertaken safely.

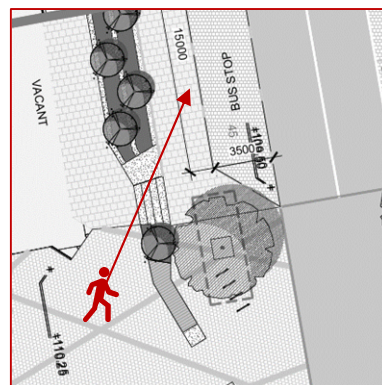
Location: Drawing 221545-1-101 (-)

Summary: *It is unclear how mobility impaired public transport users can safely access the proposed bus stop on the western side of Main Street north of the Market Square.*

Steps have been indicated between the proposed bus stop location and the footpath along the building line. This would create difficulties for mobility-impaired bus passengers, in particular wheelchair users, from accessing the public transport facilities safely.

An accessible & safe route to/from the bus stop should be provided.

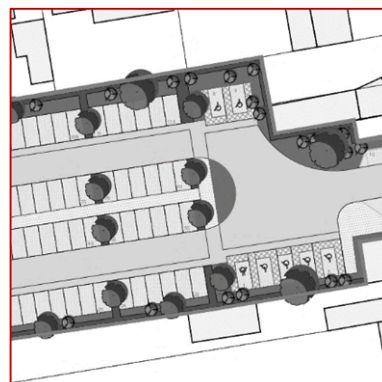
Location: Drawing 221545-1-101 (-)

Summary: Drivers may be unaware of the one-way system within the car park, and unintentionally travel against the flow of traffic, leading to low-speed head-on collisions.

The proposed carpark layout includes one-way sections. At this early stage in the design process traffic signage and road markings have not been indicated. Should drivers be insufficiently aware of the one-way flow they could unintentionally travel against the flow of traffic, leading to low-speed head-on collisions.

During the design development appropriate signs and road markings should be provided indicating the one-way section of the car park.

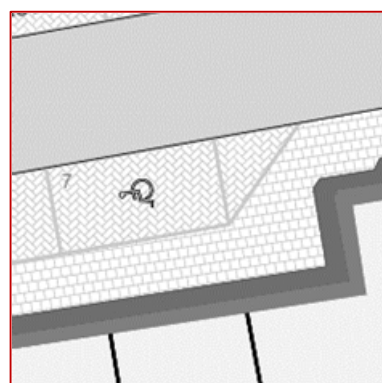
Location: Drawing 221545-1-101 (-)

Summary: The effective width of the footpath adjacent the mobility-impaired parking space within the carpark may be insufficient for the mobility-impaired, particularly wheelchair users.

The footpath adjacent the mobility-impaired parking space alongside the south-eastern footpath on the carpark access road appears to be narrow.

It is unclear if the effective width of the path will be sufficient to accommodate the mobility-impaired, particularly wheelchair users. This could result in these road users choosing to travel within the carriageway, where there is an increased risk of being struck by a vehicle.

The effective width of the footpaths within the scheme should be sufficient to accommodate all non-motorised road users.

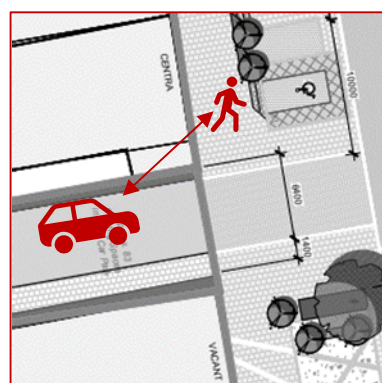
Location: Drawing 221545-1-101 (-)

Summary: The building boundary at the car park access may reduce inter-visibility between pedestrians about commence crossing and drivers exiting from the carpark onto the Main Street.

The existing building boundary either side of the car park access at its junction with Main Street may impede inter-visibility between exiting drivers and pedestrians about to commence a crossing, increasing the risk of vehicle/pedestrian.

Adequate inter-visibility should be provided between drivers exiting the carpark and pedestrians about commence a crossing at this location.

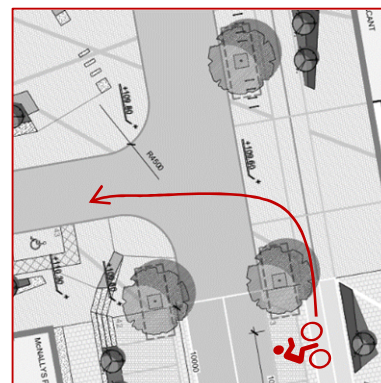
Location: Drawing 221545-1-101 (-)

Summary: It is unclear how cyclists on the proposed cycle track can safely turn onto Rocks Road, and vice versa.

A cycle track is proposed along the eastern side of Main Street. It is unclear how it is intended that cyclists can turn left from the cycle track onto Rocks Road, and vice versa.

Should a lowered kerb arrangement not be provided this may lead to cyclists attempting to traverse a full-height kerb when turning resulting in possible falls and personal injuries.

Measures should be provided which allow cyclists turn from the cycle track onto Rocks Road, and vice versa.

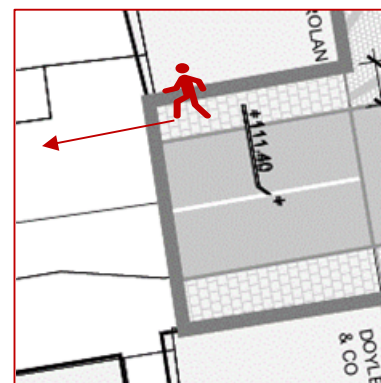
Location: Drawing 221545-1-101 (-)

Summary: Discontinuity in existing footpath along northern side of Rocks Road to the west of the Scheme.

There is a discontinuity in the footpath on the northern side of Rocks Road, west of Market Square. A footpath is shown extending along Market Square to the northern side of Rocks Road. Pedestrians on the Market Square heading west on this side of the road could continue within the carriageway with a resulting increased risk of being struck.

Either a continuous footpath should be provided along the northern side of Market Square and the footpath on the northern side of Rocks Road, or measures should be provided which direct both eastbound and westbound pedestrians on the northern side of the road to the continuous footpath along the southern side of Rocks Road, including appropriate crossing facilities where required.

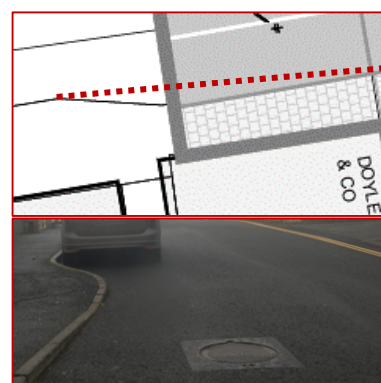
Location: Drawing 221545-1-101 (-)

Summary: The existing alignment of the kerb on the southern side of Rocks Road changes relatively abruptly immediately west of Market Square, which may lead to wheel strikes or avoidance manoeuvres.

The existing alignment of the kerb on the southern side of Rocks Road changes relatively abruptly immediately west of Market Square, which may lead to wheel strikes or avoidance manoeuvres.

Drivers often use the kerb as a guide when travelling along a carriageway, and abrupt changes in direction, or sharp deflections, may result in drivers unfamiliar with the road striking the kerb, resulting in material damage collisions, or to sudden avoidance manoeuvres.

The kerb along the southern side of Rocks Road within Market Square should transition smoothly to the existing kerb build-out.

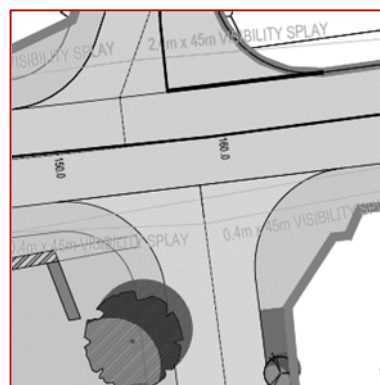
Location: Drawing 221545-1-102 (-)

Summary: Junction control/priority has not been indicated at the junction between Rocks Road and the carpark access road.

The junction control (stop, yield etc.) at the junction between Rocks Road and the carpark access Road, has not been indicated. The absence of clear junction priority may result in driver confusion and hesitation leading to unsafe entry to the junction and possible side-on collisions.

Ensure the junction control at the junction is clear and that drivers are sufficiently advised of the priority at the junction.

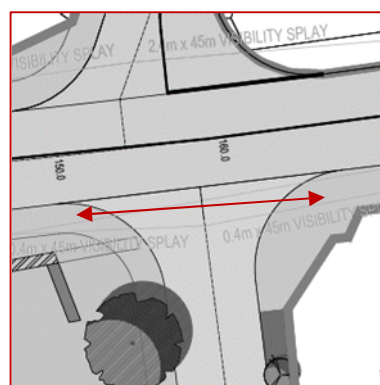
Location: Drawing 221545-1-102 (-)

Summary: No pedestrian crossing has been indicated across the proposed entrance to the carpark from Rocks Road.

No pedestrian crossing has been indicated across the proposed access to the proposed carpark from Rocks Road. This could result in mobility impaired pedestrians being unable to safely navigate this section of the road layout.

Prioritise pedestrian movements across the carpark access by providing a continuous footpath.

Alternatively, a pedestrian crossing, including dropped kerbs and tactile paving, should be provided at the carpark access.

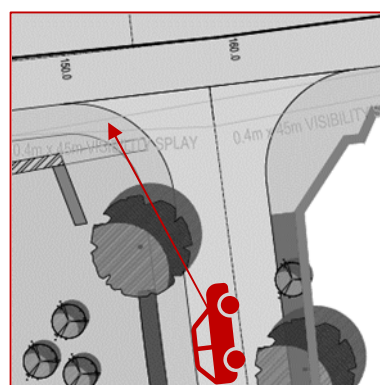
Location: Drawing 221545-1-102 (-)

Summary: Drivers exiting the carpark onto Rocks Road may have restricted visibility towards a potential sign indicating priority.

The proposed tree on the western side of the access road on the immediate approach to its junction with the Rocks Road may impede visibility towards a junction regulatory sign.

This may result in approaching drivers being insufficiently aware of the need to stop or yield, leading to overshoot into the footpath, resulting in an increased risk of vehicle/pedestrian collision.

The tree should be relocated to where it wouldn't impede visible towards junction signs for drivers exiting the car park.

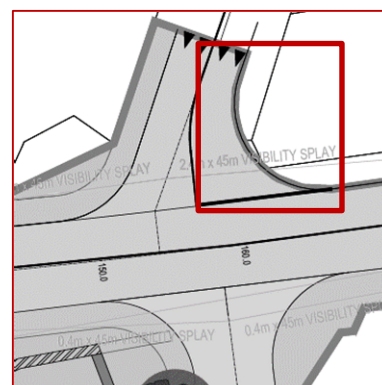
Location: Drawing 221545-1-102 (-)

Summary: Discontinuous pedestrian facilities at north-eastern corner of the Rocks Road/Bóthar Mhuire Junction.

The Rocks Road/Bóthar Mhuire junction layout is proposed to be amended as part of the scheme. However, the proposed layout does not indicate retaining the existing footpath within the north-eastern corner. Should the footpath not be retained at this location pedestrians could choose to travel within the carriageway where there is a risk of being struck by a vehicle.

A footpath should be provided in the north-eastern corner of the junction between Rocks Road and Bóthar Mhuire.

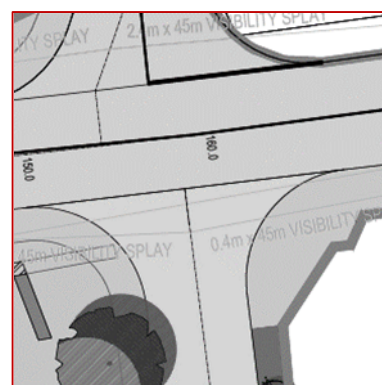
Location: Drawing 221545-1-102 (-)

Summary: Drivers on the carpark access Road approaching the junction with Rocks Road may sight onto Bóthar Mhuire.

The proposed new access onto the Rocks Road will result in an additional, relatively busy, junction in close proximity to an existing staggered t-junction and also create a crossroads arrangement between the existing side road on the northern side of Rocks Road and the new access.

This could result in a potential sight-through issue, with drivers on the side road or the new access road failing to stop at the junction resulting in overshoot and possible side-on collisions

Prioritise pedestrian movements across the carpark access by providing a continuous footpath in order to passively support speed reduction on approach to the junction.

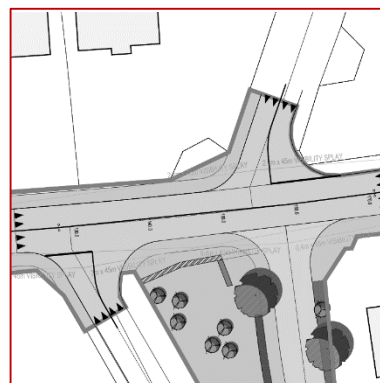
Location: Drawing 221545-1-102 (-)

Summary: Difference in levels at the proposed raised table have not been indicated.

The proposed works on the junction between Rocks Road and Bóthar Mhuire include a raised table.

It is unclear if there will be a level difference between the proposed raised-table and the adjacent footpaths.

The absence of level difference could result in visually-impaired pedestrians inadvertently entering the carriageway.

A minimum upstand of 60mm should be provided between the footpaths and the raised table.

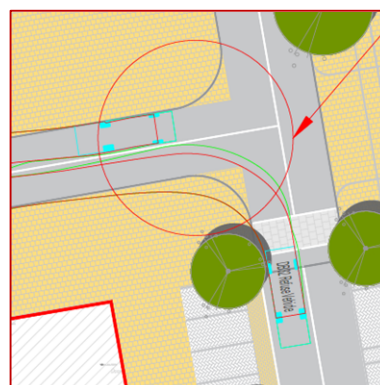
Location: Drawing 'Market Square Tracking'

Summary: Insufficient turning radii for vehicles at the junction between Main Street and Rocks Road.

The proposed realignment of the Rocks Road, and the corner radii at its junction with Main Street, may result in road layout that is not capable of accommodating the swept path of all vehicles likely to use the road & junction.

This could lead to vehicles overrunning the footpaths as they turn/traverse this area, presenting a potential hazard to NMUs within the footpath/pedestrian areas.

Sufficient turning radii should be provided to support safe turning movements at the junction between Main Street and Rocks Road.

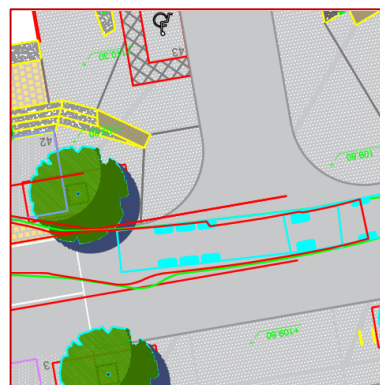
Location: Drawing 'Main Street Loading Bay Tracking'

Summary: It is unclear if the tree canopies will impede high-sided vehicles at the loading bay location on Main Street.

It is unclear if the tree canopy will impede high-sided vehicles using the loading bay on Main Street. If the tree canopy impedes the vehicle path, high-sided vehicles may enter the opposing traffic lane while exiting the loading bay while avoiding branches, resulting in an increased risk of collisions with oncoming traffic.

The tree canopies should not impede vehicles exiting the loading bay.

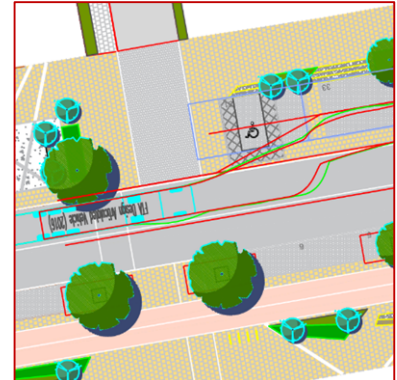
Location: Drawing 'Main Street Loading Bay Tracking'

Summary: Potential for large vehicles to collide with vehicles parked at the mobility impaired parking space adjacent the loading bay.

The swept path analysis drawings suggest evidence of large vehicles overhang conflicting with the mobility impaired parking space adjacent the loading bay which might lead to material damage.

The parking spaces and loading bay should have mutually exclusive time restrictions to avoid the potential for conflicts between parked vehicles and vehicles using the loading bay.

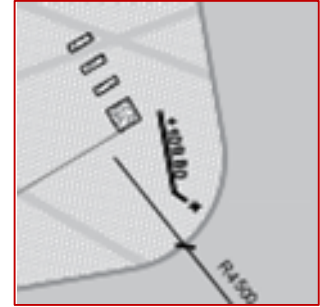
- 4.1 it is unclear from the information provided if there will be adequate tonal contrast between the footpaths and the carriageways within the proposed Scheme.

An absence of adequate tonal contrast can create difficulties for partially-sighted pedestrians navigating the proposed street layout.

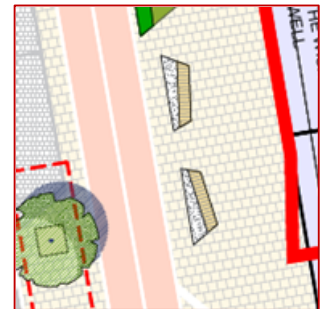
- 4.2 Natural stone & timber benches are proposed as part of the items of street furniture. It is unclear if it is proposed to provide armrests as part of these benches and if the bench bases are narrower than the rest of the bench.

Benches whose bases are narrower than the rest of the bench can create difficulties for long-cane users in detecting and avoiding colliding with the bench.

In order to accommodate the widest possible mix of disabilities, a mixture of benches with & without armrests should be provided.

The benches should have solid bases and no part of the bench should protrude beyond the extents of the base.

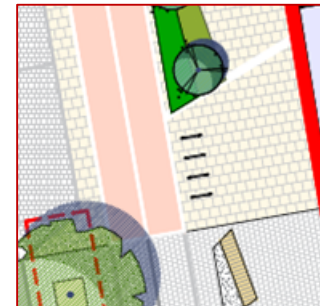
- 4.3 It is unclear if the bicycle stands proposed can accommodate a mix of bicycle types.

During the design development the proposed bicycle stands should accommodate a mix of bicycles in order to cater for the widest possible mix of cyclists (e.g. standard bikes, cargo bikes, hand-operated bikes, etc.).

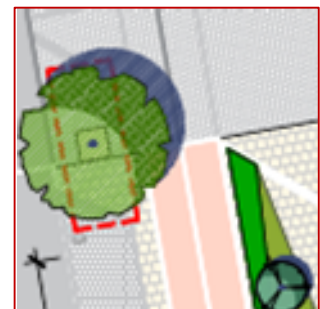
- 4.4 It is assumed that a shared surface is proposed where the cycle track terminates and recommences either side of the junction between Main Street and Rocks Road.

During the design development Ladder and Tramline tactile paving should be provided at the interfaces between shared surfaces and segregated non-motorised road user provisions (e.g. footpaths).
