**APPROPRIATE ASSESSMENT SCREENING OF
PROPOSED REHABILITATION OF DUNANCORY
BRIDGE, VIRGINIA, CO. CAVAN**

Appropriate Assessment Screening

Dunancory Bridge

February 2020

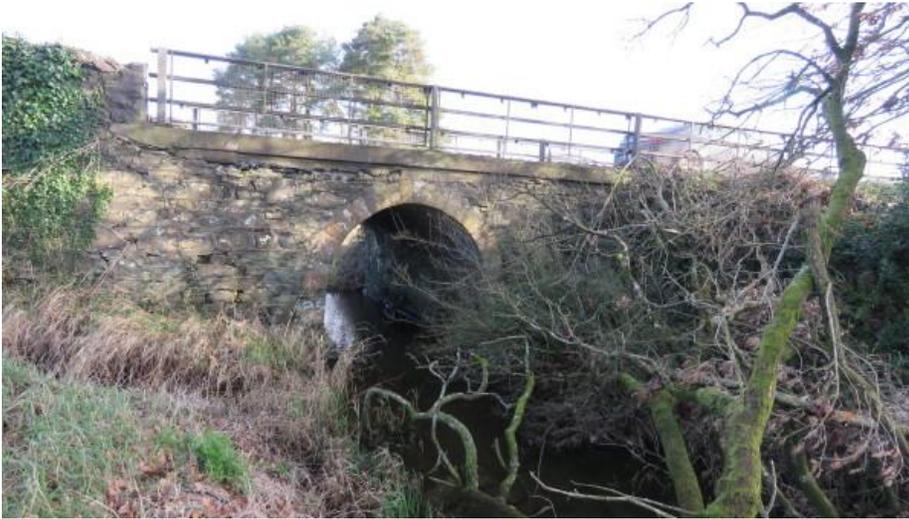
Photo 3 – southern face of western arch. A large oak tree stands just downstream of the bridge. Some boughs have broken and have fallen into the river causing a blockage.

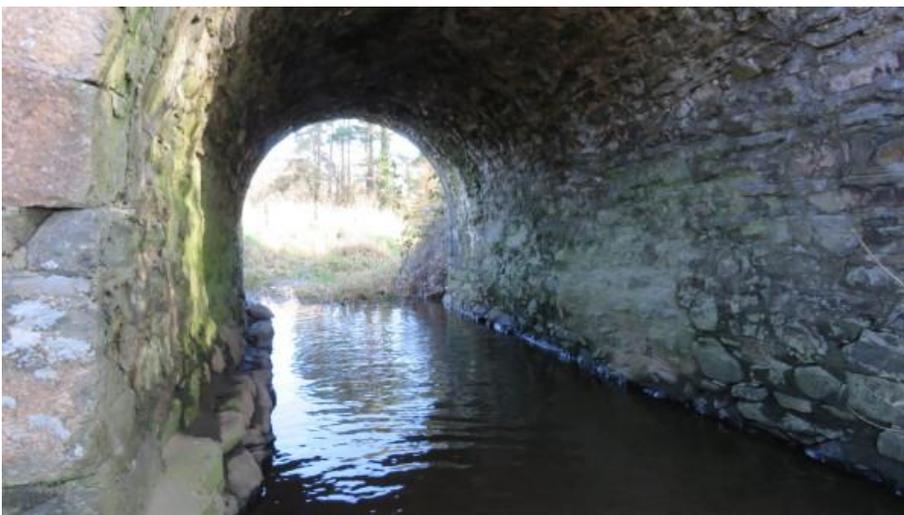
Photo 4 – view under western arch. There is a narrow plinth of stone running along the base of the western abutment.

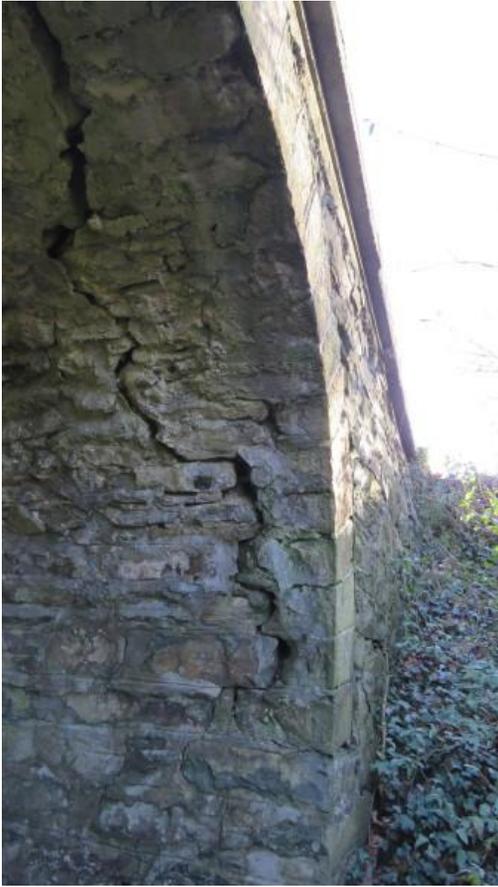
The parapet walls have been replaced with metal railings on both sides. The western arch is in poor condition. There is a large crack running around the arch barrel c.0.5 -1m in from the southern face (Photo 5). There is also a crack towards the centre of the arch. A section of stonework has collapsed from the undersurface of the arch close to the northern face. The remains of a dipper's nest were recorded wedged in this void (Photo 6). There is considerable mortar loss from between the stones under the arch. Evidence of usage by bats was recorded in a section of the crack midway under the arch. Staining and a few bat droppings were seen in this crevice, indicating that it had been used as a roosting site by bats last season (Photo 7). It may not be possible to retain this crevice due to its structural nature. Three crevices were marked with red paint for retention for bats close to the downstream face of this western arch (Photos 8 & 9).

Photo 5 – deep fissure running around arch barrel 0.5 – 1m in from southern face of western arch

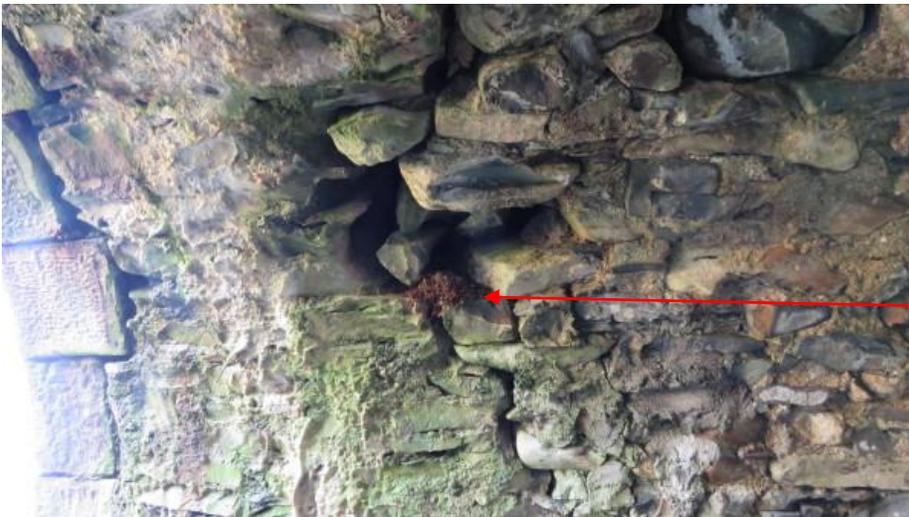
The remains of a dipper's nest were recorded in a void under this arch. It will not be possible to retain this void. Therefore, an alternative nest site must be provided to allow dippers to continue to nest at this site. A dipper box should be attached to the undersurface of the western arch.

Photo 6 – void in stonework close to northern face of western arch with remains of dipper's nest

A dipper’s nest box should be provided at under the western arch of Dunancory Bridge to allow dippers to continue to nest in this location.

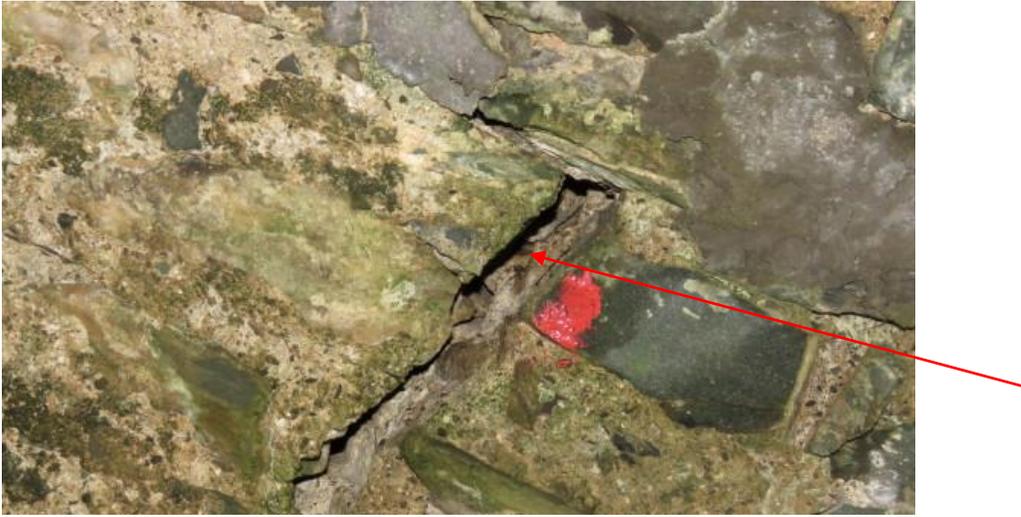
There is considerable mortar loss between the stones under the western arch which has allowed bats to roost in the crevices formed as a result. There is evidence that a small colony of bats (most likely Daubenton's bats) roosted in a section of the crack midway under the arch during the last season.

Photo 7 – crack midway under western arch with evidence of bat usage in the form of staining

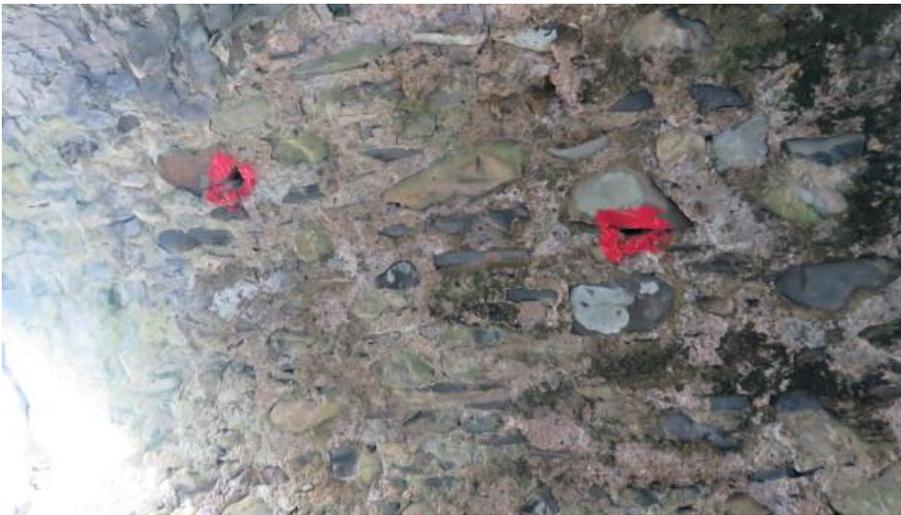
Photo 8 – Two crevices marked for retention for bats under western arch

- A bat detector survey should be conducted in May 2020 to establish the species and number of bats using the bridge
- All marked crevices must be retained for bats
- Provide nesting box for dippers under western arch towards upstream face
- Ensure that there is no light spillage from the new streetlights onto the water surface

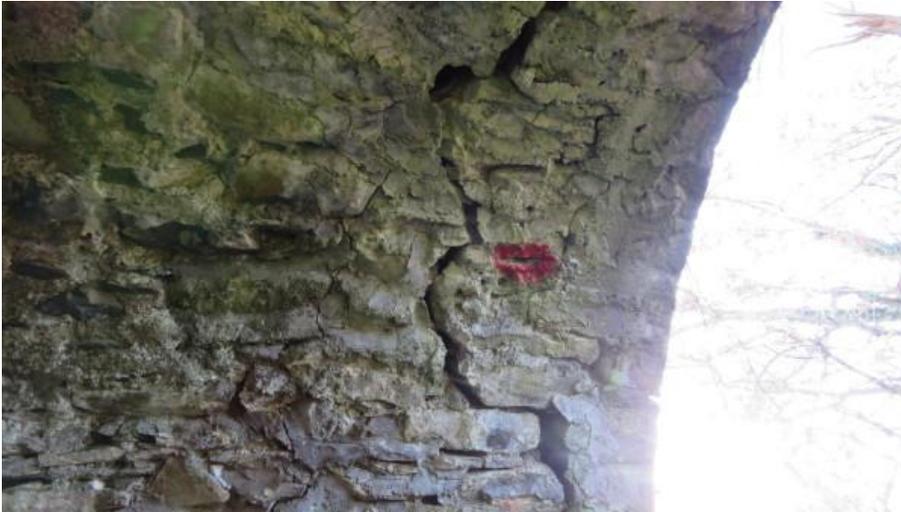
Photo 9 – Crevice marked for retention for bats towards southern face of western arch

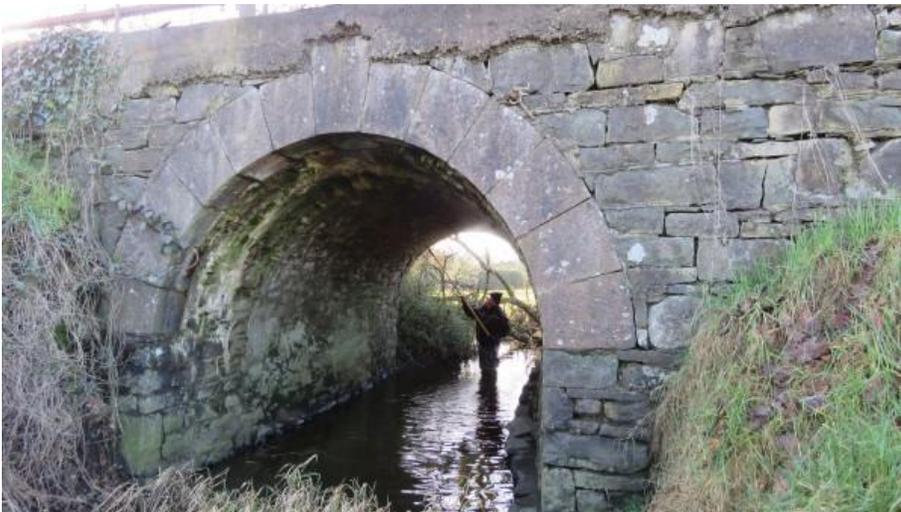
Photo 10 – northern face of western arch. Crevices in the stonework of the upstream wall are too shallow for bats.

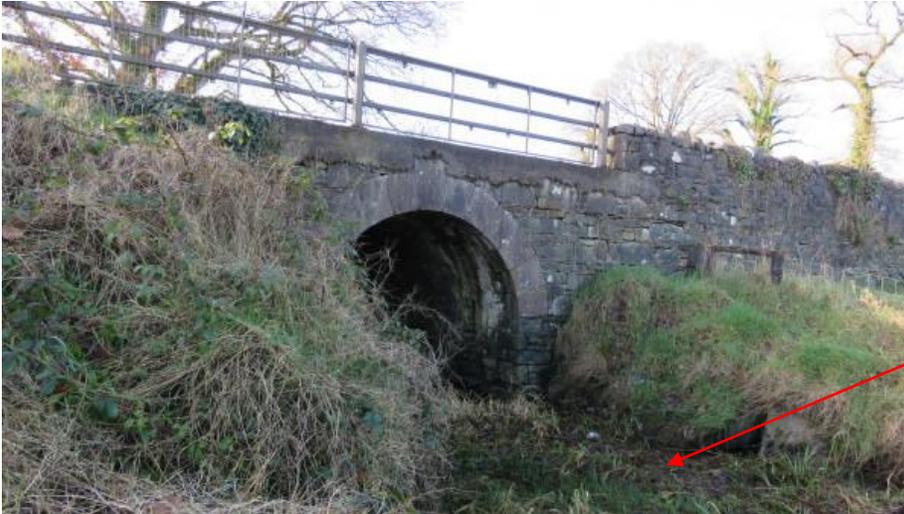
The river is choked with vegetation and a build-up of silt immediately upstream of this arch (Photo 11). This build-up should be cleared to allow river to flow freely under this arch.

Photo 11 – northern face of western arch. The channel upstream of this arch is blocked with vegetation which should be removed.

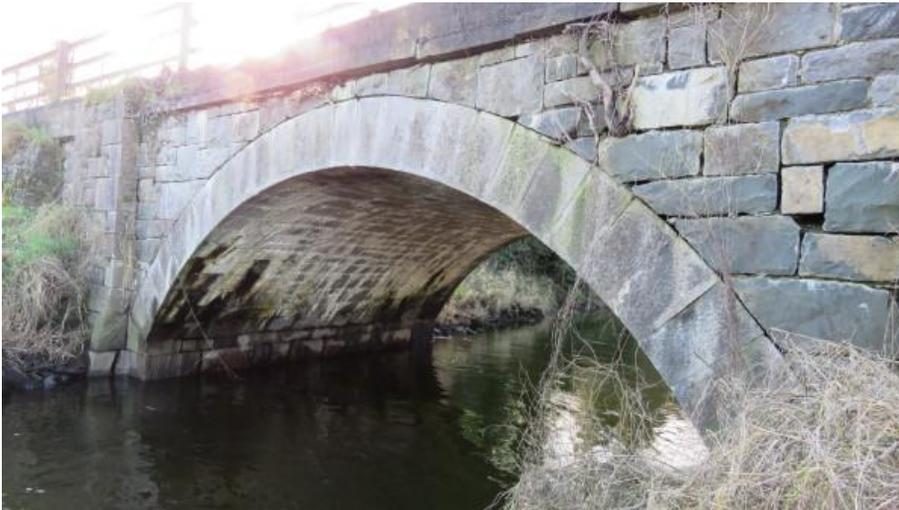
Photo 12 – northern (upstream) face of eastern arch

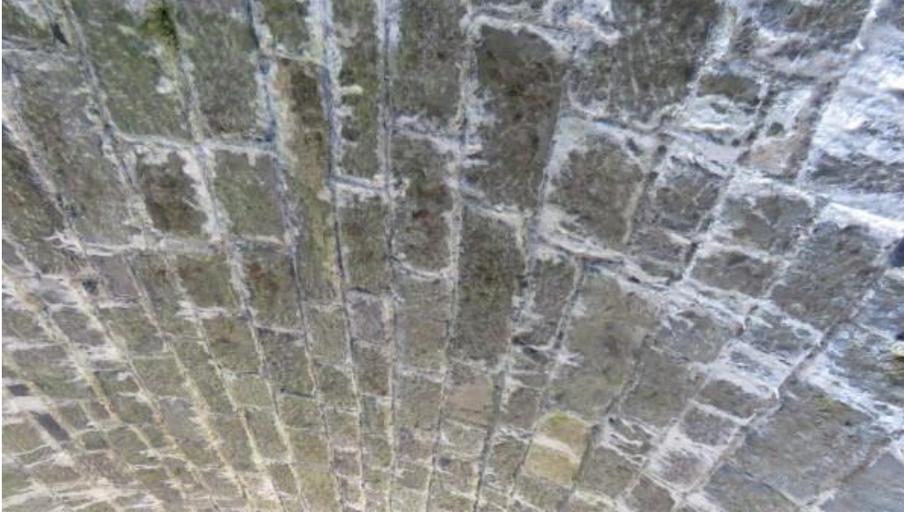
The eastern arch is in good condition. The stonework under the arch is comprised of regular cut stone and very little loss of mortar (Photo 13). There were two crevices under this arch which were considered to be suitable for bats. One crevice behind the upstream facing stones contained a few bat droppings, indicating that it has been used by bats in the past. This crevice was clearly marked with red paint for retention for bats (Photo 15). A second crevice approximately 2m in from the upstream face was also marked for retention for bats (Photo 15). There were no suitable crevices in the bridge walls.

Photo 13 – view of stonework under eastern arch which has been well-grouted in the past

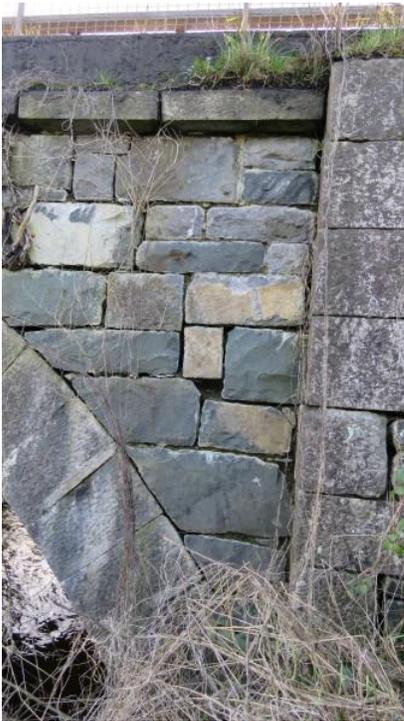
Photo 14 – upstream wall of eastern arch. Crevices too shallow for roosting bats

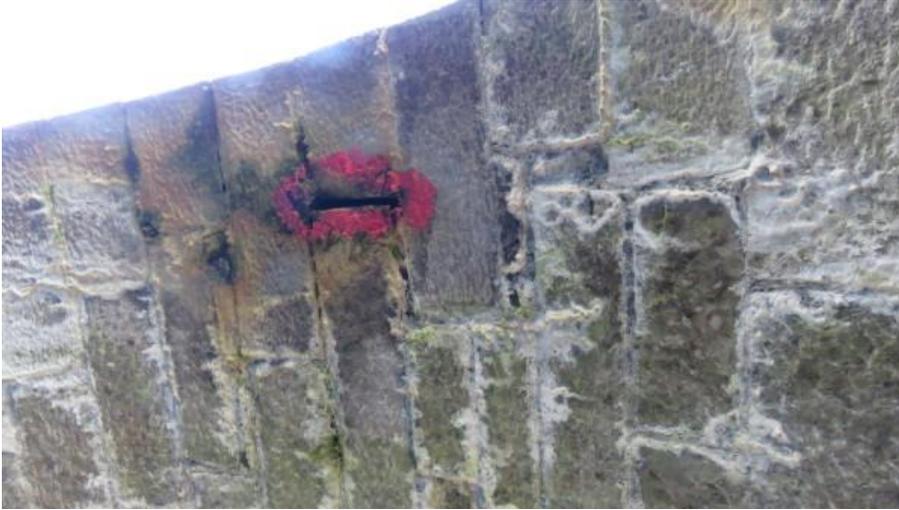
There was also evidence of bats roosting in the crevice behind the upstream facing stones of the eastern arch.

Photo 15 – Crevice marked for retention for bats behind upstream facing stones of eastern arch

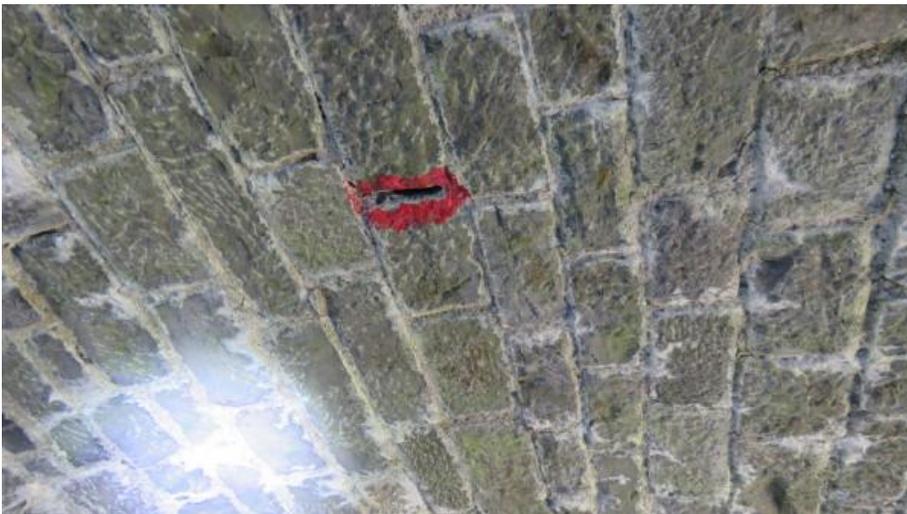
Photo 16 – Crevice marked for retention for bats in stonework at apex of eastern arch

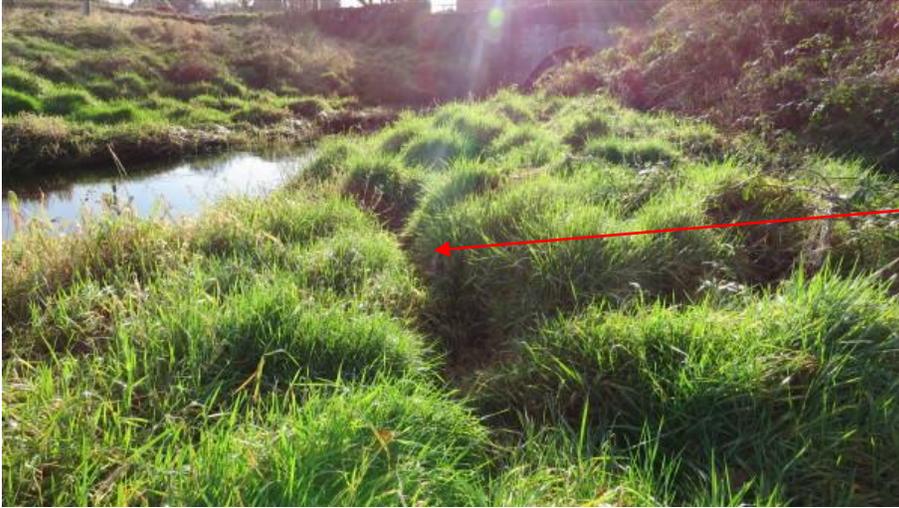
An otter trail was recorded on the grassy island between the two arches (Photo 19).

Photo 19 – otter tracks in grass between the two arches of Dunancory Bridge

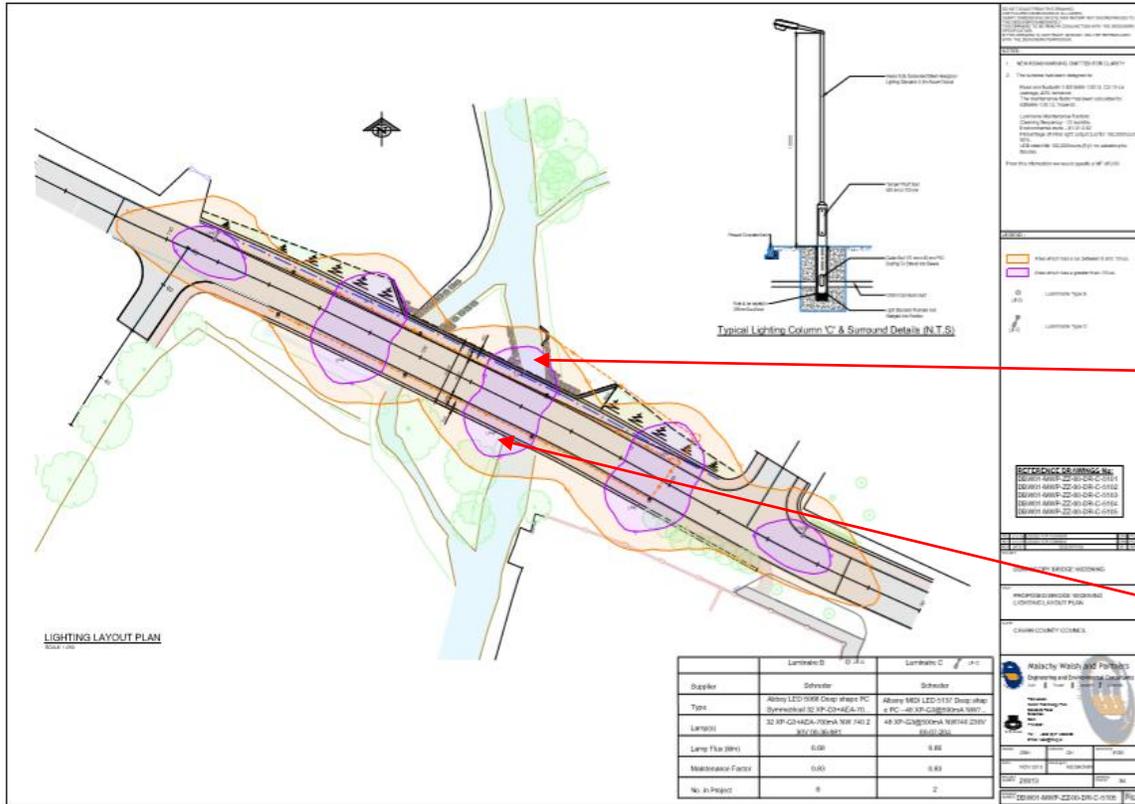
Figure 2 – Showing proposed lighting of carriageway over Dunancory Bridge. The light spillage onto the river must be reduced as it will deter bats from commuting/foraging
