Assan Bridge, Assan, New Inn, Co. Cavan (NIAH Reg. No. 40403301)

Architectural Heritage Impact Assessment (Amended for revised scheme)

28.09 2022

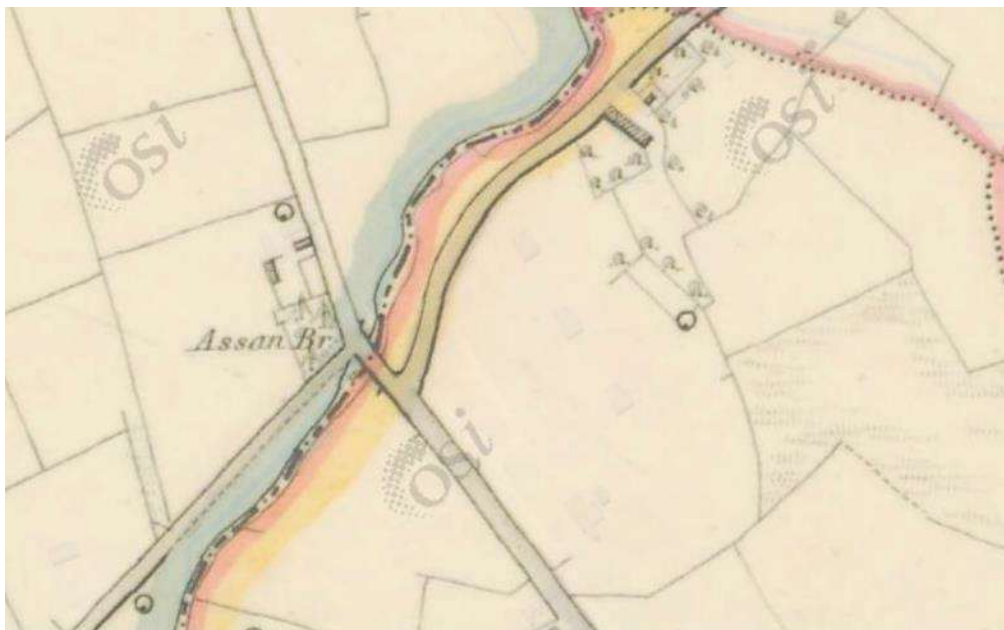
Fig. 1: Extract from the first edition Ordnance Survey map, c. 1840. Note the bridge is included on this edition of the map and is named. The river can be seen to flow from the northeast at this time.

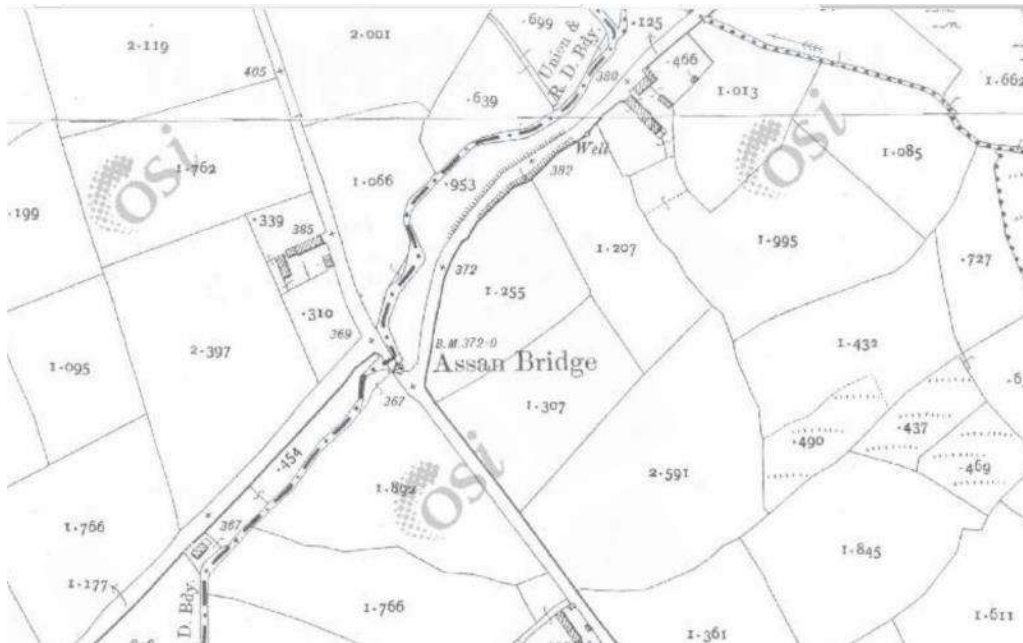
Fig. 2: Extract from c.1900 edition of Ordnance Survey map. Note that the course of the river has changed by this time and now flows towards the bridge from the side (northwest).

This will be removed as part of the riverbed realignment. However, as noted above, the course of the river has changed since the construction of the bridge and this northeast wall comprises a later intervention carried out following the change in the river course. It is not of historical significance.

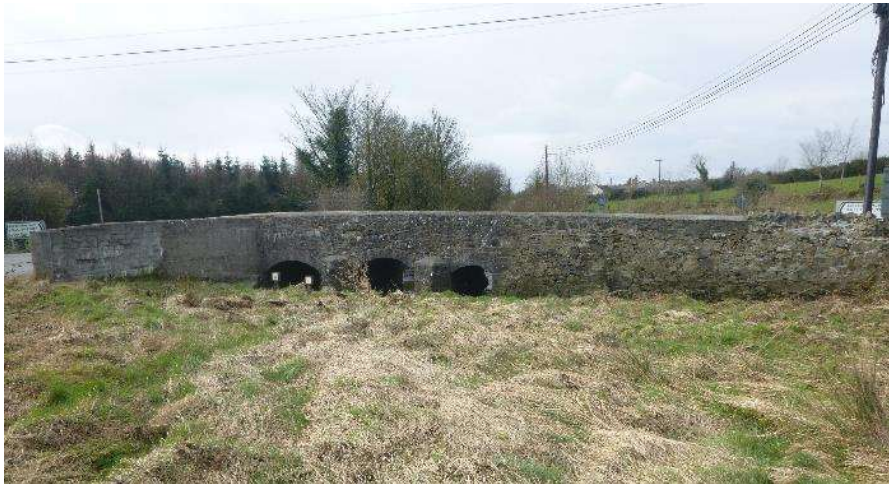
Fig. 3: Upriver elevation of the bridge

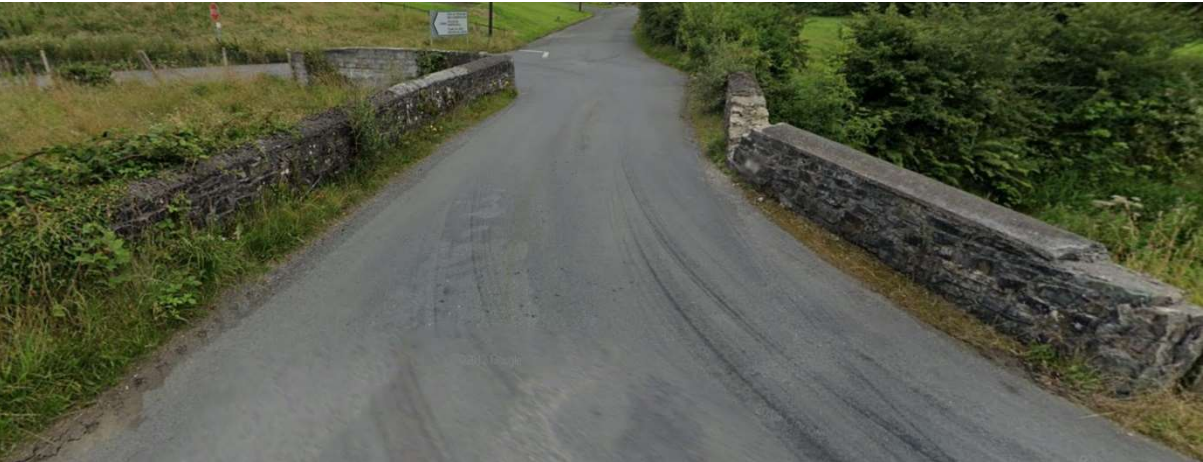
Fig. 11: Deck of bridge, view southeast (Google maps)
