Church of Ireland Church Ballyhaise County Cavan

Prepared by Bronagh Lanigan Architectural Heritage Consultant AR&R

Proposed new path at Church of Ireland Church, Ballyhaise part of trail walk in Ballyhaise

Date of Inspection: 10th October 2020

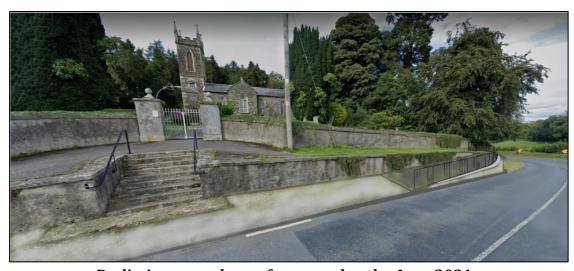
Preliminary mock-up of proposed path – June 2021
Please not existing wall and should not be impact by installation of new path.
Not shown in this mock-up image

It is important that any proposed works do not impact on the historical character of the church and setting. It is equally important that any works carried out are reversible, that no original materials will be impacted or damaged in the installation of the path. It is therefore recommended that the path and ramp do not come into contact with the wall of the existing raised path. The proposed new path and ramp must be stepped back of distance of approximatly 250-300mm.

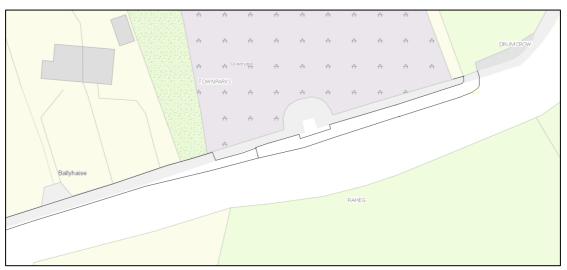
Location of proposed new path at Ballyhaise Church od Ireland Church (protected structure)

It is proposed to create a new path at road level in front of the church with a 1:12 gradient slope and railings at the east end of the path accessing trail entrance at Ballyhaise College.

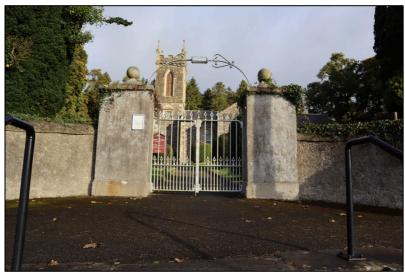
Access to the church grounds is through decorative cast-iron double gates supported by square-profile rendered piers with stone copings and ball finials. A wrought-iron overthrow (arch over gate) is supported by the piers and is likely to have had a lantern.

Figure 1: View of main entrance gates to church

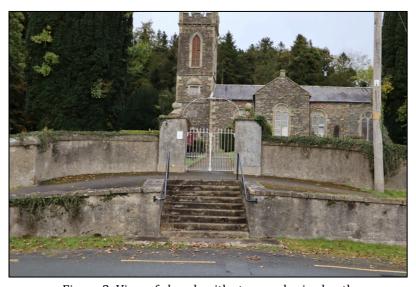
The raised path has a flight of 9 steps at its centre leading to the main entrance gates. The rendered retaining wall with flat stone capstones returns around the steps.

Figure 2: View of church with steps and raised path

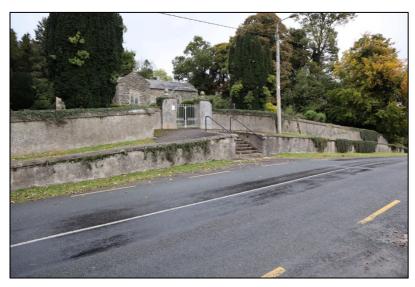
The existing raised path at the church is unsafe and not suitable for public use. There are no railings to prevent a fall off the unprotected edge onto the road.

Figure 3: View of raised path and retaining wall

Having visited the site it is recommended that a path at road level be installed in front of the church.

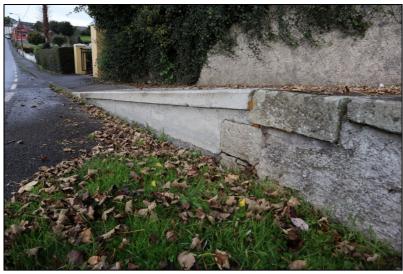
The raised path to the west of the church (village side) has a stony surface with grass edges and a new concrete ramp over two stone steps at the end of the path. The path to the east of the church (Ballyhaise House side) has a grassy surface with a track worn by pedestrians. The path to the east leads to a pedestrian gate that accesses the grounds of Ballyhaise House. There are original limestone flat capstones on the edge of the rendered retaining walls supporting the raised path.

Figure 4: New ramp installed recently at west end of raised path

No further unauthorized works should be carried out at Ballyhaise Church of Ireland Church. Please consult with the relevant planner or Heritage Officer for advice on suitable works.

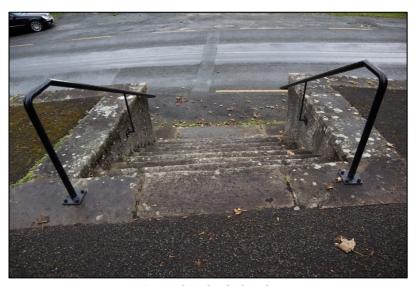
Figure 5: New handrails fitted to steps

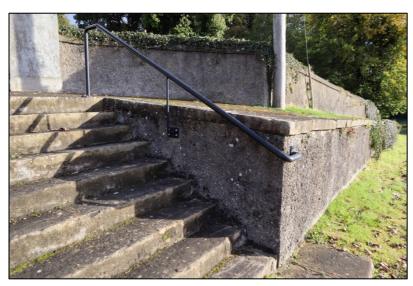
Figure 6: Safety handrail at steps

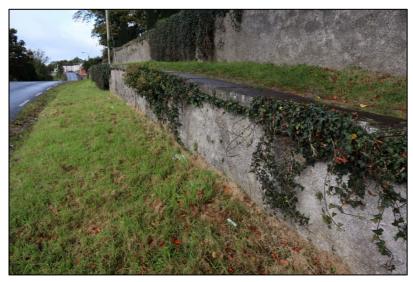
Figure 7: View of retaining wall to east (Ballyhaise College side)

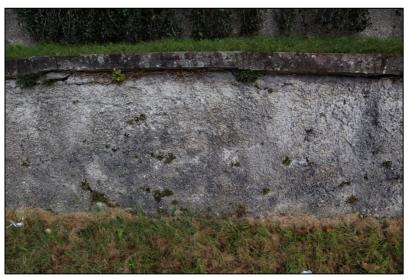
Figure 8: Detail of rendered raised wall with flat copingstones

It is crucial that materials and finishes used compliment the existing materials and finishes at the church. It is therefore recommended that stone kerbstones are installed on the paving in front of the church. It is also recommended that a dashed render, to match finish on the existing walls at the church, be used on the wall forming the ramp at the east end of the path.

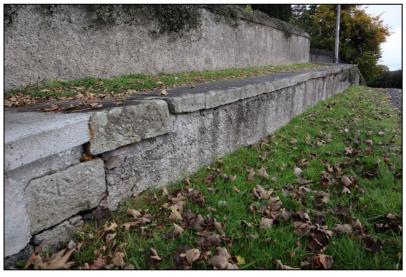
Figure 9: View of retaining wall to west (village side)

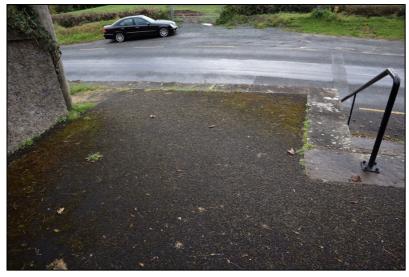
Figure 10: Tarmacadam surface at steps and leading to entrance gates

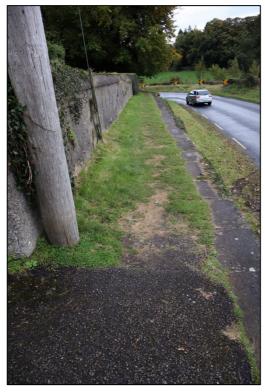
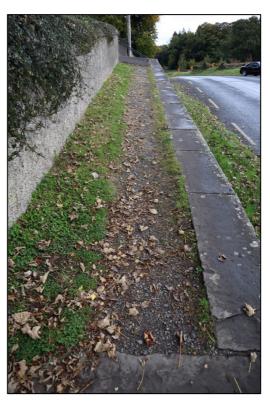
Figure 11: Grassy surface to raised path leading towards Ballyhaise College (east end)
Figure 12: Stony surface to raised path leading towards village

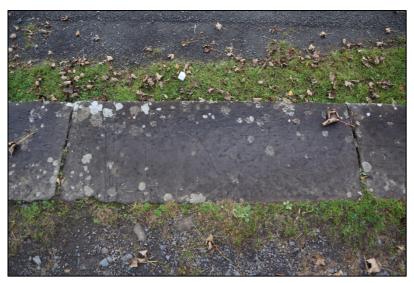
Both sides of the path measure approximately 46meters in length and at its highest point the raised path is approximately 4.5ft above the road level. The capstones are approximately 18" wide.

Figure 13: Detail of limestone flat coping stones forming edge of raised path

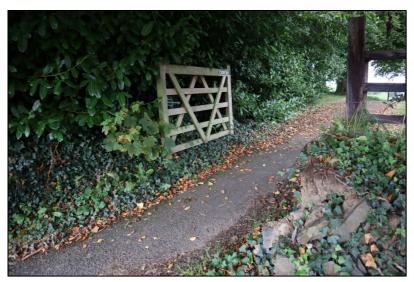
Figure 14: Access to Ballyhaise College from end of east raised path

At the east end of the path a 1:12 gradient slope will be formed to access the wooded path into Ballyhaise College at the high level. This solution will allow universal access to the proposed trail and avoid use of the existing raised path.

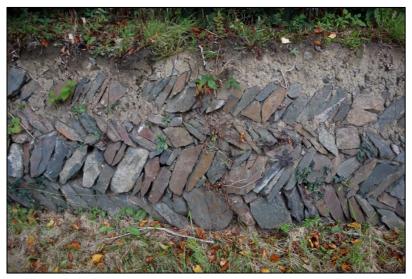
Figure 15: Detail of herringbone wall bounding part of Ballyhaise College land at end of raised path

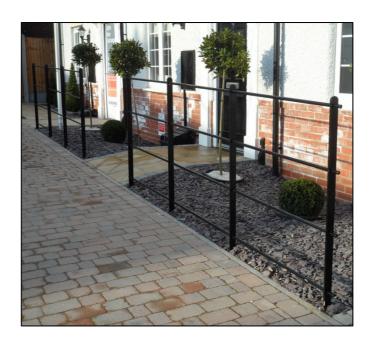
Suitable railing type: Flat-iron posts.

It is important that a railing type and style used on the ramp that is in keeping with the historic character of the setting is selected. Compacted Ballylusk gravel (or locally sourced similar) should be considered as a suitable surface for the new path.
