Architectural Heritage Impact Assessment Report For Kingscourt Town Centre Regeneration Scheme, Co. Cavan.

Client: Cavan County Council

Date: 06th December 2022

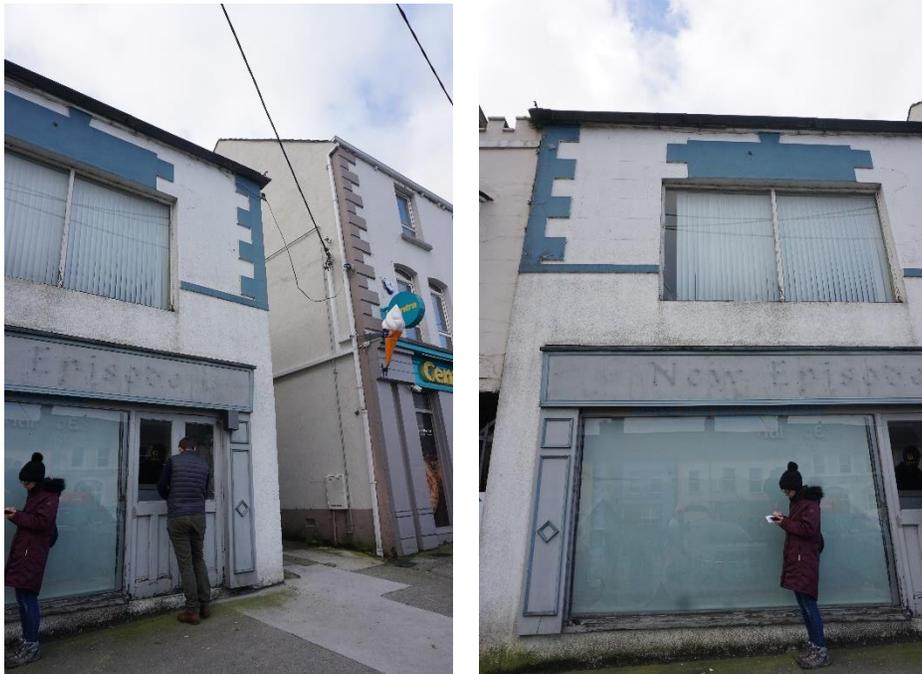
At ground floor level, the building hold a hairdressing unit. The unit had been renovated to accommodate the tenants (date unknow). All works at ground floor level are modern and no historical features of merit could be observed on the day of inspection.

Photograph 1 – View of the front elevation

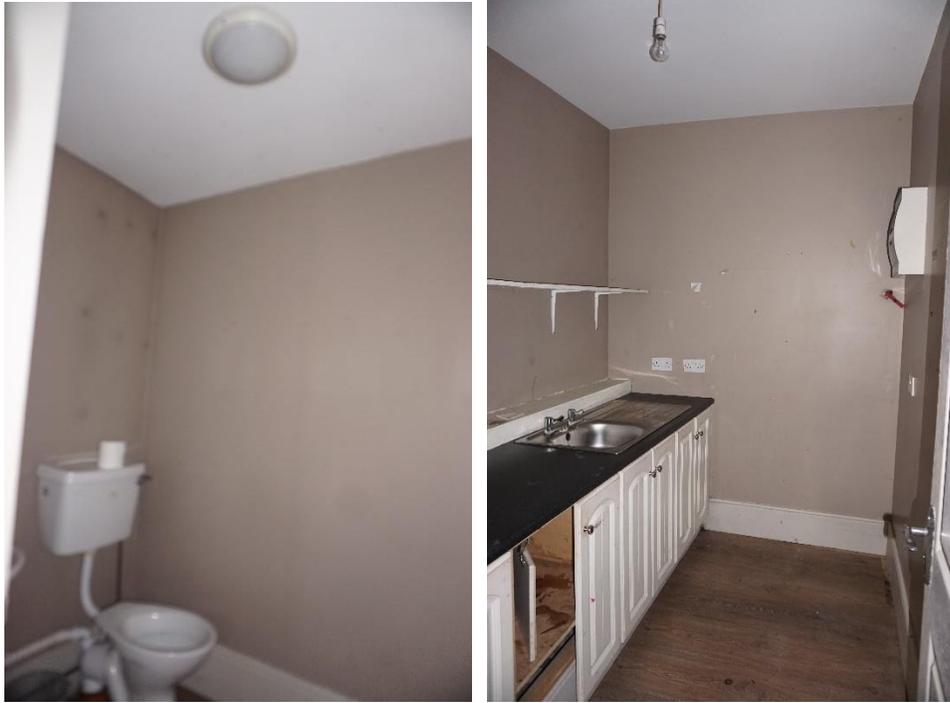
Photograph 2 – View of the interiors

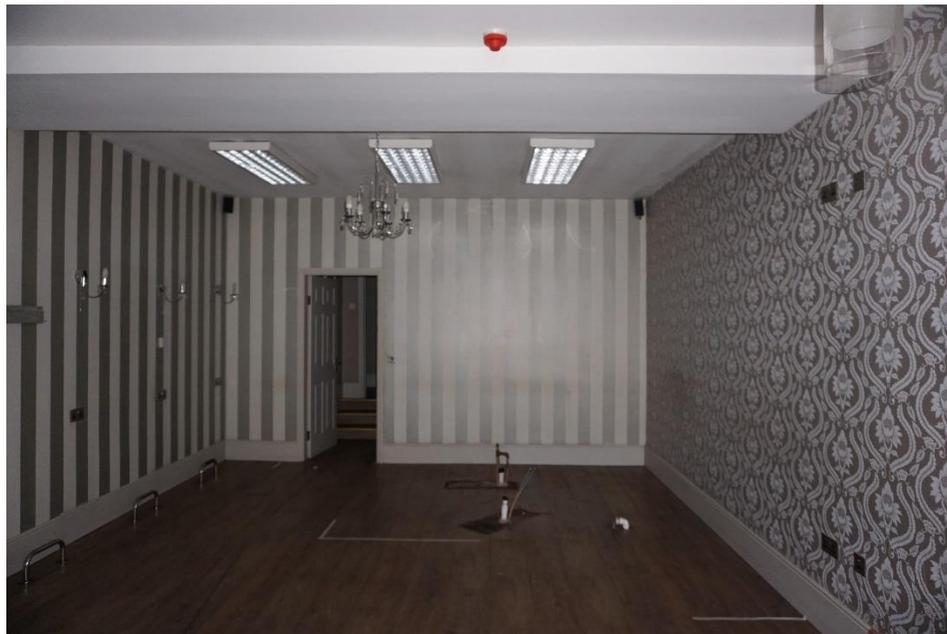
Photograph 3 -View of the former unit

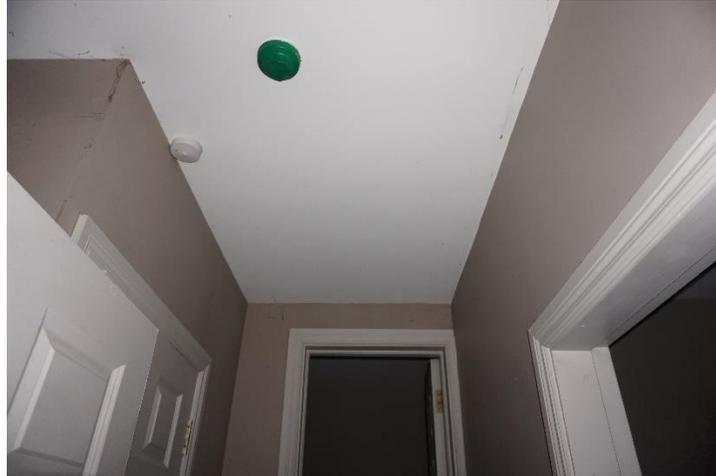
Photograph 4 -View of the modern internal fit out

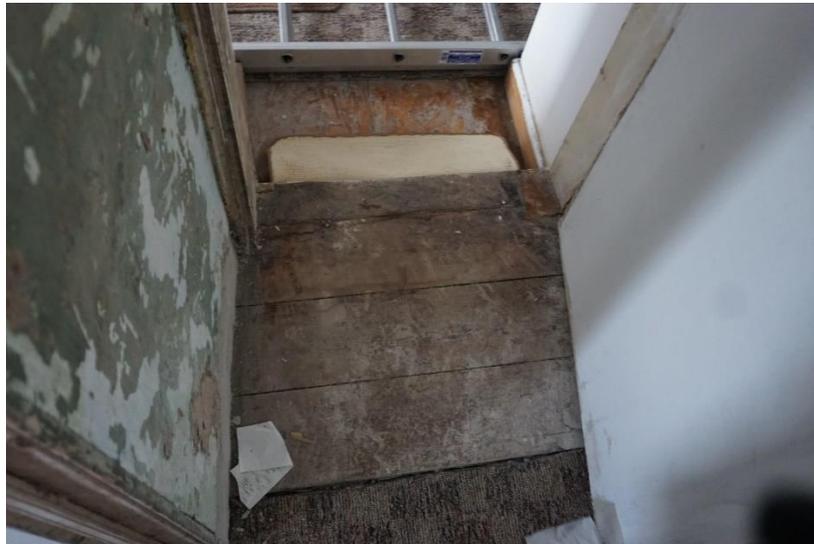
Photograph 9 – Images of flooring into bedroom unit.

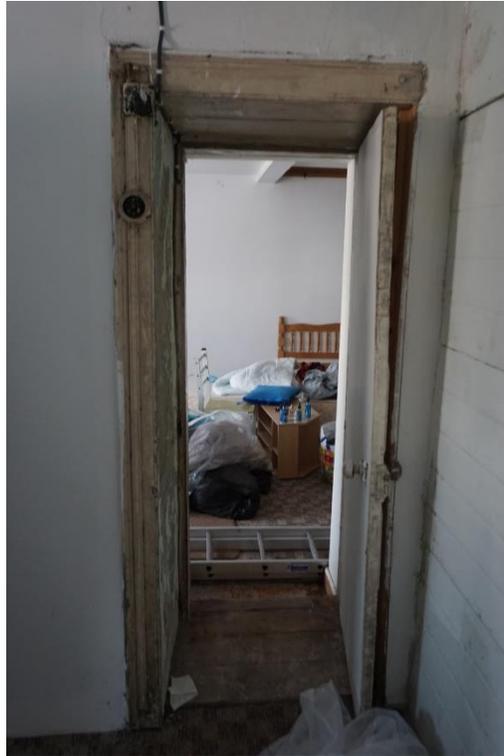
Photograph 10 – Entrance door into bedroom unit

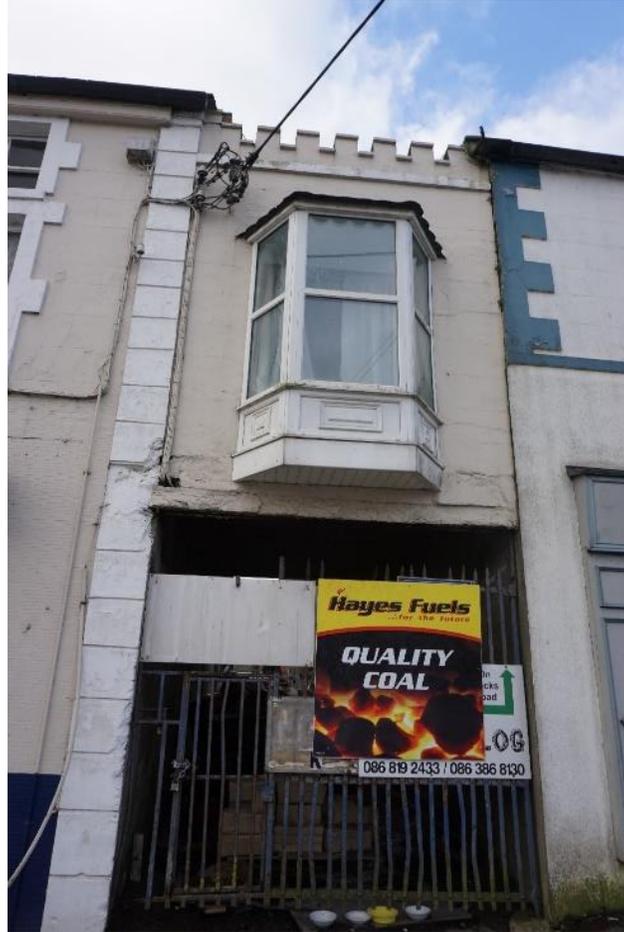
Photograph 12 – View of the bedroom unit from the streetscape.

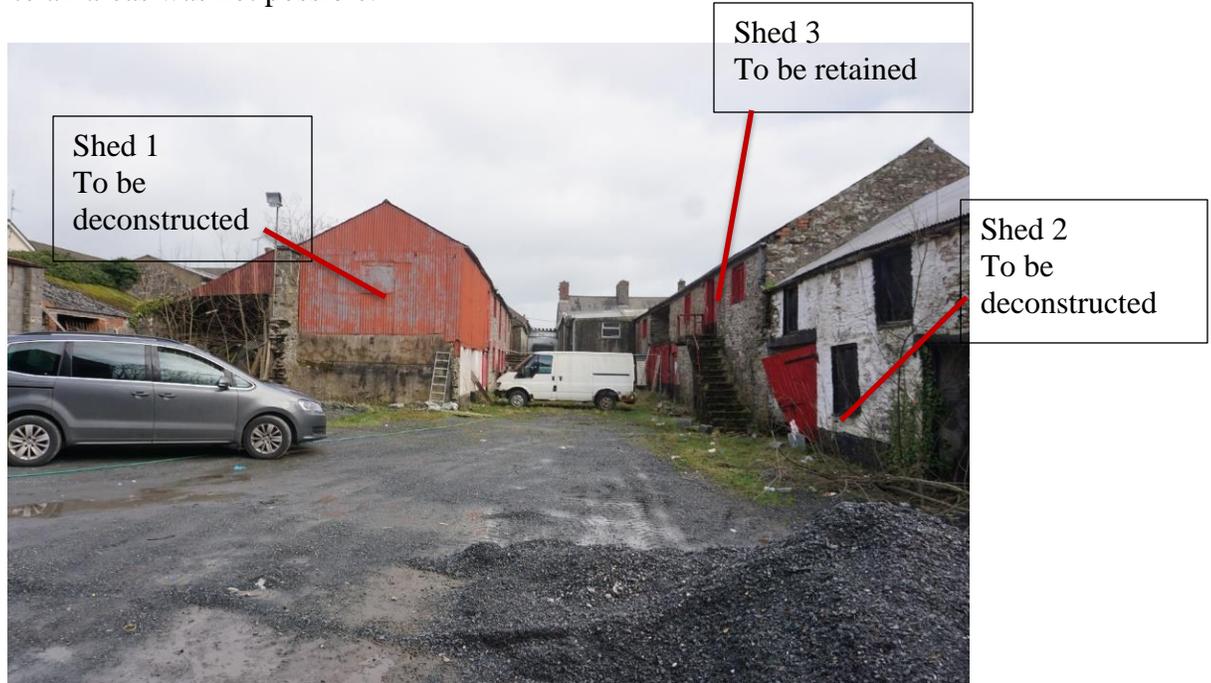
To the rear of the building is a number of outbuildings that are due to be deconstructed during the proposed works. These buildings include modern steel sheds and a mixture of single and two storey stone sheds with natural slate roofs. A number of the buildings are in a poor condition, missing slates have allowed water ingress which has caused internal damage to the buildings. Please note that access to all areas was not possible.

Photograph 14 - View of the rear of the buildings.

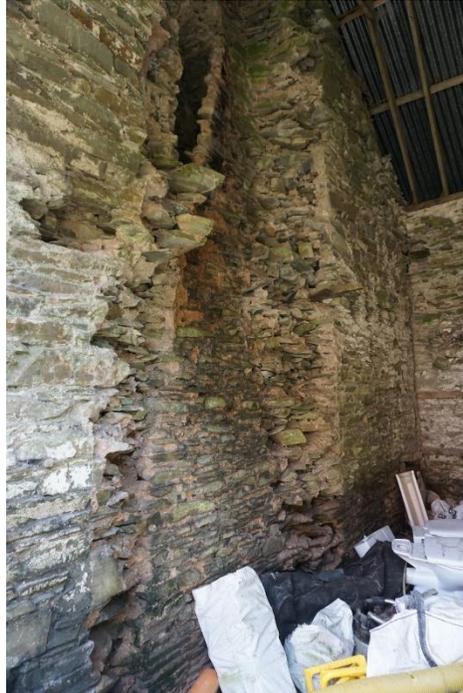
Photograph 15 – Internal View of the sheds to be deconstructed. Internal walls in disrepair. (Shed 2)

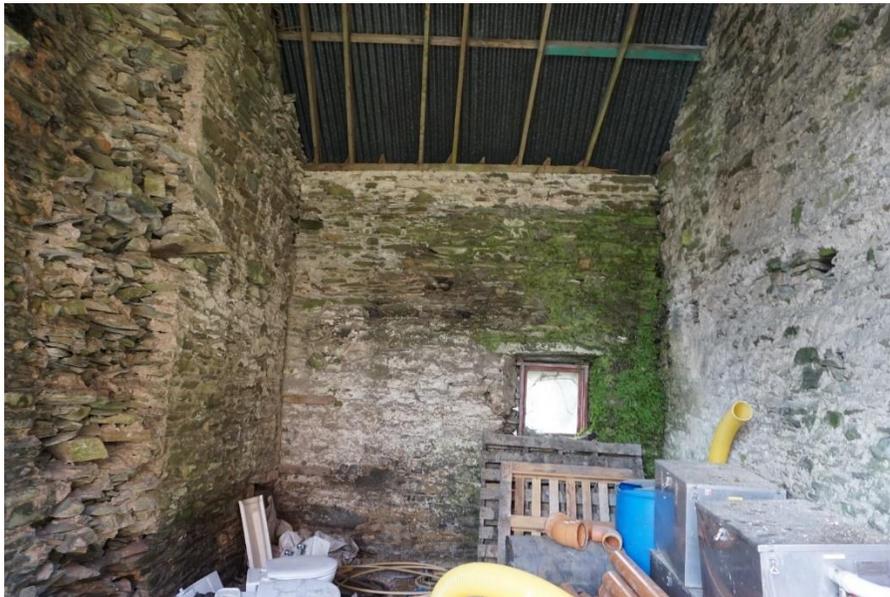
Photograph 16 – Internal View of the sheds to be deconstructed. Internal walls in disrepair. (Shed 2)

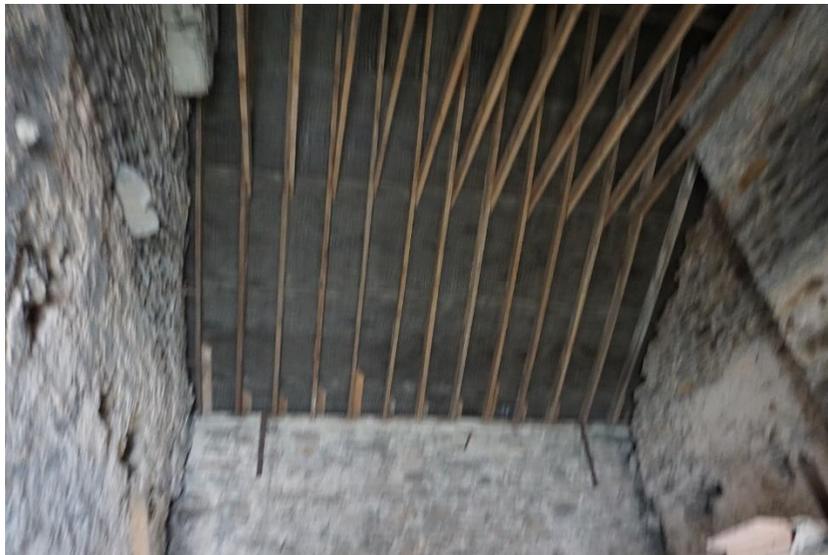
Photograph 18 - Internal View of the sheds to be deconstructed. (Shed 2)

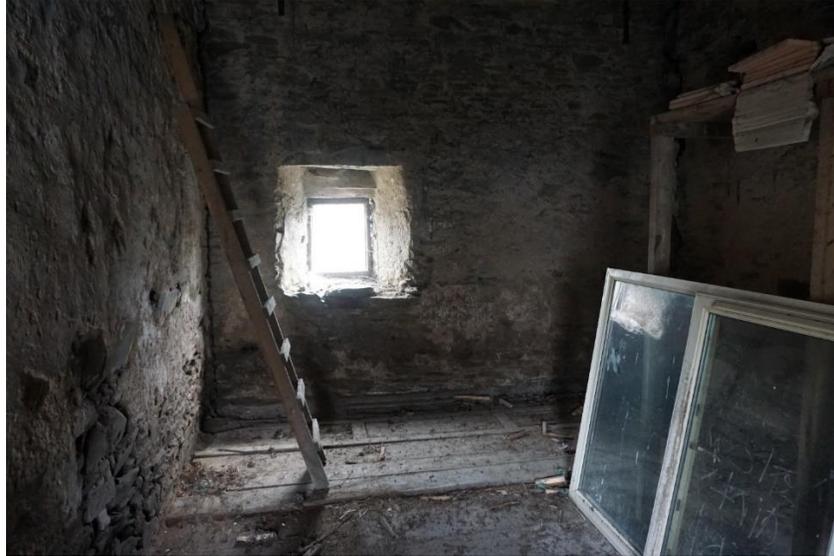
Photograph 19 - Internal View of the sheds to be deconstructed. Internal walls in disrepair. (Shed 2)

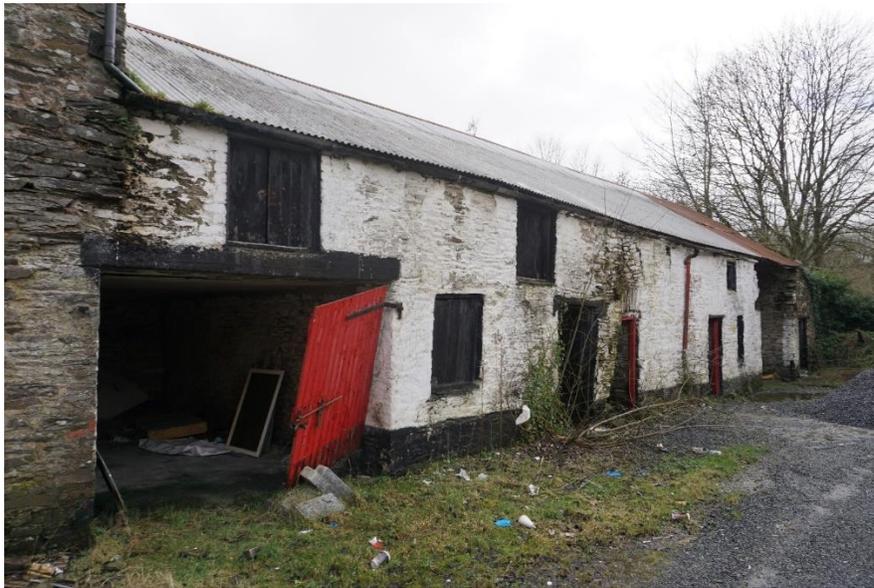
Photograph 20 - External View of the sheds to be deconstructed. (Shed 2)

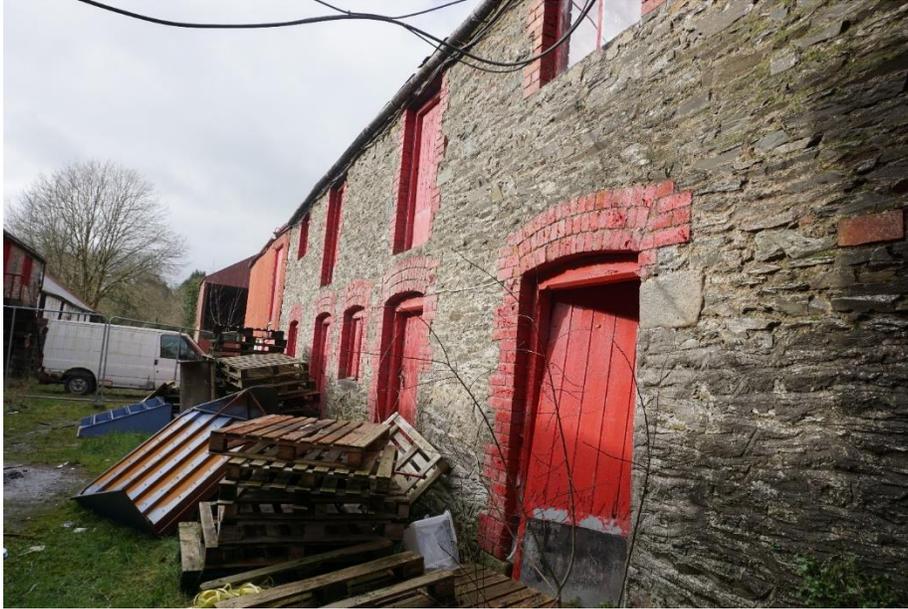
Photograph 21 – Outbuilding to be deconstruction. (Shed 1)

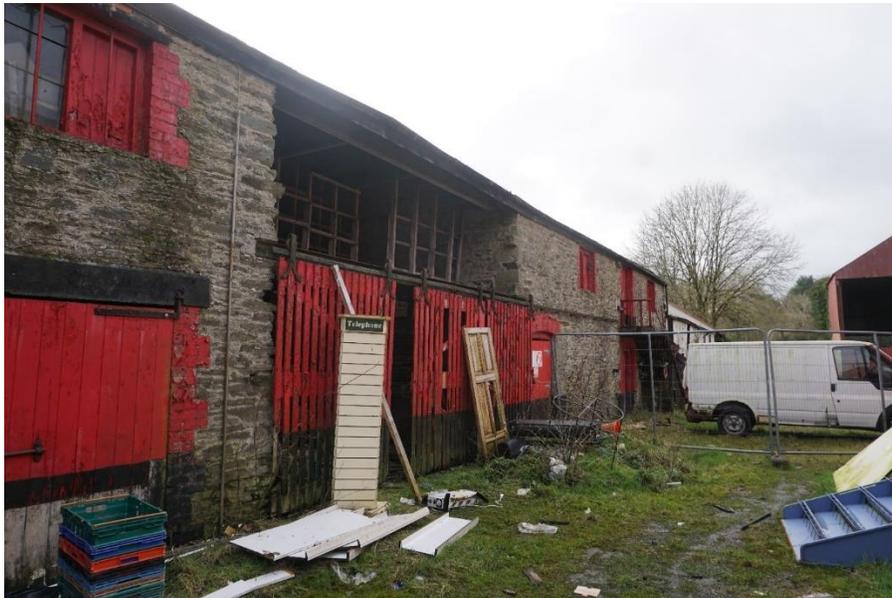
Photograph 22 - Outbuilding to be retained. (Shed 3)

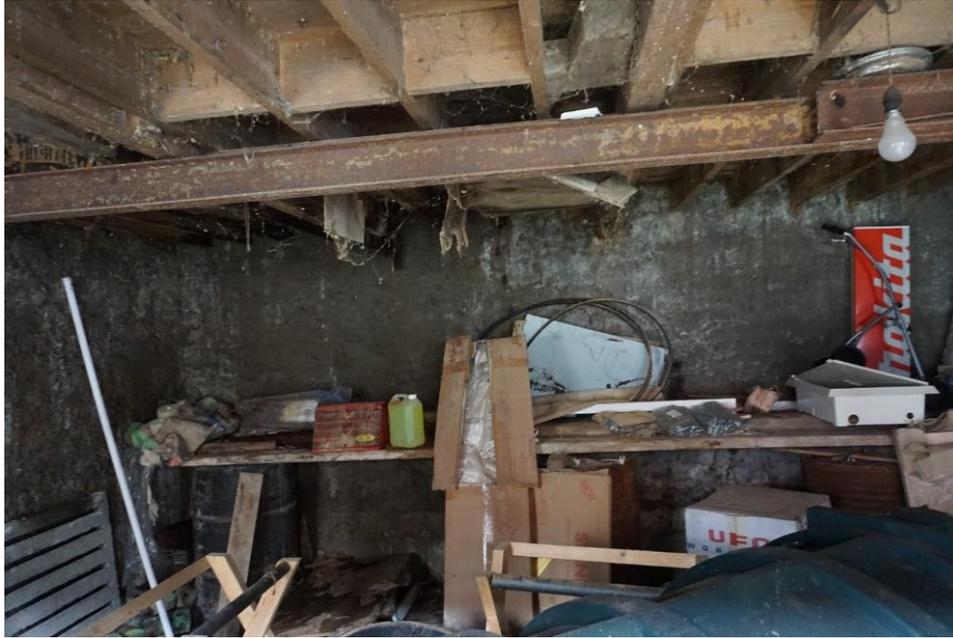
Photograph 23 – Internal View at ground floor level of Shed 1

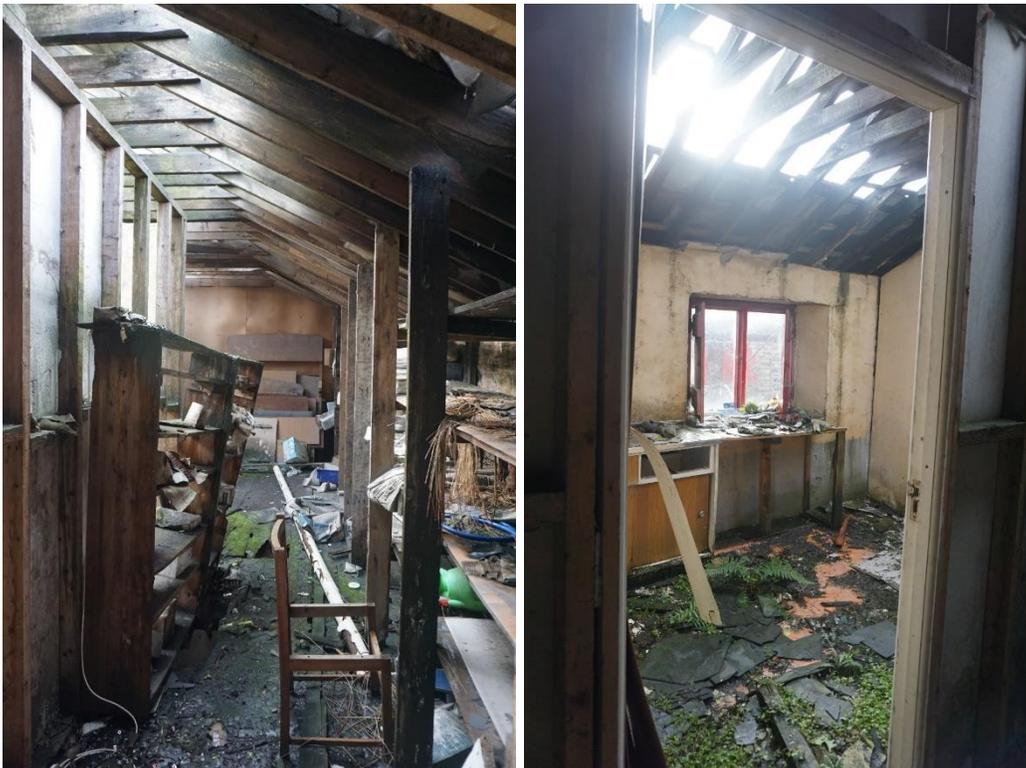
Photograph 24 -Internal View of Shed 1 – First Floor level

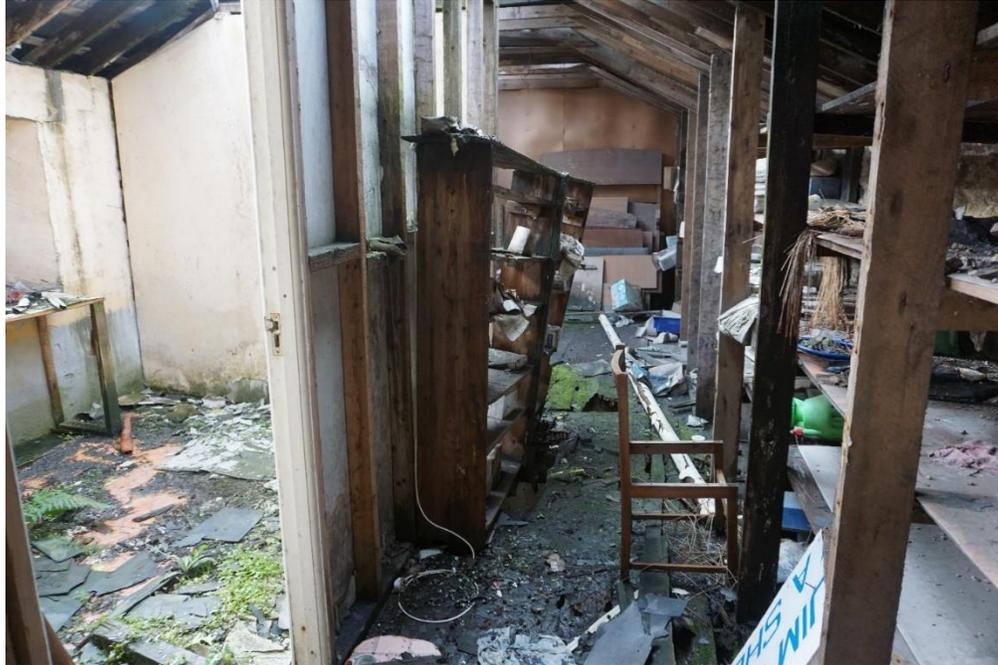
Photograph 25 – Internal View of Shed 1 – First Floor level

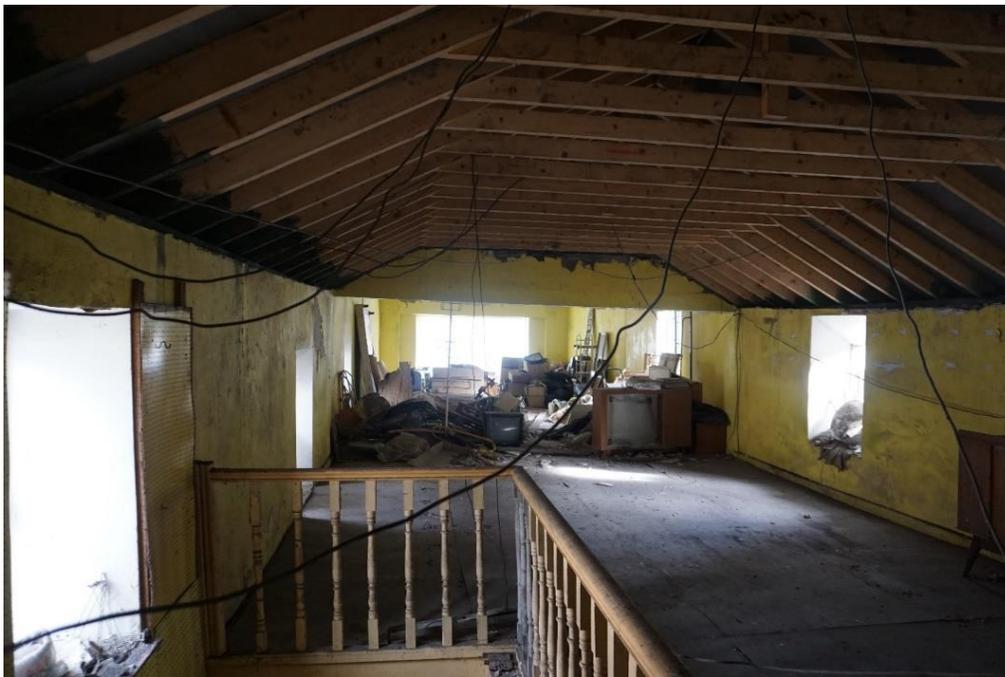
Photograph 26 - Internal View of Shed 1 – First Floor level (view towards the road)

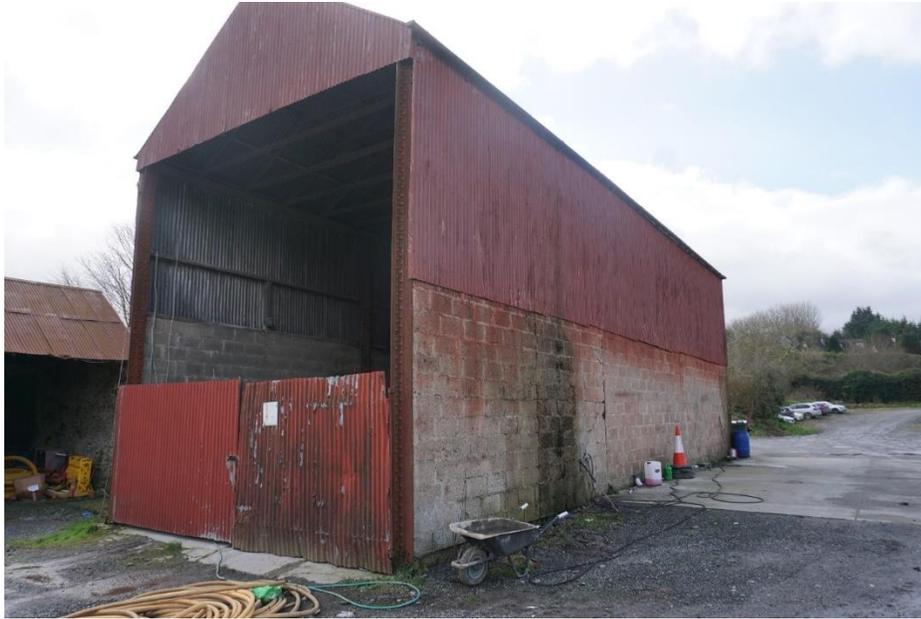
Photograph 27 - View of modern shed to be removed.

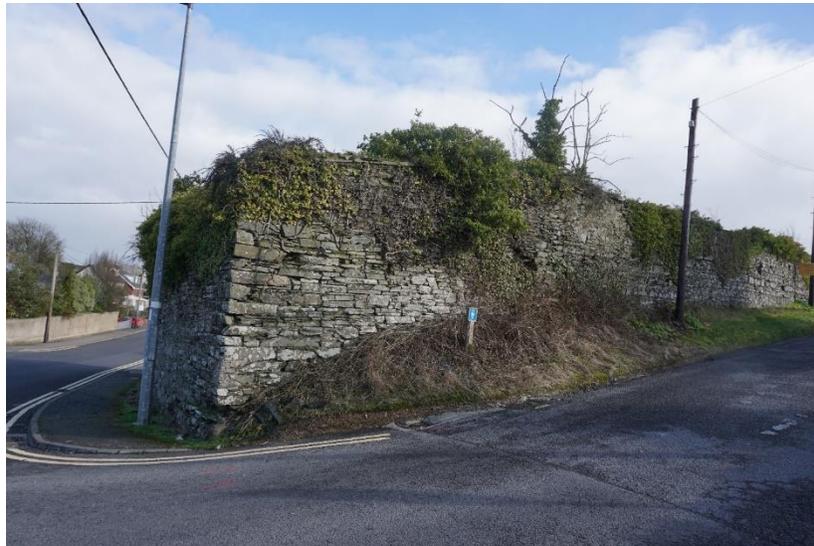
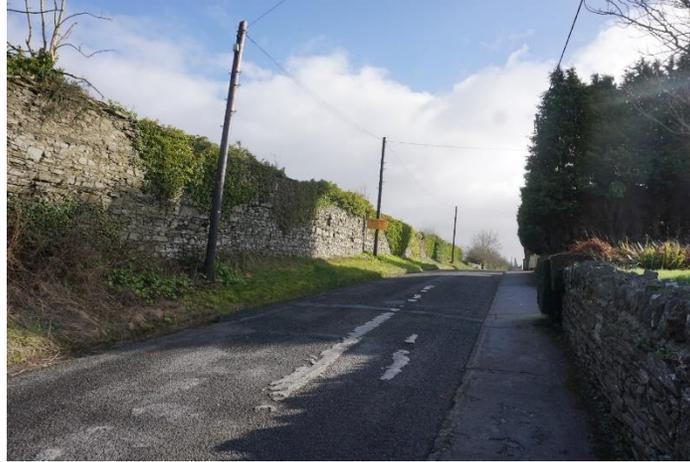
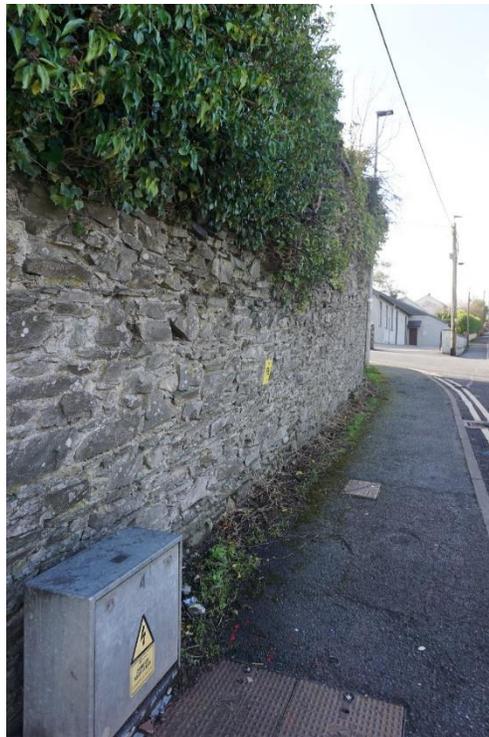
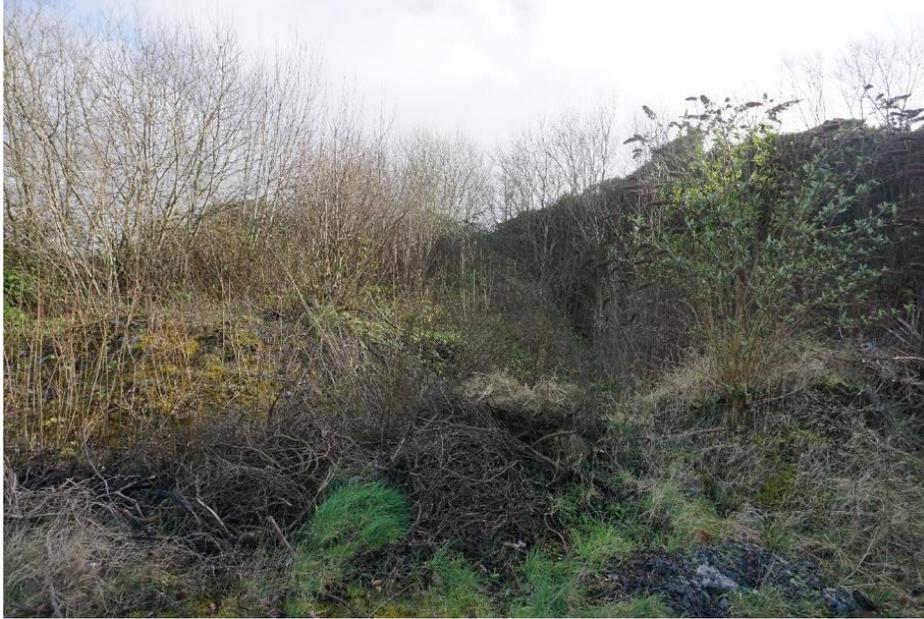
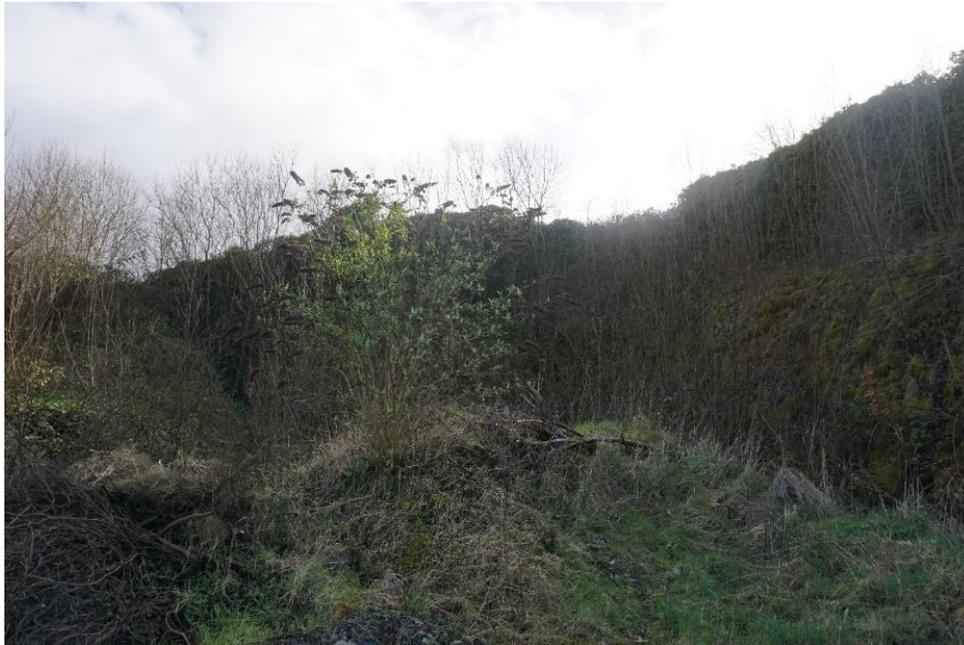
At the rear of the proposed site is a stone wall that divides the site from the front and the rear of the site while another stone wall divided the entire site and chapel lane. These walls are overgrown with vegetation. A full assessment of these walls will be carried out during the works.

Photograph 28 - View of the external boundary wall

Photograph 29 - View of the external boundary wall along St Mary's Road.

Photograph 30 - View of the external boundary wall

Photograph 31 - View of the external boundary wall

Photograph 32 - View of the external boundary wall

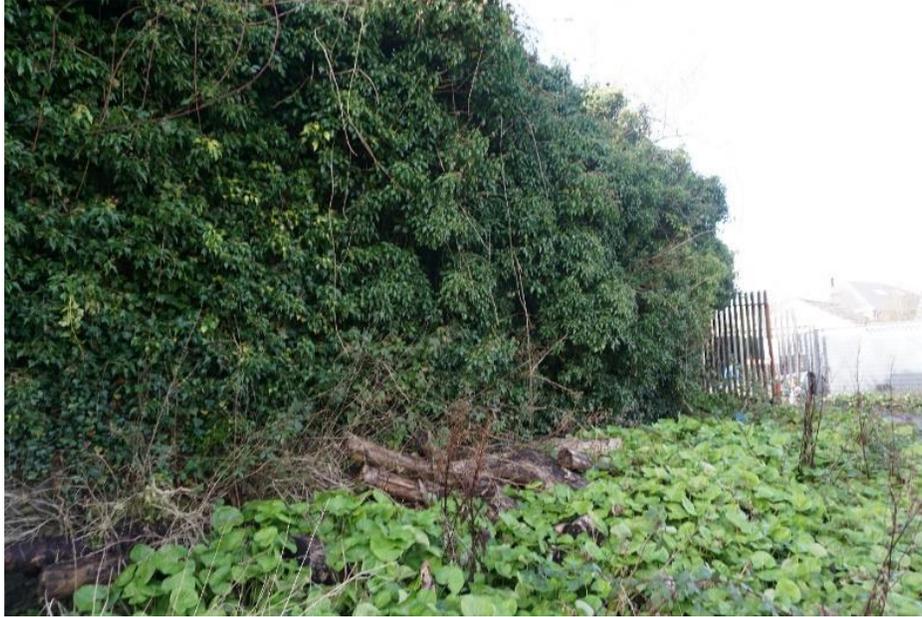
Photograph 33 – View of wall within the site – to be retained.

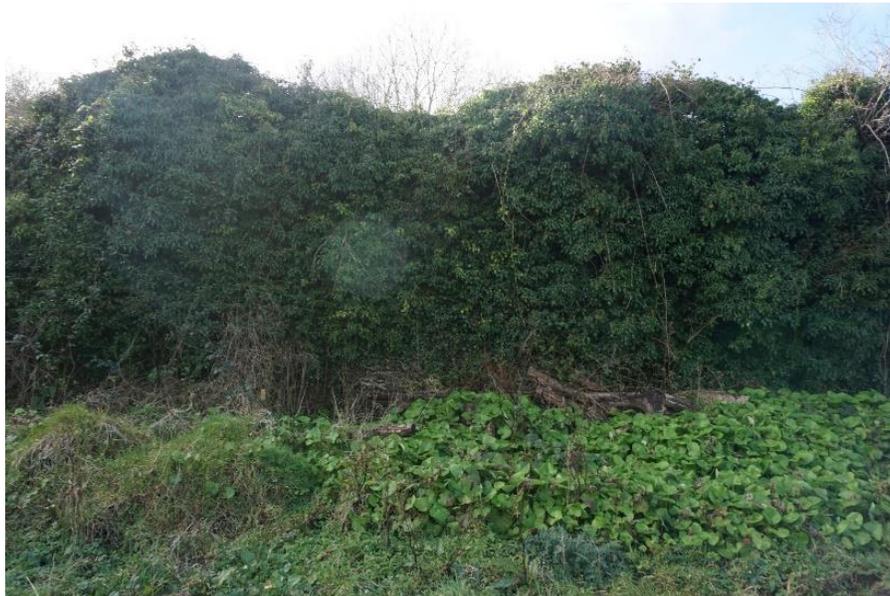
Photograph 34 - View of wall within the site – to be retained.

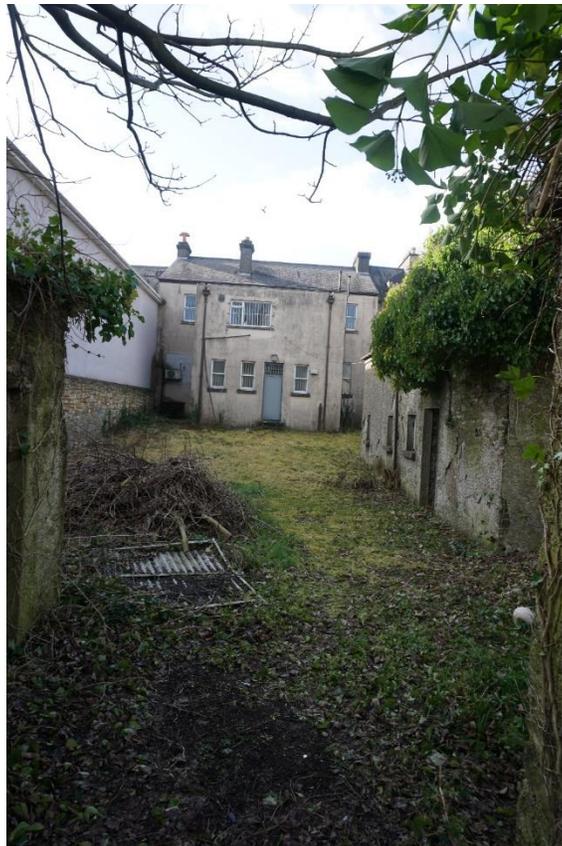
An extension was constructed at the rear of the building (date unknown) this main holds all toilet facilities and the holding area for the former bank.

Photograph 35 – Image of the rear of the building

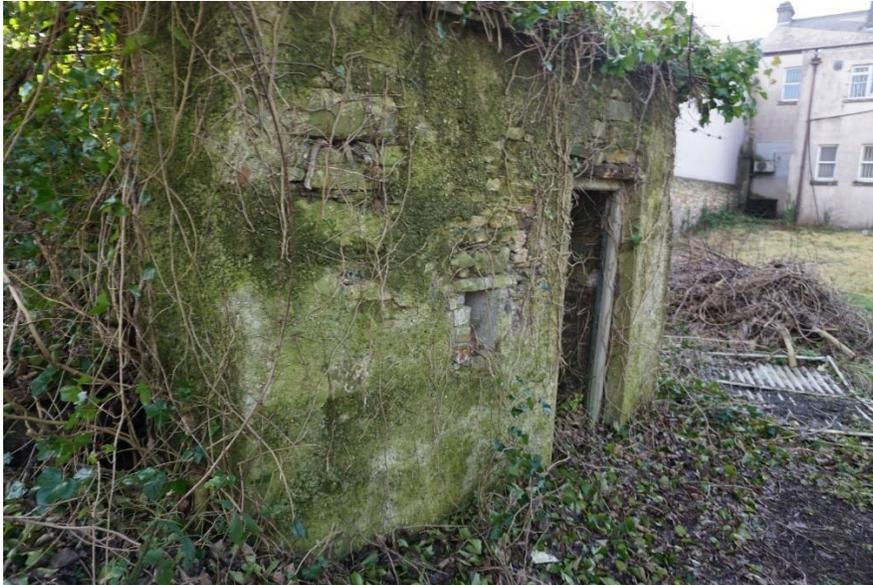
Externally, a shed is located at the rear of the building which has a concrete floor. The site is enclosed by a stone wall that is covered in vegetation. Another outbuilding can be found at the rear of the building however this is fully overgrown.

Photograph 36 – View of the outbuilding at the rear of the building.

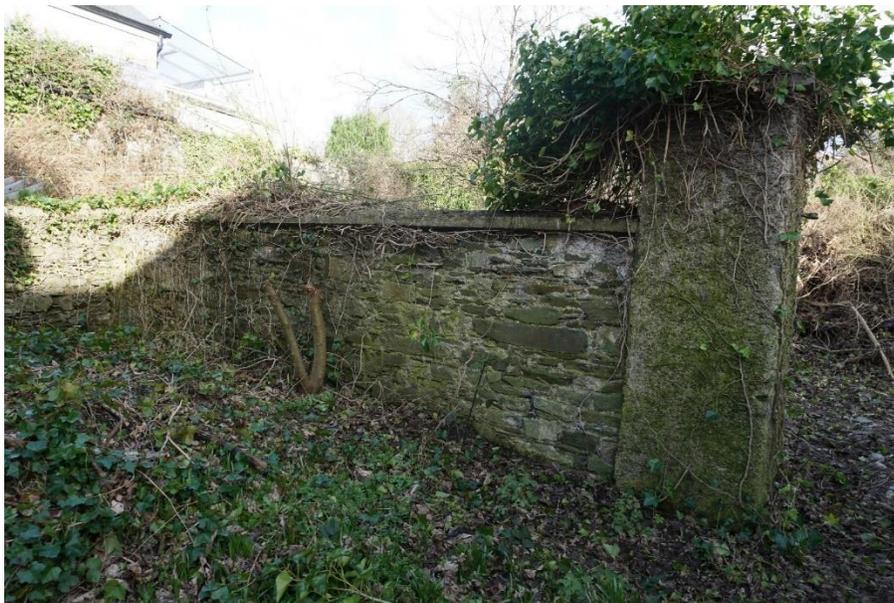
Photograph 37 - View of the stone wall at the rear of the building

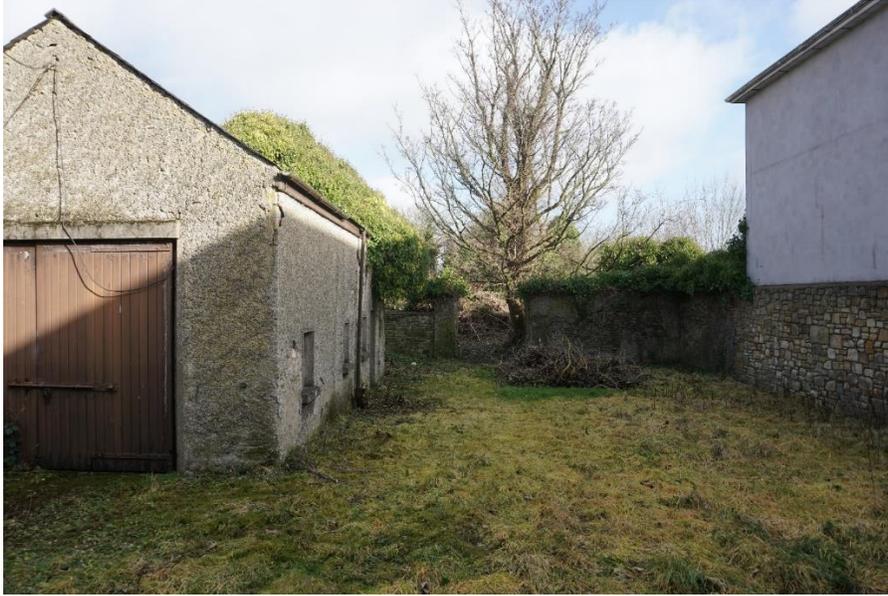
Photograph 38 - View of the rear shed

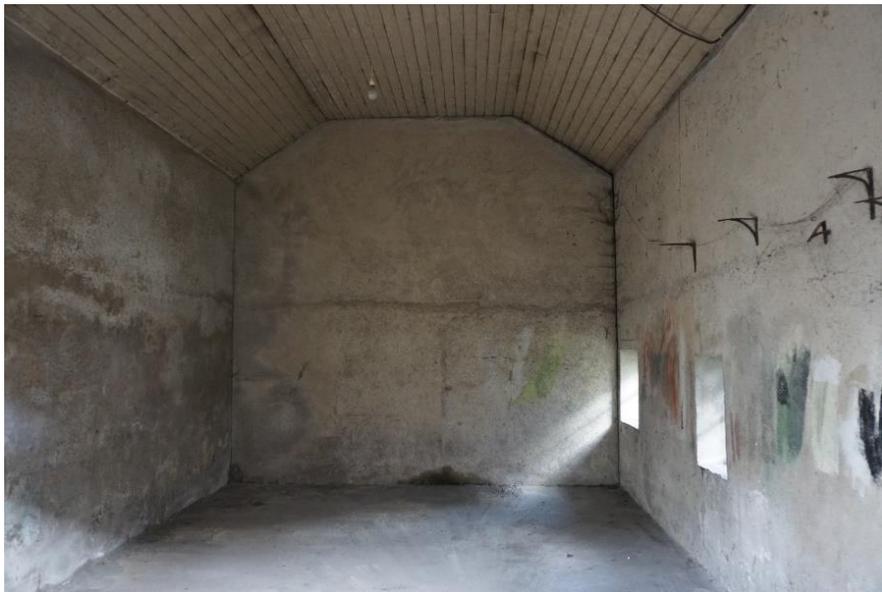
Photograph 39 - Internal view of the rear shed

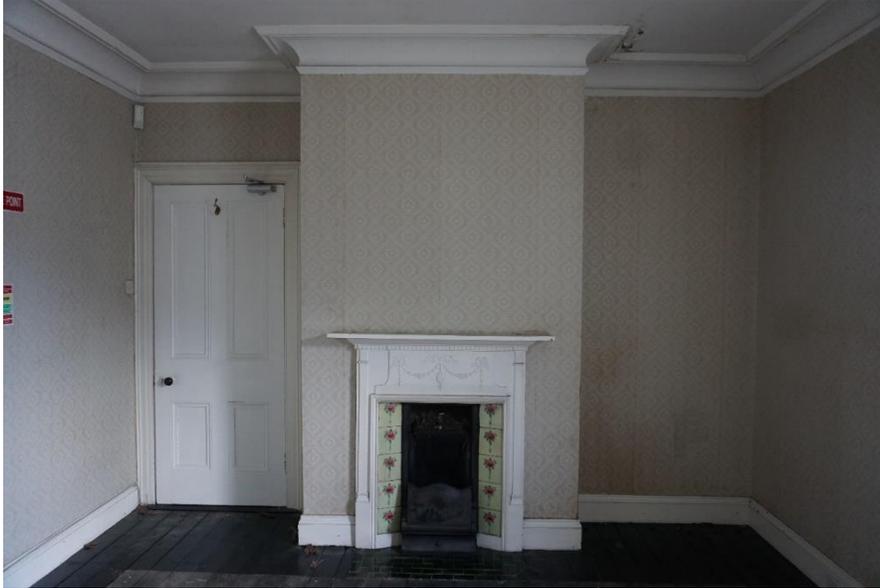
Photograph 40 – Internal view of bedroom within the original section of the building

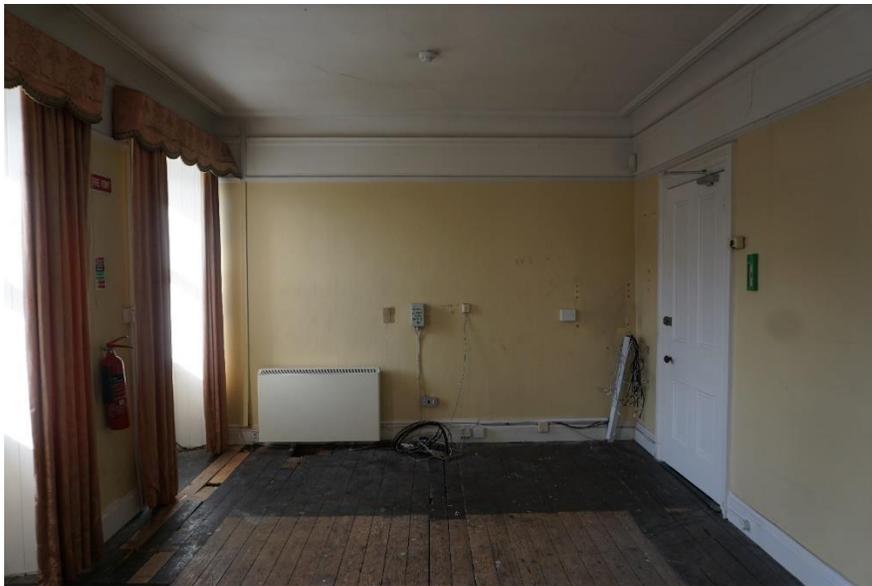
Photograph 41 - Internal view of a former office space

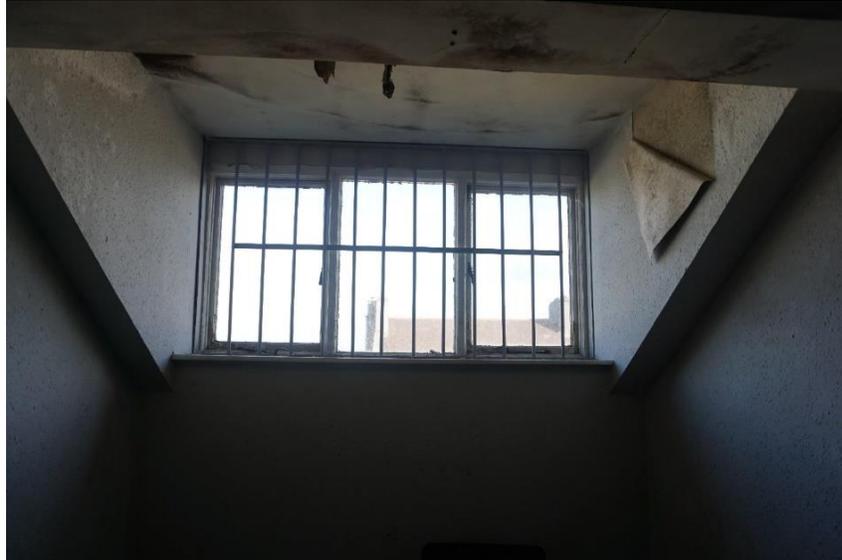
Photograph 54 -Image of the windows within the top floor

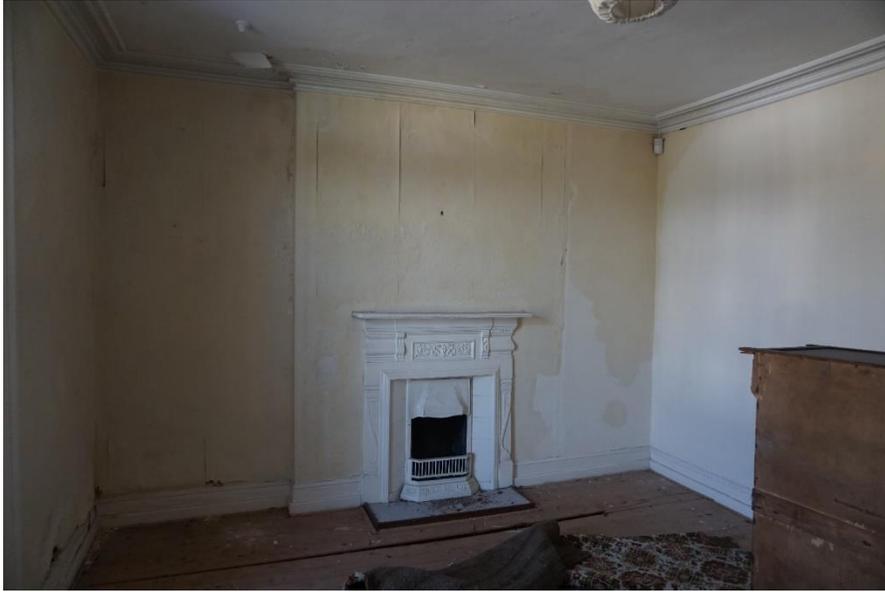
Photograph 60 – View of internal space

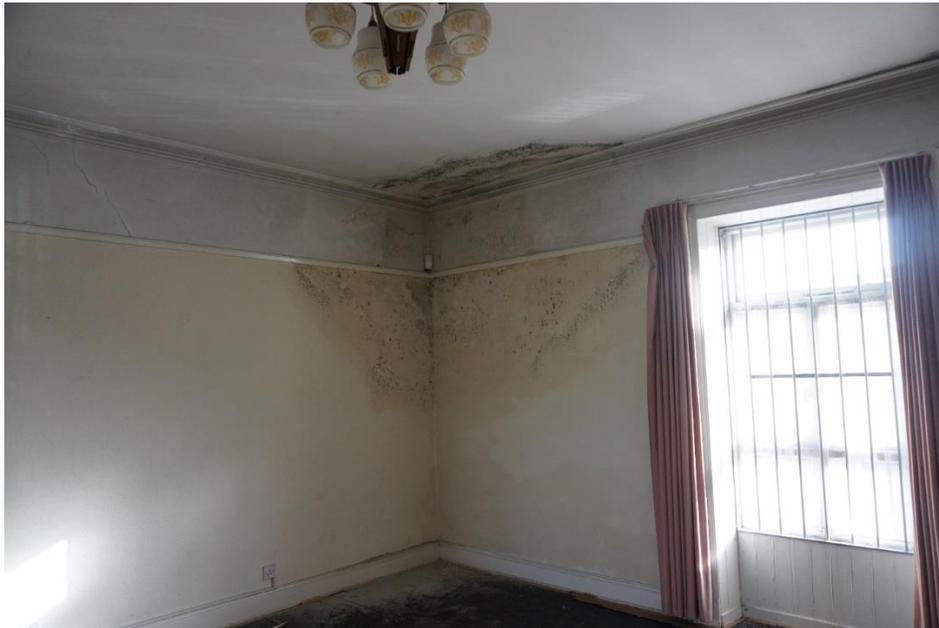
Photograph 63 - View of water ingress at the front of the building

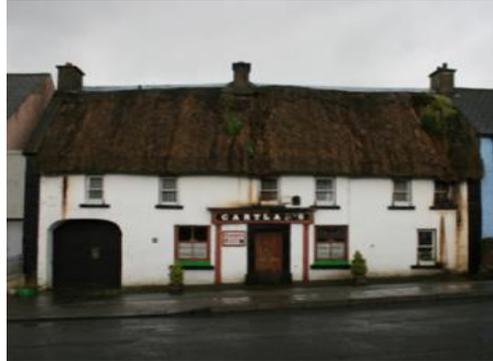
Reg No	40310020
Rating	National
Categories of Special Interest	Architectural, Social, Technical
Original Use	House
Historical Use	Shop/retail outlet
Date	1770 - 1790
Coordinates	278589, 295952
Date Recorded	16/07/2012
Date Updated	--/--

This is an important example of an urban two-storey thatched house, which is unfortunately in poor condition. The elevation is well balanced with informal pairing of the upstairs windows lending regularity in contrast with the variety of openings on the ground floor. The centrally placed pub front with its flanking windows has an interesting informal symmetry. The house is indicative of a scale of thatched houses that once characterised Irish towns and villages. It is a significant addition to the architectural heritage of the county.

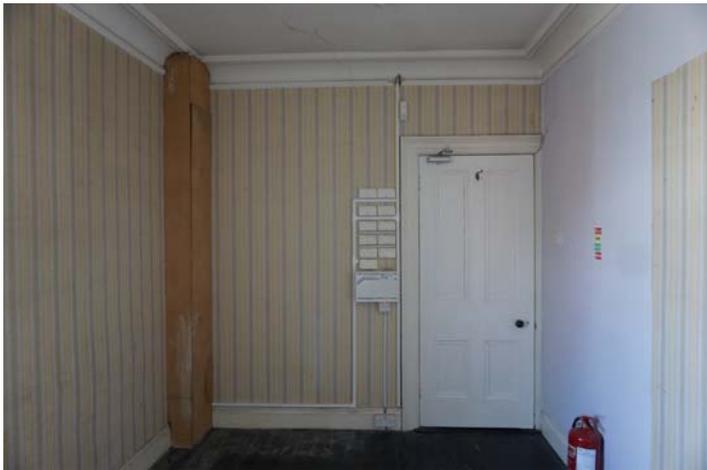
Photograph 59 – View of water ingress damage

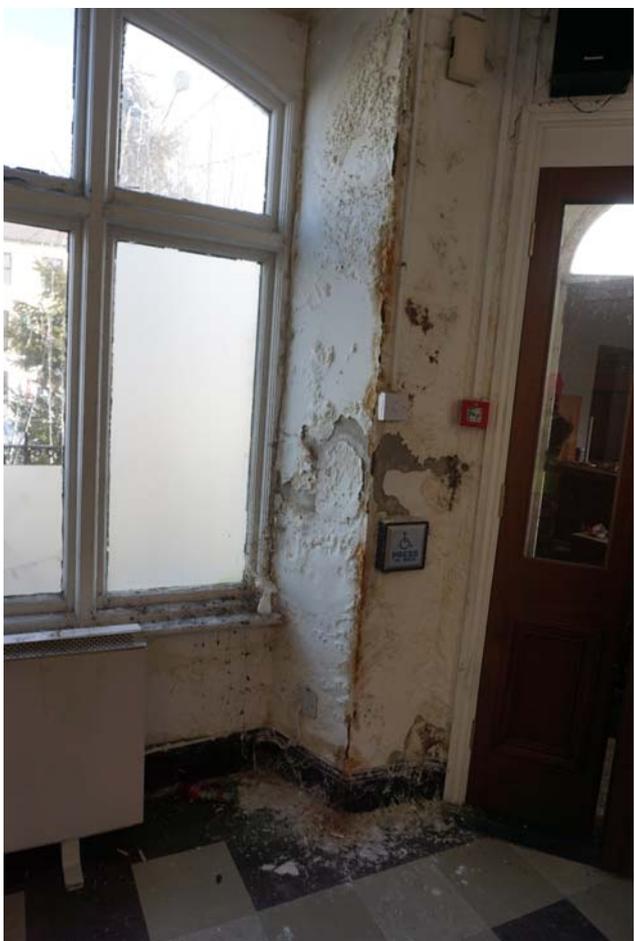
Photograph 71 – View of water damage at ground floor level
